Influence of Thermal Damage on the Mechanical Strength of Trimmed CFRP

Guillaume Mullier, Jean François Chatelain

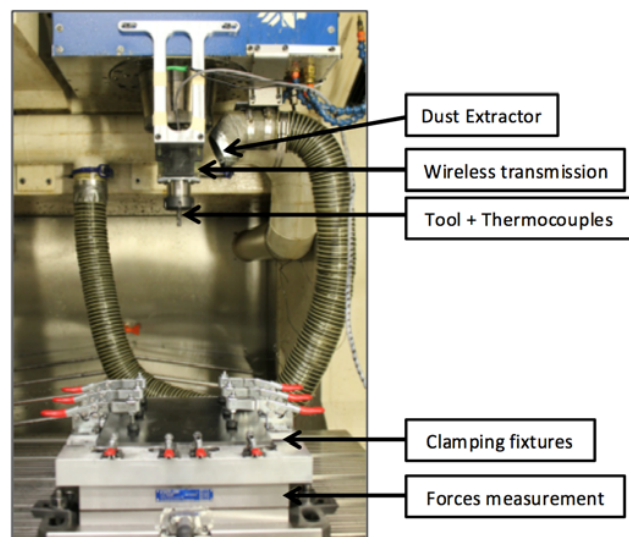
Fig. 1 Experimental set-up for dry trimming of CFRP

It was experimentally determined that a distance of 1.7mm between the cutting area and the welded tip position was suitable for the thermocouple to remain stuck on the tool, resisting the chip flow and the variation in temperature throughout the cutting. As shown in Fig. 1, the temperature data was collected and wirelessly transmitted using a module

embedded in the spindle (Michigan Scientific Corporation M-320). In addition, cutting forces were recorded using a 3-axis dynamometer table (type Kistler 9255B). The trimming operations were performed using a 3-axis CNC high speed center Huron K2X10 with a maximum spindle speed of 28000rpm at 30kW. The up-milling cutting mode at full radial and axial depths of cut was utilized, so as to minimize macroscopic mechanical defects.

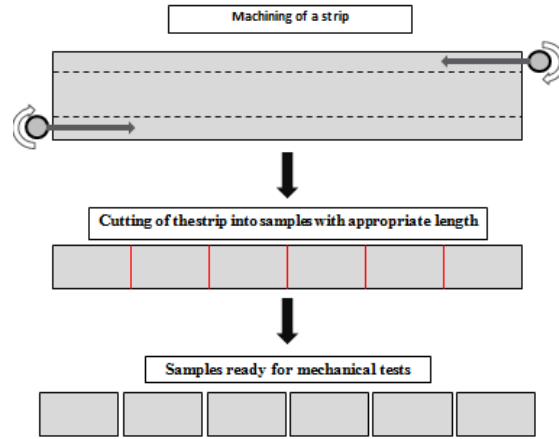
Fig. 2 Trimming of samples

The machined samples were rectangular strips of constant width, cut into smaller test samples of desired length using an abrasive diamond saw (Fig. 2). The final samples will exhibit symmetrical damage (thermal and mechanical) on both bending edges (Fig. 3). Damage which may have been introduced by abrasive cutting have no particular impact as it is out from the supports.

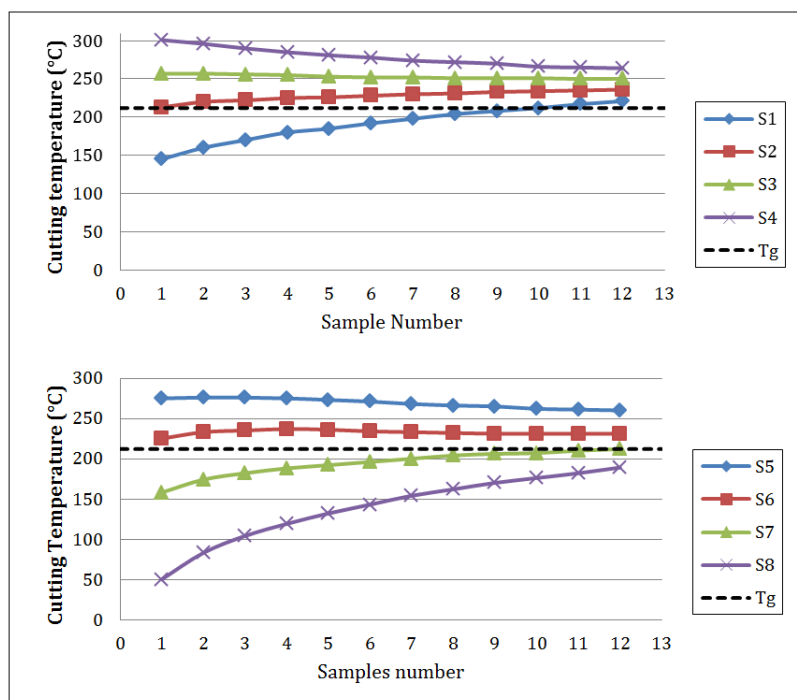
Fig. 5 Cutting temperatures of short beam samples (new tools)

produced (Table II). Strips S2 to S6 were machined with temperatures exceeding the glass transition temperature of the epoxy. The cutting temperature is converging towards the natural cutting temperature of the tool (which is function of the cutting parameters) for both series: it was found to be around 250°C (Fig. 5).

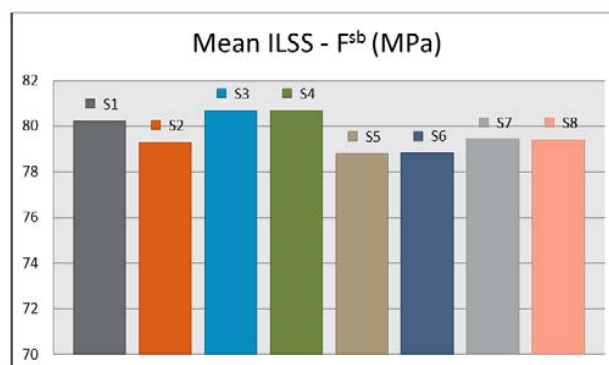
Fig. 6 Averaged ILSS values for each strip (new tools)

As shown in Fig. 6, results regarding interlaminar shear stress resistance for new tools could not show any trend regarding cutting temperature and length of cut. Looking at a single strip, there is no particular trend from sample number 1 to 12. Also, the mean ILSS value of each strip is comprised between 79 and 81MPa, which is due to ordinary variation. This phenomenon indicates that the cutting temperature has no influence on the ILSS resistance of the material when using a new tool.

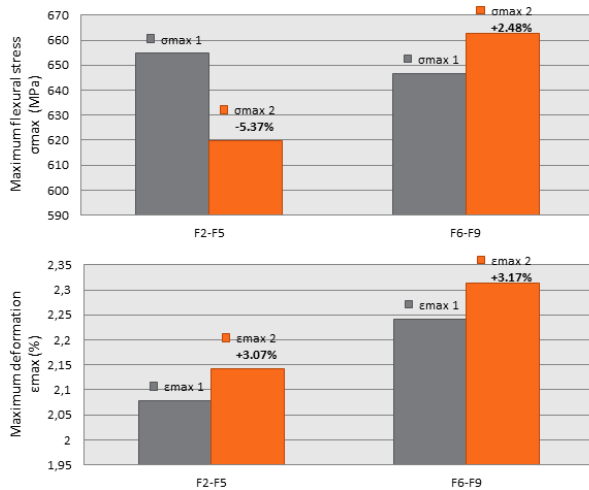
Fig. 7 Mean values from three point bending tests (new tools)

Results coming from the three point bending test show little variation: the trend regarding mean maximum flexural stress reverses, while the trend regarding maximum deformation is

too low to be attributed to the effect of rising cutting temperature (Fig. 7).

In Fig. 7, the mean values are calculated as:

The stress $\sigma_{\max 1}$ and deformation $\varepsilon_{\max 1}$ relates to first sample machined (lower cutting temperature) while $\sigma_{\max 2}$ and $\varepsilon_{\max 2}$ relates to second machined sample (higher cutting temperature) on a given strip.

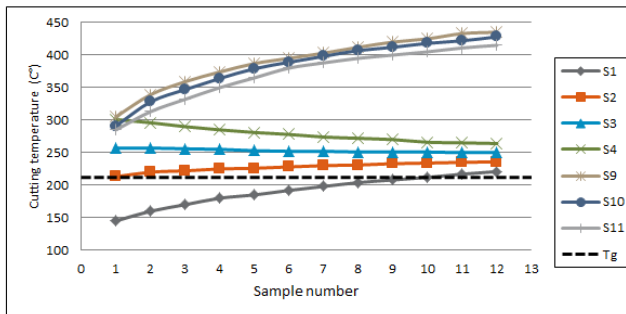
Fig. 8 Cutting temperature of short beam samples (new and worn tools)

The second approach proposes to proceed with the same methodology as previous, but using worn tools and an approximately constant preheating temperature. A total of 36 samples were machined using 3 worn tools exhibiting different levels of flank wear (Vb), coating integrity and cutting edge radii (Table IV). The cutting temperature now peaks up to 425°C at the end of the cutting process (Fig. 8). Globally, the temperature at which samples are machined is a lot higher than the glass transition temperature of the resin, thus thermal damage is likely to occur.

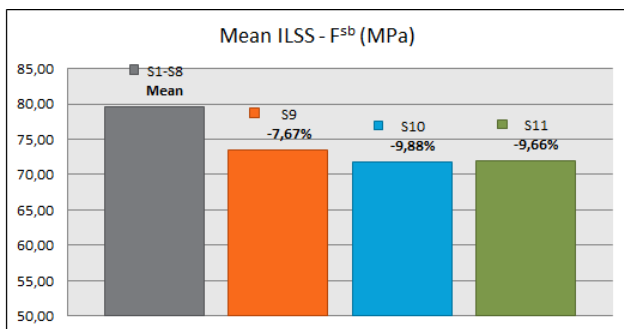
Fig. 9 Comparison between mean ILSS values of samples machined using new and worn tools

As shown in Fig. 9, ILSS did not show any conclusive variation with the cutting temperature on a given strip. However, the mean value of each strip (S9 to S11) compared to the averaged ILSS value over S1 to S8 strips shows that substantial amount of both thermal and mechanical damage occurs during machining. The loss of resistance ranges from -7.67 to -9.88%.

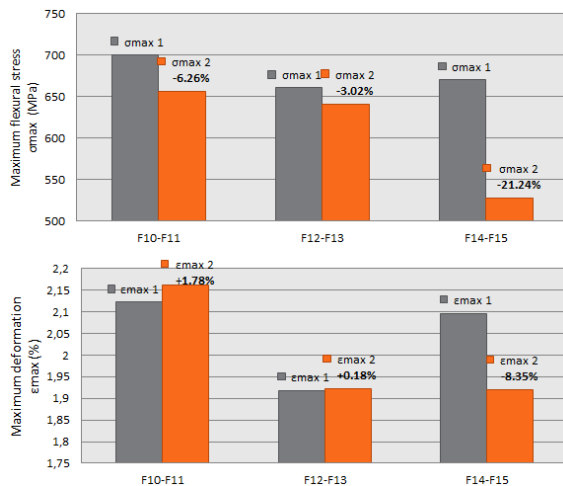
Fig. 10 Calculated mean values from three point bending tests

In Fig. 10, the mean values calculated are nearly equal to the mean results from samples machined using new tools. However, trends regarding the cutting temperature can be seen for all the tools when considering the maximum flexural stress. The second machined sample always exhibits a lower maximum flexural stress than the first one ($\sigma_{\max 2}$ VS $\sigma_{\max 1} = -3\%$ to -21%). This phenomenon indicates that the rising temperature during the cutting induces increasing thermal damage: this explains why the second

portion of a given strip exhibits lower resistance than the first one.

In Fig. 10, the mean values are calculated as:

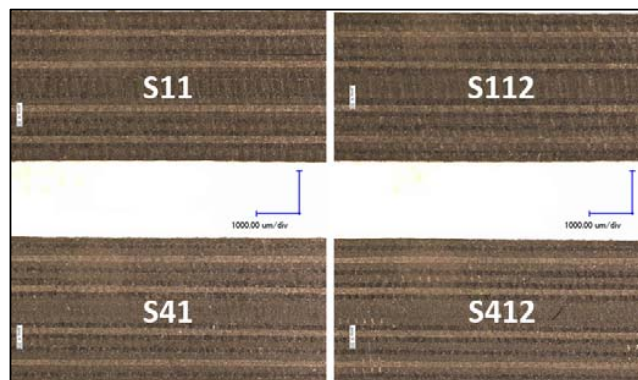
Fig. 11 Constant damage induced on the machined surface of short beam samples regardless of the cutting temperature (new tools)

Inspection of the surface finish is an interesting way to anticipate or understand a reduction of the mechanical strength of the material. In this case, great surface integrity can be observed for the specimens trimmed with a new tool, regardless of the cutting temperature (Fig. 11). The -45° plies show some fibres pull-out, which is a typical defect when dealing with CFRP machining. As tool wear increases, degradation of the matrix occurs and the different plies become harder to differentiate from each other (Fig. 12). This strongly indicates that the resin went through deterioration, resulting in a softened and more homogeneous surface. Also, the surface appears to be darker, which suggests charring of

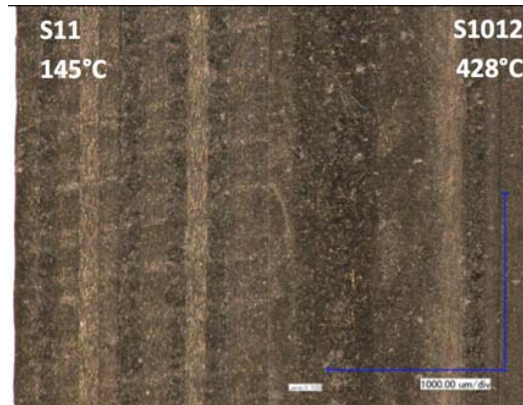
Fig. 12 Comparison between the machined surface using a new tool at low cutting temperature and a worn tool at high cutting temperature

the matrix. In addition, little delamination on the surface plies and some fiber reorientation can be noticed. Also, looking at the surface of the laminate machined using worn tools, increasing degradation in the near zone of the cutting can be seen with the increase of the cutting speed: resin moves back towards the middle of the sample, leaving fibers out of the resin, resulting in some kind of delamination from thermal origin (Fig. 13). Damage on the surface plies for samples machined using new tools was constant and of brittle nature: simultaneous snatching of both fibers and resin and absence of delamination
