# Non-Destructive Evaluation of Launch Tube Welds with Radiography

**Abstract**—The non-destructive testing of launch tube weld with radiography was investigated and evaluated with AWS D1.1 standard. The paper started with preparation of launch tube and radiographic inspection. X-Ray inspection then was done and gotten the result. The judgment of inspection results were concluded by certified person and finally, the evaluation with AWS D1.1 standard was conducted as well.

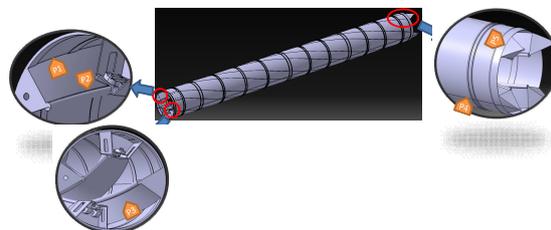
Fig. 2 Inspection position on launch tube

Inspection position: The position is shown in Fig.2

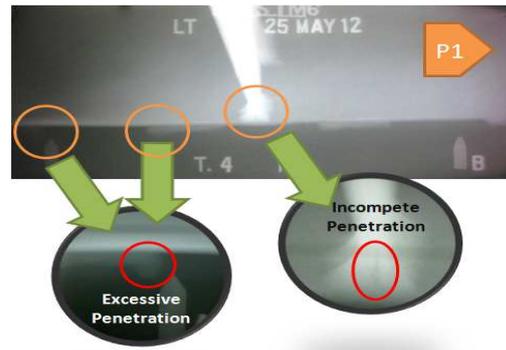
Fig. 3 Inspection result of position P1

No.	Position	Defect	Size	AWS D1.1	Evaluation
1	P1 weld size 5 mm.	EP	1 mm. in length	2 mm. max	Conform
		IP	4 mm. in length	4 mm. max	Non-Conform
2	P2 weld size 5 mm.	P	1 mm. in dia.	2 mm. max	Conform
3	P3 weld size 5 mm.	Found nothing	-	-	Conform
4	P4 weld size 5 mm.	Found nothing	-	-	Conform
5	P5 weld size 5 mm.	P	1 mm. in dia.	2 mm. max	Conform

The weld position P1 contains IP size about 4 mm. AWS D1.1 allows weld discontinuity in case of weld size 5 mm. not exceed 4 mm. in size. Generally, this weld position conforms to standard however, it is marginal accepted and position P1 plays a vital characteristic because it reinforces rail support and will be loaded with impact in service. Consequently, weld position P1 has been rejected and needing corrective action such as removing obsolete weld bead, re-welding, and then inspection again.

This paper studied non-destructive inspection, judgment, and evaluation of launch tube's weld. The judgment of weld performed by certified NDT at least RT level II person. AWS D1.1 had been adopted to assess which welds conformed. The discussion case was weld position P1 which decided as marginal accept because it relied on lower bound of AWS standard. However, P1 could not accept due to it impacted to efficiency of launch tube.
