Performance of Bridge Girder with Perforations under Tsunami Wave Loading

Abstract—Tsunami disaster poses a great threat to coastal infrastructures. Bridges without adequate provisions for earthquake and tsunami loading is generally vulnerable to tsunami attack. During the last two disastrous tsunami event (i.e. Indian Ocean and Japan Tsunami) a number of bridges were observed subsequent damages by tsunami waves. In this study, laboratory experiments were conducted to study the effects of perforations in bridge girder in force reduction. Results showed that significant amount of forces were reduced using perforations in girder. Approximately 10% to 18% force reductions were achieved by using about 16% perforations in bridge girder. Subsequent amount of force reductions revealed that perforations in girder are effective in reducing tsunami forces as perforations in girder let water to be passed through. Thus, less bridge damages are expected with the presence of perforations in girder during tsunami period.

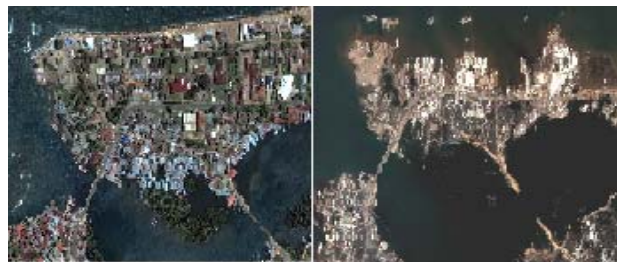
Fig. 1 Effects of tsunami 2004, along coastal line and bridge structures in Banda Aceh, Indonesia

destruction could be identified to be done by tsunami rather than earthquake. Tsunami has the power to destroy or collapse the infrastructures including bridges in its course. Fig. 1 showed the impact attributed by 2004 tsunami along coastal line in Indonesia. Several structural damages were featured by many researchers during 2004 tsunami [1]-[5]. Therefore, it is evident that the tsunami induced forces should be introduced in the design of coastal structures.

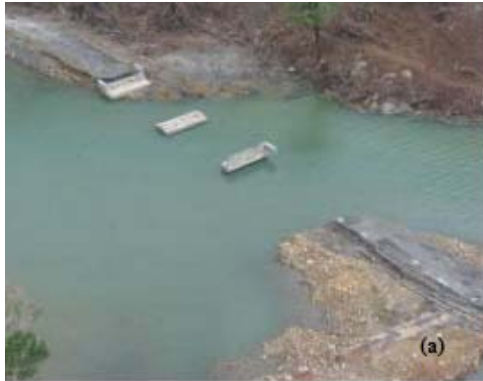
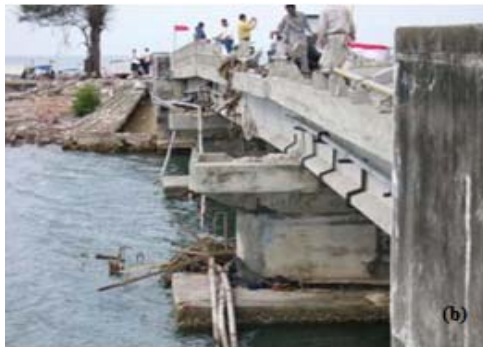
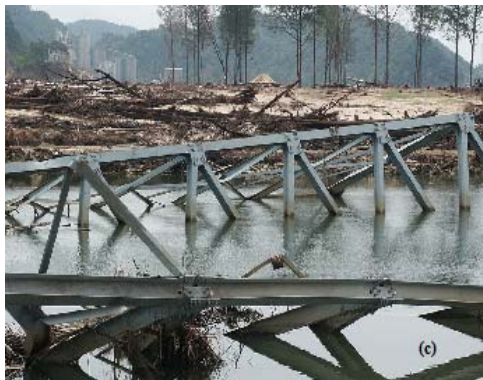
Fig. 2 Bridge damage due to tsunami attack in Banda Aceh (a) Total Wash-Away of Deck [7] (b) Excessive Deck Displacement [12] (c) Damaged steel truss bridge with damaged cement plant in the background in Lhok Nga, Banda Aceh

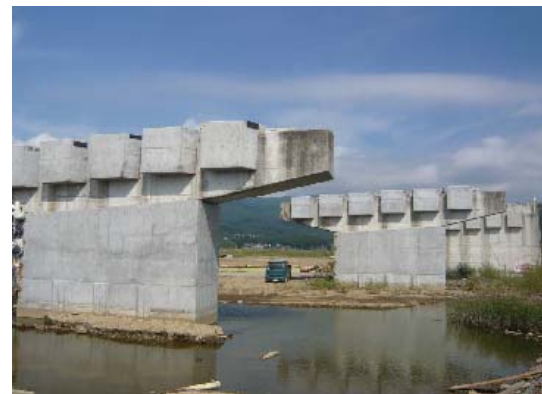
Fig. 5 Damaged Numata-Kosen bridge during Tohoku Tsunami

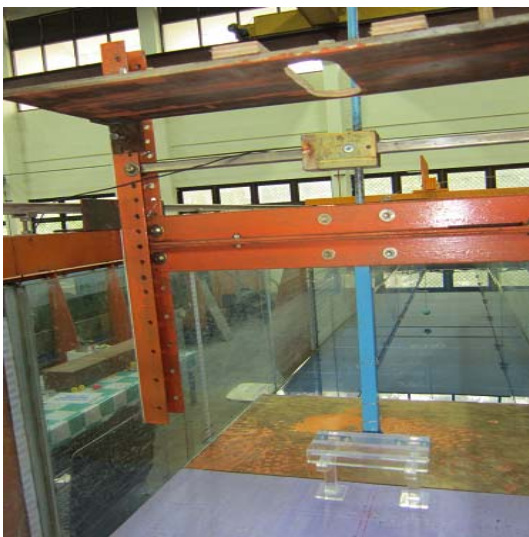
Fig. 9 Photo of the bridge model installed inside the flume
