# Recurring as a Means of Partial Strength Recovery of Concrete Subjected to Elevated Temperatures

Shree Laxmi Prashant, Subhash C. Yaragal, K. S. Babu Narayan

**Abstract**—Concrete is found to undergo degradation when subjected to elevated temperatures and loose substantial amount of its strength. The loss of strength in concrete is mainly attributed to decomposition of C-S-H and release of physically and chemically bound water, which begins when the exposure temperature exceeds 100°C. When such a concrete comes in contact with moisture, the cement paste is found rehydrate and considerable amount of strength lost is found to recover. This paper presents results of an experimental program carried out to investigate the effect of recurring on strength gain of OPC concrete specimens subjected to elevated temperatures from 200°C to 800°C, which were subjected to retention time of two hours and four hours at the designated temperature. Strength recoveries for concrete subjected to 7 designated elevated temperatures are compared. It is found that the efficacy of recurring as a measure of strength recovery reduces with increase in exposure temperature.

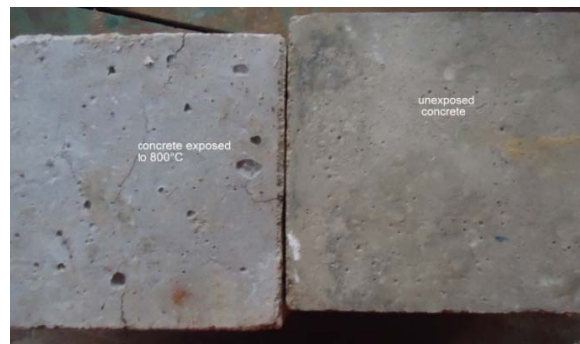
Fig. 2 Concrete exposed to 800°C

Fig. 2 shows the surface of concrete exposed to 800°C along with the concrete at room temperature. Concrete subjected to elevated temperature showed colour change and surface cracking. Changes reported here are similar to those reported by previous researchers [3], [11]. The concrete color changed from normal (at ambient conditions) to pink (400°C) to grey (700°C-800°C). Color changes are found to depend on target temperature. Fig. 2 also shows severe cracking of concrete subjected to 800°C. Cracks are distributed all over the surface of the cubes, but were more pronounced at the edges. However no spalling of edges has taken place. Severe cracking after 700°C and 800°C exposure signifies the deterioration on bond between cement paste and aggregates resulting into substantial loss of strength.
