Seismic Behaviour of Romanian Orthodox Churches, Modeling of Failure Modes by Rigid Blocks

Marius Mosoarca, Victor Gioncu, Ovidiu Cosma

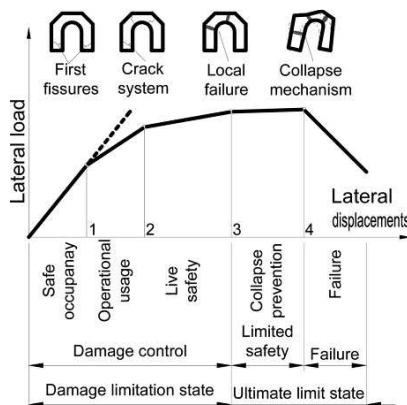
Fig. 1 Behaviour of a masonry triumphal arch

It is well known that masonry structure analysis requires nonlinear modeling accounting for the low tensile capacity and the consequent cracking phenomena. It is well known though that such models cannot be used in the case of very complex structural systems characterized by large number of degree of freedom. In the same time, it is very clearly that the methodologies required for the two limit states differ very much. While for damage limitation state one can use the elastic analysis (with or without considering some fissuration effects), for the ultimate limit state, the methodology must be very different. Therefore, analyzing the behavior of historical buildings, it is needed to be adopted a two step procedure as shown in Fig. 1.

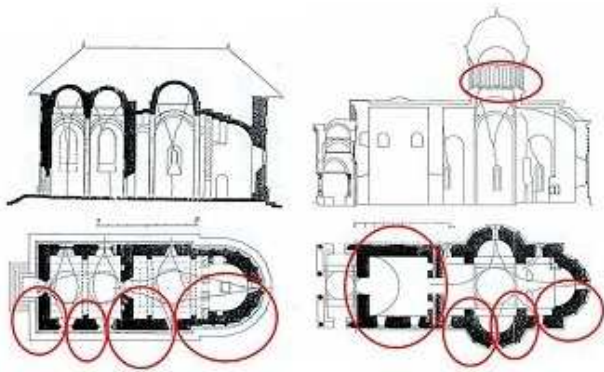
Fig. 7 Damage of Borzesti and Cozia churches due to 1977 Vrancea Earthquake [2]

earthquakes, Fig. 7 presents the Borzesti (rectangular plan) and Cozia (three-lobed plan) churches [2].

Analyzing the occurred system of fissures and cracks it is very clear that the spatial collapse mechanism is formed by a longitudinal fracture and multiple transversal fractures which round the pendentives, due to the great rigidity of these ones.

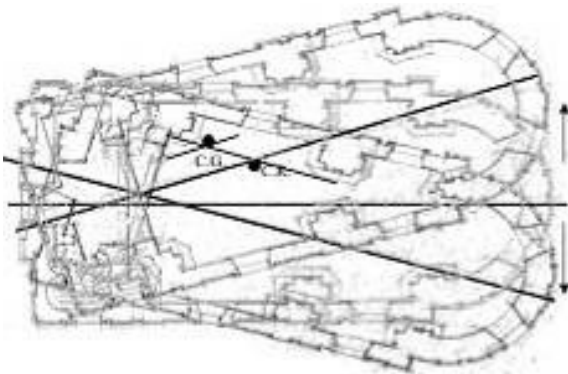
Fig. 12 Rotation of the church

In these circumstances, taking into account the position of the church to the two poles, the church's main action direction is longitudinal. Given the longitudinal asymmetry of the church, the west is much stiffer than the east. The center of rigidity of the structure is moved to the west. At the same time, taking into account the different stiffness of the stair area on the opposite side, the center of rigidity is moved in north. Rotation of the church from the center of rigidity is shown in Fig. 12. It can be noticed that the round wall next to altar is the most stressed, being the farthest from the center of rigidity.

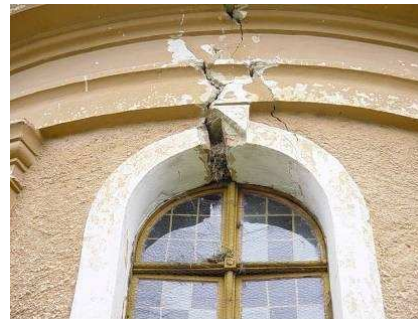
Fig. 14 Cracks at the eastern wall

Brick walls are 75 cm thick, reinforced with brick pillars in front of the roof arches. Masonry structure has a longitudinal symmetry, except the West side where the presence of the stair has introduced an asymmetry characterized by walls with a thickness of 40-45 cm. The window openings on the altar apse and reduced thickness of the wall under the windows have caused cracks in Fig. 14.

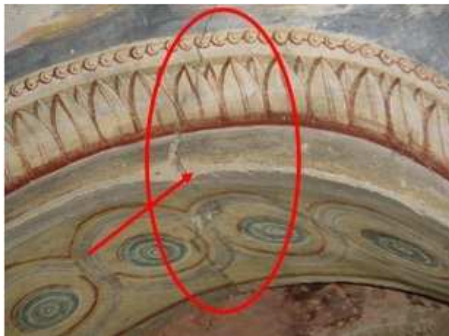
Fig. 16 Cracks at arches

Eastern Tower, not being bounded by land and moving freely with the dome, has minor cracks. Inside the church there are cracks at the top of the vaults because arches don't have ties for taking vertical loads in Fig. 15.

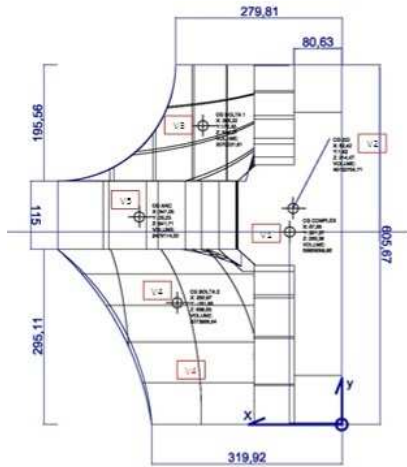
Fig. 20 Dimensions in plan and positions of centers of gravity for block 3

In Fig. 19 and Fig. 20 are shown the dimensions in plan, the positions of the center of gravity and the point of application of seismic force for failure blocks 2 and 3 in 3D coordinates. There are five centers of gravity for each failure block caused by wall, domes and arches. Values of stabilization and overturning moments are presented in Tables III and Table IV. The values are presented in (3) and (4).
