Structural Performance of a Timber-Concrete Bridge Prototype

Pedro Gutemberg de Alcântara Segundinho, José Antonio Matthiesen, Marcelo Rodrigo Carreira

Keywords—Binding, bridge prototype, timber and concrete.

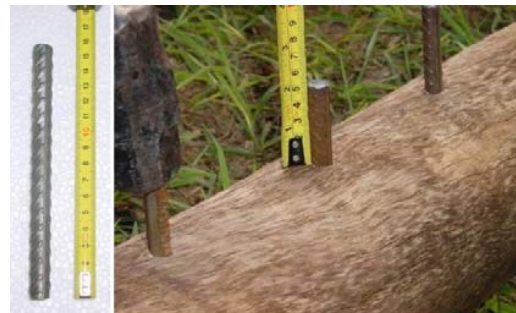
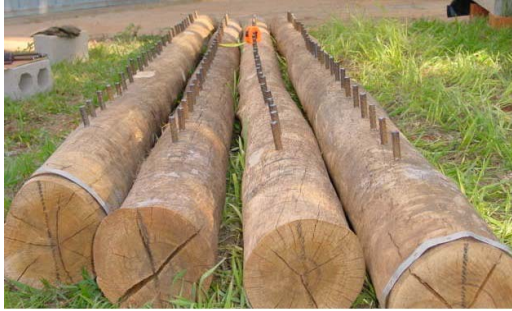
The kind of timber which was used in the timber-concrete bridge construction was *Eucalyptus Urophylla* – *Eucalyptus urophylla*, classified according to [4]. The metal pins used for binding (Figs. 1 (a) and (b)) were made of construction steel bars CA 50, cut on 12.5mm diameter, 150mm length, riveted with 15cm spaces among each other, on pre-drilled holes of 11mm diameter and 100mm depth. A minimum reinforcement was adopted for the concrete slabs, referring to 0.15% of the cross-sectional area to support the efforts, according to [5]. Four timber beams were used for building this bridge prototype. They were characterized through a non-destructive test of static bending, according to [4]. The concrete used for the slab of the timber-concrete bridge prototype was characterized according to compliance with [5].

Fig. 1 Metal pins put on the wood beams (a) and (b)

The study of the timber-concrete bridge prototype also contributes to a better understanding of the binding between these two materials by metal pins tacked with no glue. Certainly, metal pin connectors bounded as an "X", with smaller spacing, may provide greater efficiency for this type of binding. Besides that, further studies about cyclic loading in this type of binding are needed, in order to assess the service life of this structural system.

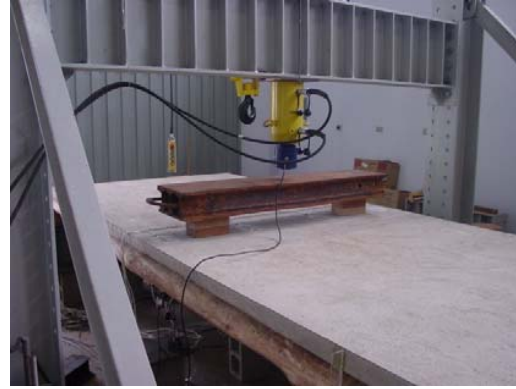
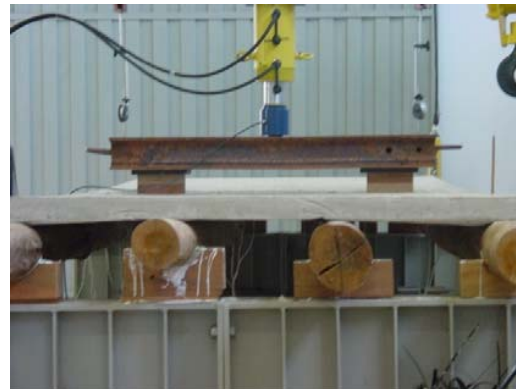
The timber-concrete bridge prototype essays were carried out with applied concentrated loads simulating a vehicle axis on reduced 1:2 scale, located on the central section, according to Figs. 3 (a) and (b).

Fig. 3 Timber-concrete bridge prototype test (a) and (b)

Experimental tests on the timber-concrete bridge prototype were performed in laboratory. To obtain data on vertical displacement, timber and concrete deformation, instruments were placed on the central section of the timber-concrete bridge prototype (Fig. 2). An Iotech DAQbook 120 data acquisition system was used to obtain data from 0.001 mm precision dial gauges, KC70-A1-11 and KFD5-C1-11 strain gauges (SG), and a 1000kN capacity load cell; this system was loaded on a DASYLab 5.0 data acquisition software interface.

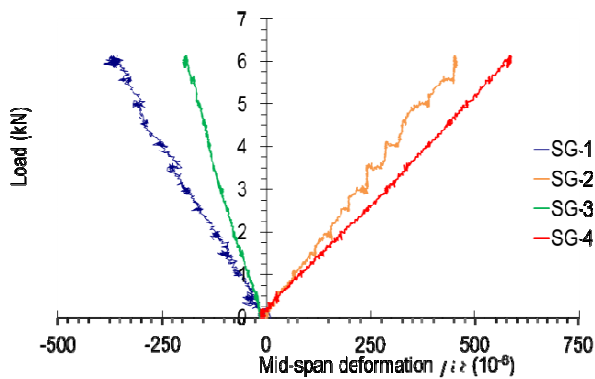
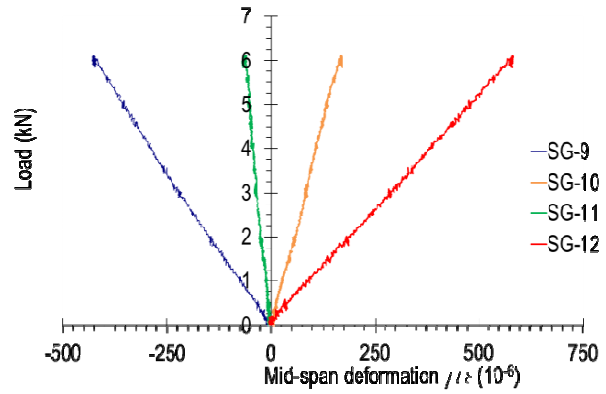
On Figs. 4 (a) to (e) the obtained results from the experimental tests on the timber-concrete bridge prototype are presented. These results show vertical displacement and deformation arising from simulations with load train on reduced 1:2 scale. Experimental results were obtained with care not to exceed an $L/500$ deflection value (8mm vertical displacement) on the central section of the timber-concrete

bridge prototype. The L/500 vertical displacement limitation was due to the serviceability limit state for reinforced concrete structures, according to [5], being lower than the L/200 vertical displacement limitation on the serviceability limit state of timber structure designs, according to [4].

Fig. 4 Mid-span deflection (a), deformation (b) B-1, (c) B-2, (d) B-3 and (e) B-4

From these laboratory experimental results, it is possible to conclude that the values of vertical displacements and deformations are linear up to an $L/500$ serviceability limit deflection of the reinforced concrete, which confirms the good performance of this structural system.

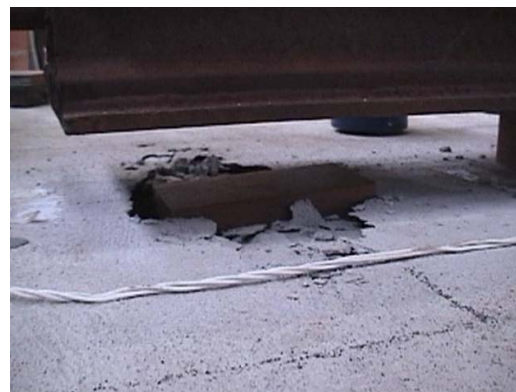
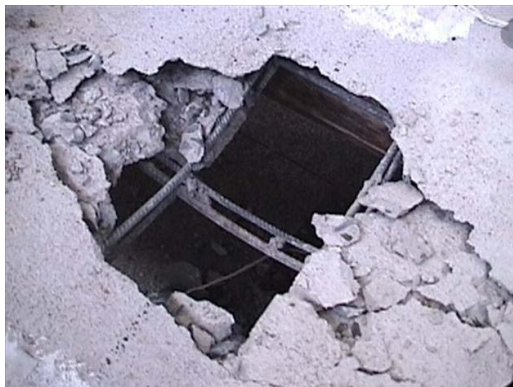
In this experiment, the bridge prototype was taken to rupture by means of the same loading, simulating a load train (Figs. 5 (a) and (b)); the rupture occurred because of a puncture on the concrete slab with a load value of 285kN (142.5kN per wheel) and 8cm vertical displacement. Under these conditions, concrete had also ruptured because of compression on the central cross section of the timber-concrete bridge prototype.

Fig. 5 Rupture of the bridge prototype's central section (a) and (b)
