Sustainable Development in Disaster Affected Rural Areas: The Case of Dinar Villages

Nese Dikmen

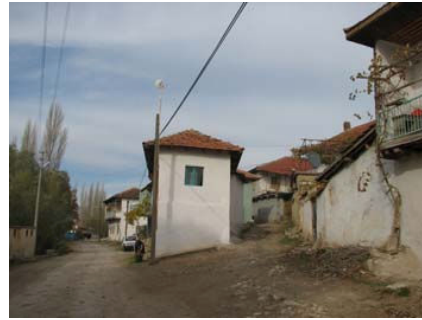
It was observed that the traditional settlements and the houses in the region show the characteristics of rural areas in Turkey. However, there are differences between the settlements erected after the disaster and traditional settlements. In spite of existing villages' organic form, new settlements were erected on a grid pattern. It is very difficult to distinguish the new settlements from each other, however the existing villages and the buildings in them have their own characteristics related to physical, socio-cultural and economical factors. Fig. 1 shows an existing village and Fig. 2 illustrates a new settlement.

Fig. 1 View from an existing village (Dikici Village)

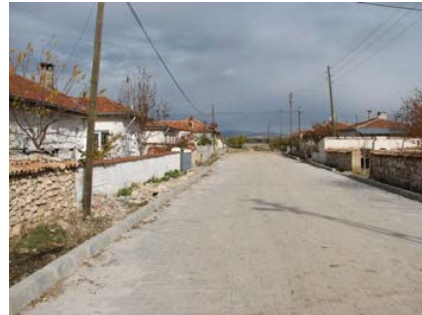
Fig. 2 View from a new settlement (Gencali Village)

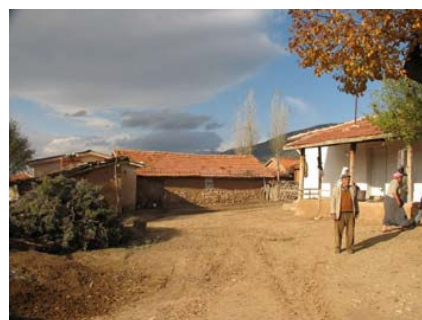
Research reveals that villagers modified the post-disaster houses and the cattle sheds. In addition, some of the beneficiaries constructed new buildings on their lots. Common additions are leans to roofs, storerooms and bread houses (space used for making bread) and most common new buildings are straw houses and cattle sheds (Fig. 3). Economy is dependent on agriculture and animal rearing in this region. Research in the region shows that some of the beneficiaries who rear animals did not get cattle shed, however some villagers who do not have animals got cattle shed during the provision period. Because of this, villagers who rear animals constructed cattle sheds and straw houses, beneficiaries who do not have animals changed the functions of cattle sheds.

Fig. 3 Addition to the post-disaster house and new buildings on the lot (Kızılı Village)

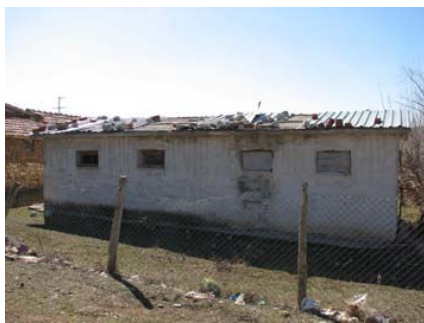
There are workmanship problems on some of the houses. Since metal claddings on the roofs of the cattle sheds were not fixed properly, the claddings have moved up in some of the villages (Fig. 4). Also, drain pipes of some houses and cattle sheds have fallen down. In addition, cracks were observed on the walls of a few houses. Some villagers, who could afford, repaired the buildings. One family left their post-disaster house, on which there are cracks. They said that they did not feel safe in the house.

Fig. 4 Cattle shed with it's moved up roof cladding (Kızıllı Village)

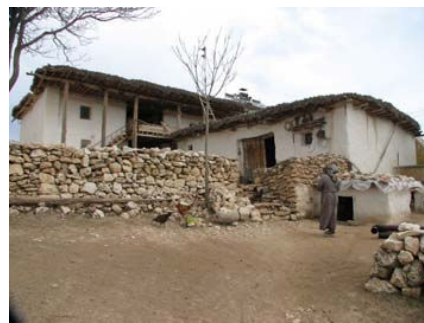
It was seen that the villages and the houses in them are the products of the socio-cultural factors in the study area. The houses in the villages have different characteristics depending on the life styles of the users (Fig. 5). However, the post-disaster houses, designed years ago for any region and any family, do not meet the needs of some of the families. The users had to make additions to the houses and construct new buildings on the lots.

Fig. 5 A traditional house (Karahacılı Village)
