The Comprehensive Study Based on Ultrasonic and X-ray Visual Technology for GIS Equipment Detection

Abstract—For lack of the visualization of the ultrasonic detection method of partial discharge (PD), the ultrasonic detection technology combined with the X-ray visual detection method (UXV) is proposed. The method can conduct qualitative analysis accurately and conduct reliable positioning diagnosis to the internal insulation defects of GIS, and while it could make up the blindness of the X-ray visual detection method and improve the detection rate. In this paper, an experimental model of GIS is used as the trial platform, a variety of insulation defects are set inside the GIS cavity. With the proposed method, the ultrasonic method is used to conduct the preliminary detection, and then the X-ray visual detection is used to locate and diagnose precisely. Therefore, the proposed UXV technology is feasible and practical.

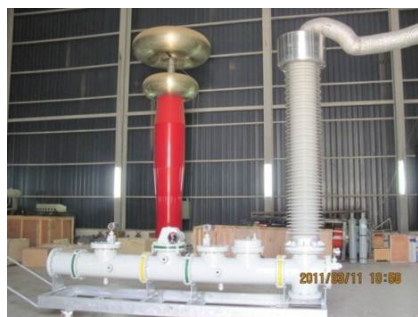
Fig. 2 The physical photo

From the experimental flow chart of the UXV in the Fig. 1, first, the measuring circuit is arranged for the experiment. Then, the insulation defect is set inside the GIS cavity. The ultrasonic method is used to detect preliminarily. If the PD signal is detected, X-ray is used to irradiate the GIS, It is to determine whether there is the insulation defect. The PD detection in GIS cannot depart from the actual operation. If it uses simply coaxial cavity as experimental object, the experimental results will be quite different from the actual situation. So the experiment uses 252kVZF11-252 (L)-type test model which is designed and manufactured specially. Fig. 2 and Fig. 3 show the physical photo and the structure diagram of the experimental model respectively.

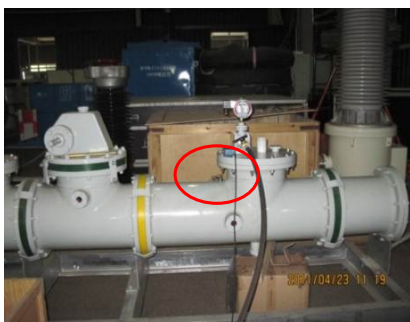
(a) Site layout of the ultrasonic detection equipment

Fig. 5 The site layout photos of the detection equipment

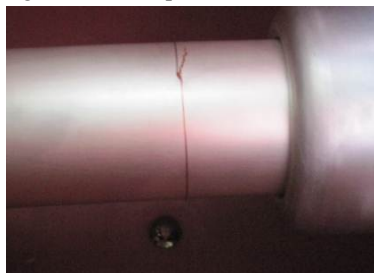
(a) Tip on the high-voltage conductive pole

Fig. 6 The physical layout photos of teh simulated insulation defects

protrusion and the metal suspension as the insulation defect models which are usually caused by poor processing, mechanical damage or scratches when assembling. The high field strength area is created around the metal protrusion, and PD occurs consequently. During the experiment, a section of copper wire is wrapped around the high-voltage conductive pole in the bus segment chamber to simulate this defect type. It is shown in Fig. 6 (a). The length of the tip is 40 mm and the diameter is equivalent to 300 μ m. The second defect model is shown in Fig. 6 (b). A metal tip is set inside the GIS chamber wall. The material is iron wire whose equivalent diameter is 100 μ m and whose cutting-edge length is 30mm. The third model is shown in Fig. 6 (c). A piece of aluminum block is hung in the high-voltage conductive pole by the insulation rope. The distance is 20mm between the aluminum block and the high-voltage conductive pole.

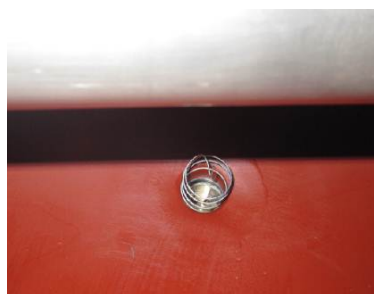
(b) Tip on the ground electrode

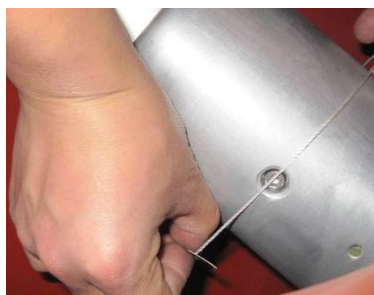
(c) Floating potential
