Urban Search and Rescue and Rapid Field Assessment of Damaged and Collapsed Building Structures

Abstract—Urban Search and Rescue (USAR) is a functional capability that has been developed to allow the United Kingdom Fire and Rescue Service to deal with ‘major incidents’ primarily involving structural collapse. The nature of the work undertaken by USAR means that staying out of a damaged or collapsed building structure is not usually an option for search and rescue personnel. As a result there is always a risk that they themselves could become victims. For this paper, a systematic and investigative review using desk research was undertaken to explore the role which structural engineering can play in assisting search and rescue personnel to conduct structural assessments when in the field. The focus is on how search and rescue personnel can assess damaged and collapsed building structures, not just in terms of structural damage that may be countered, but also in relation to structural stability. Natural disasters, accidental emergencies, acts of terrorism and other extreme events can vary significantly in nature and ferocity, and can cause a wide variety of damage to building structu

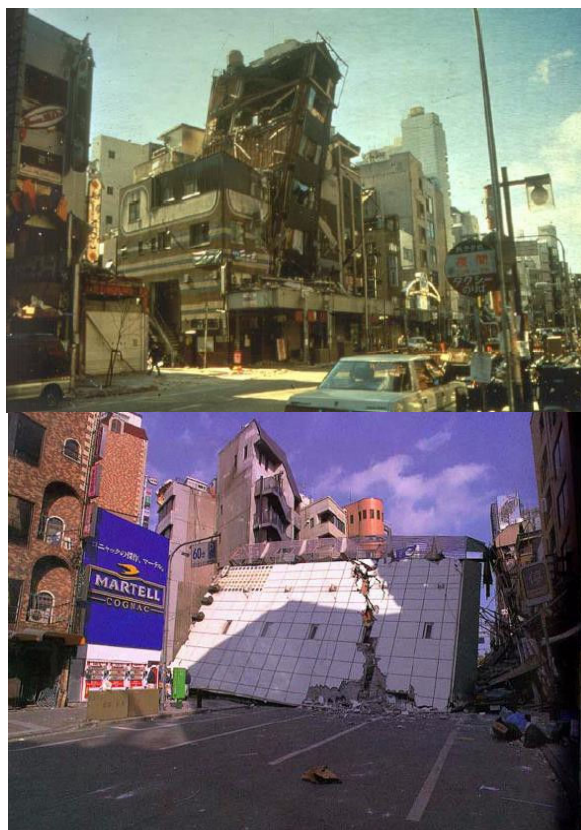
Fig. 3 Example of damage witnessed after the 1995 Kobe, Japan earthquake (a) An unstable building structure [1]. (b) An unstable building structure which collapsed less than 24 hours after the original earthquake [1]

may have collapsed and others may have become unstable which could collapse at anytime, see Fig. 3.

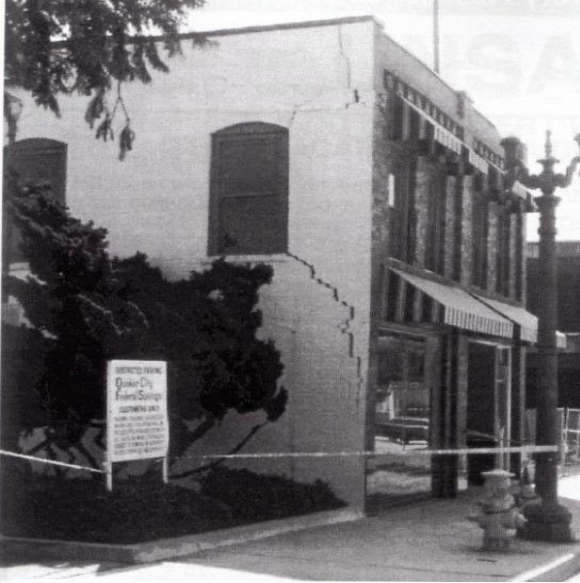
Fig. 6 Example of a crack pattern in the side wall of a masonry building documented in the ATC-20 series [29]

A notable feature of the ATC-20 series is the frequent use of diagrams and photographs as visual aids to emphasise guidelines and procedures, and to illustrate what to look for during visual inspections. Throughout the ATC-20 series it states that a considerable amount of judgment is required to assess damaged building structures and it is very difficult, if not impossible, to develop damage evaluation procedures and guidelines that can be used without judgment. To help those undertaking the tasks of assessing and classifying damage to building structures following an earthquake, photographs have been included throughout the ATC-20 series to document the different types and varying extent of damage, see Figs. 6-9.

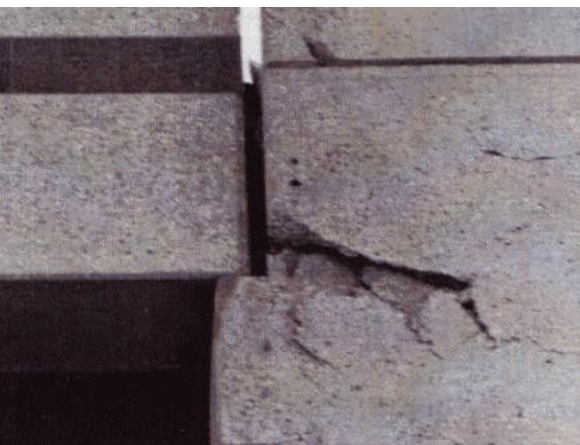
Fig. 8 Example of cracking of a precast concrete support of a parking structure documented in the ATC-20 series [29]

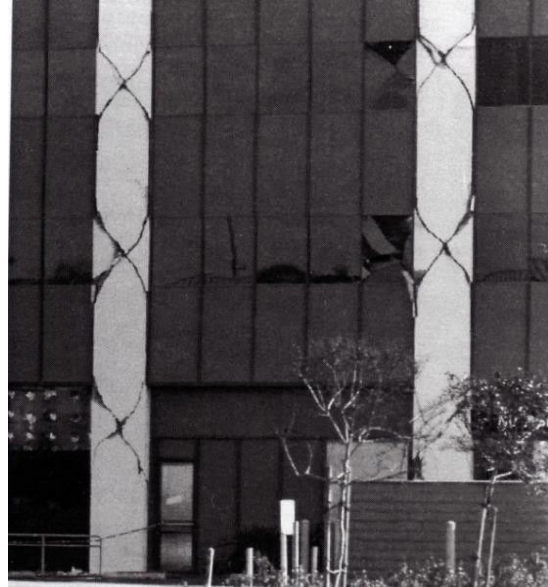
Fig. 9 Example of failed concrete piers (x-cracks) of a multi-storey building documented in the ATC-20 series [29]

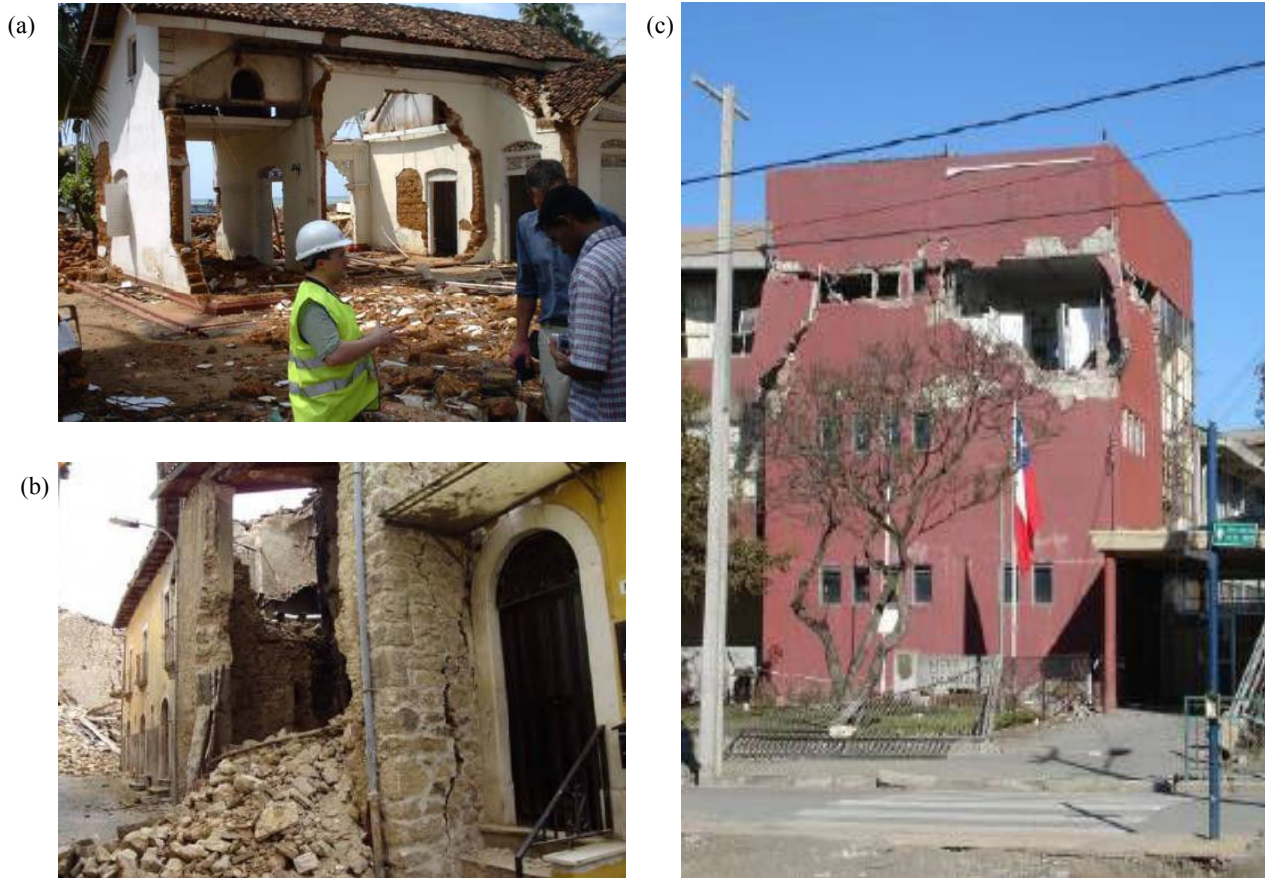
Fig. 10 Examples of damaged and collapsed building structures documented in reports by EEFIT (a) Tsunami damage to a residential building in Kalutara, Sri Lanka [32] (b) Earthquake damage to a traditional residential building in San Gregorio, Italy [41]. (c) Earthquake damage to a school building in Talcahuano, Chile [35]

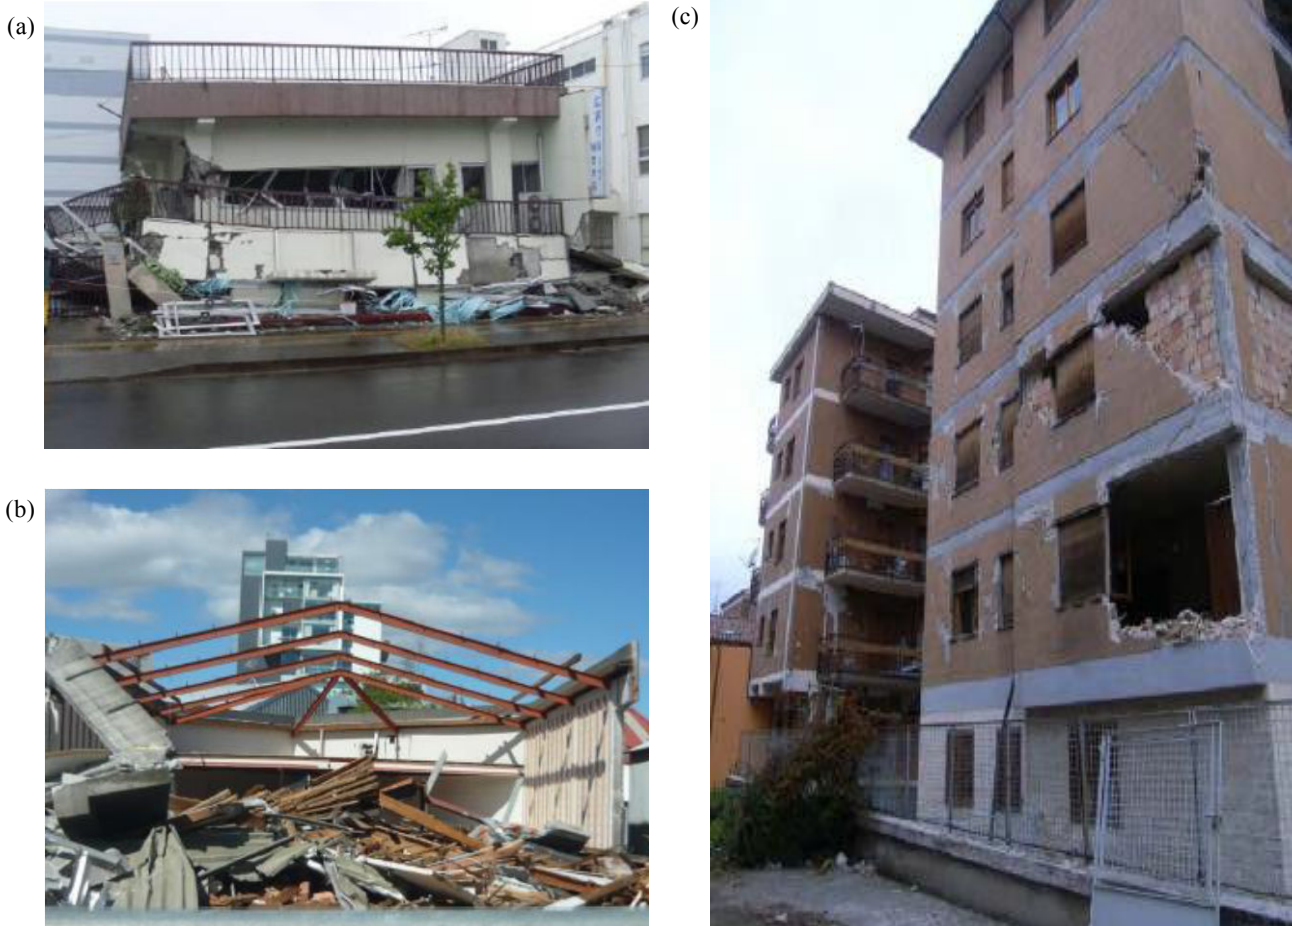
Fig. 11 Examples of damaged and collapsed building structures documented in reports by EEFIT and other publications (a) A collapsed office building in Oroshi, Japan [36]. (b) A partially-collapsed warehouse in Christchurch, New Zealand [39]. (c) Earthquake damage to an apartment block in L'Aquila, Italy [41]
