# Observation and Study of Landslides Affecting the Tangier – Oued R'mel Motorway Segment

S. Houssaini, L. Bahi

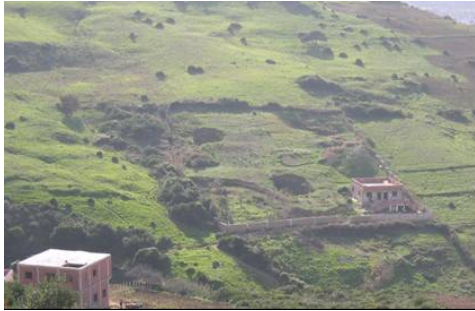
This is the case is most frequently observed on the project area. Fig. 2 shows a representative case of landscapes encountered in the case of a pelitic substratum (Here Sector Ksar).

Fig. 2 Solifluction between Ksar and Oued

The hummocky slope aspect does not prevent the development of vegetation. The main cause of the solifluction formation comes from the presence of water in the surface layers which are made of very plastic clays, the ultimate product of weathering of the underlying mudstones.

The thickness of the layers movement generally does not exceed those of clay formations covers (maximum 2-3 m).

Stabilization of such slope passes including a drainage layer (using spurs, masks, trenches) and recovery.

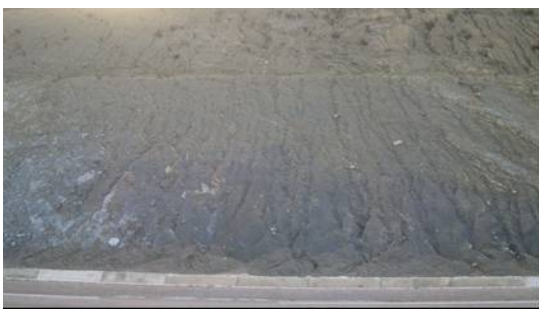
Fig. 4 Gully in road embankments in mudstones - Oued R'mel

Fig. 4 shows another form of typical pelitic gully areas. As mudstones are slightly permeable materials, the entire (or almost) precipitation will flow on the surface. The pelites deteriorate outdoors in fine materials to very fine (GTR class: A1, A2 or A3). With slope, water carries these clays altered at the foot of slope and leaves flow paths that can be deep (here: about 20 to 50 cm between the peak and the bottom of ravines).

A gully can be stabilized by:

- Limiting the rate of runoff by creating slope failure in the ravine;
- Facilitating the infiltration of precipitation sumps or drainage trenches; [5].
- Developing evapotranspiration with a resistant plant tissue;
- Evacuating faster precipitation in watertight concrete example ditches.

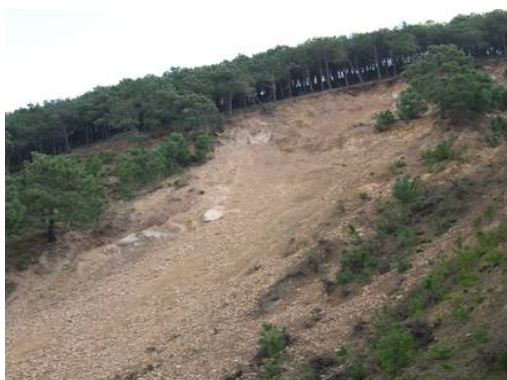
Fig. 6 shows the final form of slope instability: rock falls. The blocks come from regressive erosion of an outcrop, consisting here of sandstone. Blocks down the slope and are classified grano-foot slope. [6].

Fig. 6 Scrap blocks and talus cone - Lachbâa

The areas affected by this phenomenon have a steep slope, and thus are very limited. They can easily detect the landscape.

Two types of protection are possible for this problem:

- Passive protection: creating barricade traps, rocks and / or installation of net Anti-Submarine (usually called ASM)
  - Active protection: periodic purge, protection of the cliff
- In the case of this project, passive solutions have been favored with the creation of traps stones and barricades.
