# Observation and Study of Landslides Affecting the Tangier – Oued R'mel Motorway Segment

**Abstract**—The motorway segment between Tangier and Oued R'mel has experienced, since the beginning of building works, significant instability and landslides linked to a number of geological, hydrogeological and geothermic factors affecting the different formations.

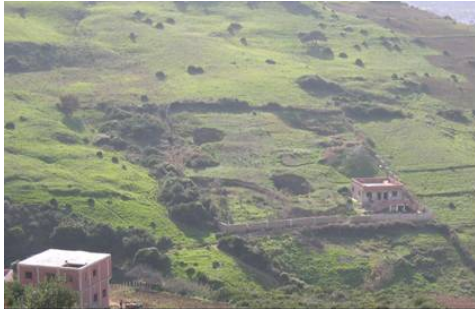
This is the case is most frequently observed on the project area. Fig. 2 shows a representative case of landscapes encountered in the case of a pelitic substratum (Here Sector Ksar).

Fig. 2 Solifluction between Ksar and Oued

The hummocky slope aspect does not prevent the development of vegetation. The main cause of the solifluction formation comes from the presence of water in the surface layers which are made of very plastic clays, the ultimate product of weathering of the underlying mudstones.

The thickness of the layers movement generally does not exceed those of clay formations covers (maximum 2-3 m).

Stabilization of such slope passes including a drainage layer (using spurs, masks, trenches) and recovery.

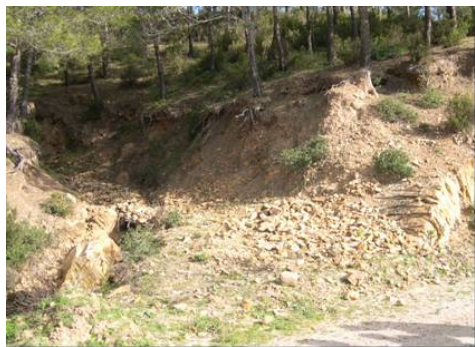
Fig. 3 Gully in a trough in the sandstone - Lachbâa

Fig. 3 shows the typical shape of a large gully erosion in the sandstone beds. During important rainfalls, water runs off the soil and is collected in the ravines of this type. The weathered sandstone blocks are pushed down slope because of the kinetic energy of the water, caused by the steep slope, together with a large volume of water (depending on the watershed) in motion. After some time, the bed of the trough stabilizes the massive sandstone unaltered. Erosive cycle will resume once the new bed is altered during a stormy new episode.

A gully can be stabilized by:

- Limiting the rate of runoff by creating slope failure in the ravine;
- Facilitating the infiltration of precipitation sumps or drainage trenches; [5].
- Developing evapotranspiration with a resistant plant tissue;
- Evacuating faster precipitation in watertight concrete example ditches.

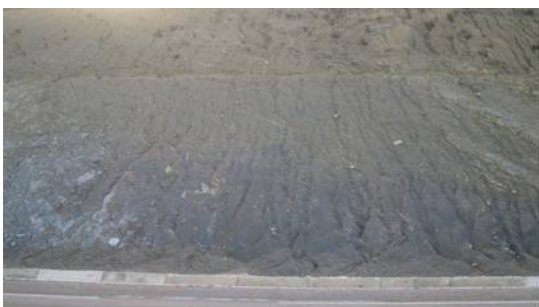
Fig. 4 Gully in road embankments in mudstones - Oued R'mel

Fig. 4 shows another form of typical pelitic gully areas. As mudstones are slightly permeable materials, the entire (or almost) precipitation will flow on the surface. The pelites deteriorate outdoors in fine materials to very fine (GTR class: A1, A2 or A3). With slope, water carries these clays altered at the foot of slope and leaves flow paths that can be deep (here: about 20 to 50 cm between the peak and the bottom of ravines).

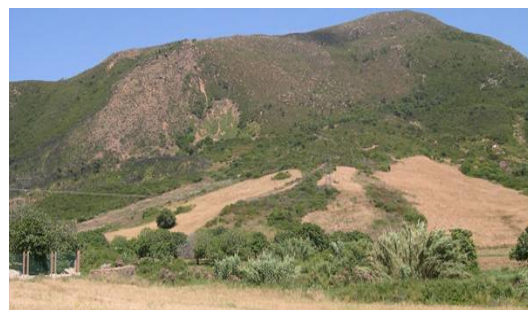
Fig. 5 presents the case of landslide identified on the geological map. It is an old slide (known fossil) which can move again according to changes in hydrogeological conditions, mechanical characteristics, evolution of the mechanical characteristics of materials and other factors such as topographic changes during earthworks.

Fig. 5 Landslide interesting pouring - Valley Ksar es Shrir

The fracture surfaces in this case may be quite deep (generally greater than 5 m but sometimes beyond 10 m deep).

Slip Photography featured on 4 would be difficult to stabilize. Because the strain rates are very low (stabilization phase,) a solution would be there to limit overload and do not alter the hydrogeological conditions, unless to improve them. However, in the absence of a sufficient decrease in the observation of this shift, the bias was to remove the route of this area.

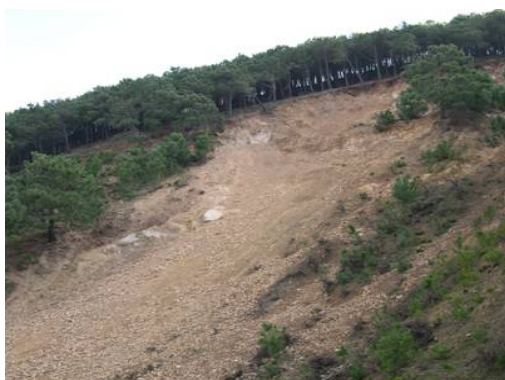
Fig. 6 shows the final form of slope instability: rock falls. The blocks come from regressive erosion of an outcrop, consisting here of sandstone. Blocks down the slope and are classified grano-foot slope. [6].

Fig. 6 Scrap blocks and talus cone - Lachbâa

The areas affected by this phenomenon have a steep slope, and thus are very limited. They can easily detect the landscape.

Two types of protection are possible for this problem:

- Passive protection: creating barricade traps, rocks and / or installation of net Anti-Submarine (usually called ASM)
  - Active protection: periodic purge, protection of the cliff
- In the case of this project, passive solutions have been favored with the creation of traps stones and barricades.
