Non-Destructive Evaluation of Launch Tube Welds with Radiography

Abstract—The non-destructive testing of launch tube weld with radiography was investigated and evaluated with AWS D1.1 standard. The paper started with preparation of launch tube and radiographic inspection. X-Ray inspection then was done and gotten the result. The judgment of inspection results were concluded by certified person and finally, the evaluation with AWS D1.1 standard was conducted as well.

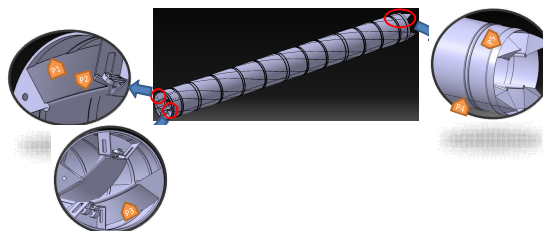
Fig. 2 Inspection position on launch tube

Inspection position: The position is shown in Fig.2

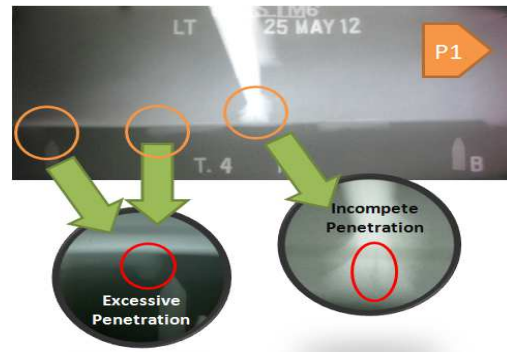
Fig. 3 Inspection result of position P1

No.	Position	Defect	Size	AWS D1.1	Evaluation
1	P1 weld size 5 mm.	EP	1 mm. in length	2 mm. max	Conform
		IP	4 mm. in length	4 mm. max	Non-Conform
2	P2 weld size 5 mm.	P	1 mm. in dia.	2 mm. max	Conform
3	P3 weld size 5 mm.	Found nothing	-	-	Conform
4	P4 weld size 5 mm.	Found nothing	-	-	Conform
5	P5 weld size 5 mm.	P	1 mm. in dia.	2 mm. max	Conform

The weld position P1 contains IP size about 4 mm. AWS D1.1 allows weld discontinuity in case of weld size 5 mm. not exceed 4 mm. in size. Generally, this weld position conforms to standard however, it is marginal accepted and position P1 plays a vital characteristic because it reinforces rail support and will be loaded with impact in service. Consequently, weld position P1 has been rejected and needing corrective action such as removing obsolete weld bead, re-welding, and then inspection again.

This paper studied non-destructive inspection, judgment, and evaluation of launch tube's weld. The judgment of weld performed by certified NDT at least RT level II person. AWS D1.1 had been adopted to assess which welds conformed. The discussion case was weld position P1 which decided as marginal accept because it relied on lower bound of AWS standard. However, P1 could not accept due to it impacted to efficiency of launch tube.
