# Evaluation of Performance Requirements for Seismic Design of Piping System

Bu Seog Ju and Woo Young Jung

**Keywords**—Nonstructural component, piping, hospital, seismic, bracing.

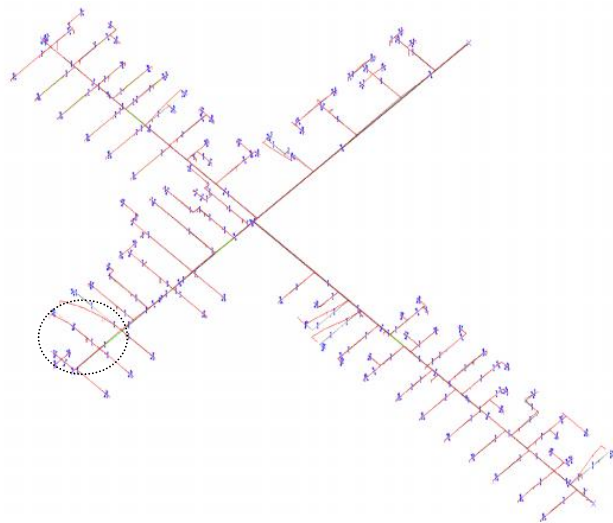
Fig. 6 Displacements of Piping System Subjected to the Lateral Force

Fig. 6 showed the displacements of piping system due to the lateral force. The maximum displacement (31.76 cm) caused in the circle area of piping system and additional results were given in Table II.

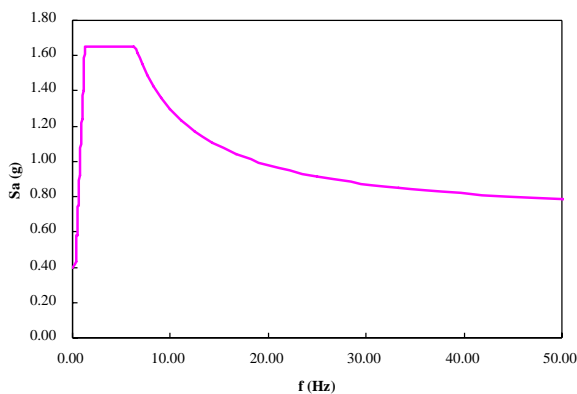
Fig. 7 Design Spectrum Based on UBC-97

Next, in order to understand the dynamic characteristics of piping system, the design spectrum (Fig. 7) based on UBC-97 was created for the piping system.

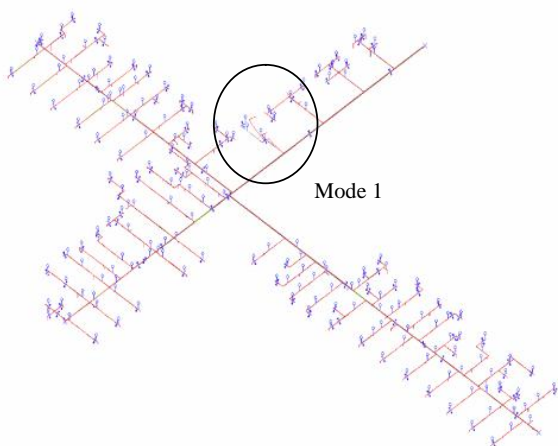
Fig. 8 Piping System Mode Shapes

Furthermore, the fundamental and second frequency of the piping system in fig. 8 was 0.6450 Hz and 0.8384 Hz, respectively. The design spectrum also was applied to the horizontal direction at the piping system. The maximum displacement was 70.13 cm at a branch piping system. Table III also was given the forces and moments in the dynamic analysis.
