# Ageing Deterioration of Silicone Rubber Polymer Insulator under Salt Water Dip Wheel Test

**Abstract**—This paper presents the experimental results of silicone rubber polymer insulators for 22 kV systems under salt water dip wheel test based on IEC 62217. Straight shed silicone rubber polymer insulators having leakage distance 685 mm were tested continuously 30,000 cycles. One test cycle includes 4 positions, energized, de-energized, salt water dip and de-energized, respectively. For one test cycle, each test specimen remains stationary for about 40 second in each position and takes 8 second for rotate to next position. By visual observation, severe surface erosion was observed on the trunk near the energized end of tested specimen. Puncture was observed on the upper shed near the energized end. In addition, decreasing in hydrophobicity and increasing in hardness were measured on tested specimen comparing with new specimen. Furthermore, chemical analysis by ATR-FTIR was conducted in order to elucidate the chemical change of tested specimens comparing with new specimen.

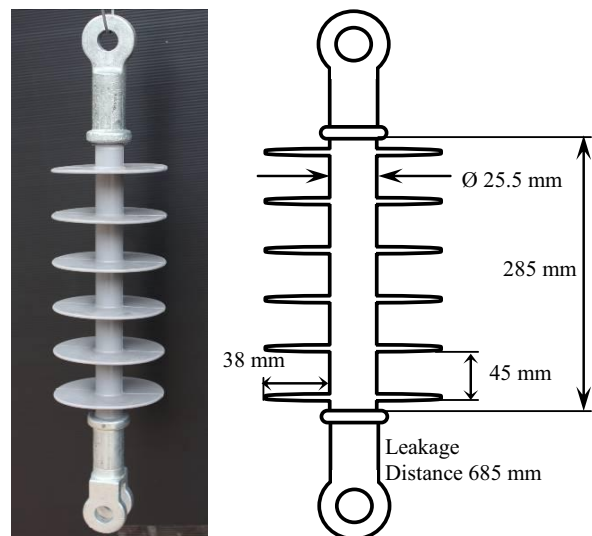
Fig. 1 Specimen.

Straight shed polymer insulators made were of HTV silicone rubber with ATH (Alumina trihydrate) was used in this experimental. Four pieces of the specimen were tested together under test conditions based on IEC 62217 [9]. Configuration and dimension of the specimen are illustrated in Fig. 1.

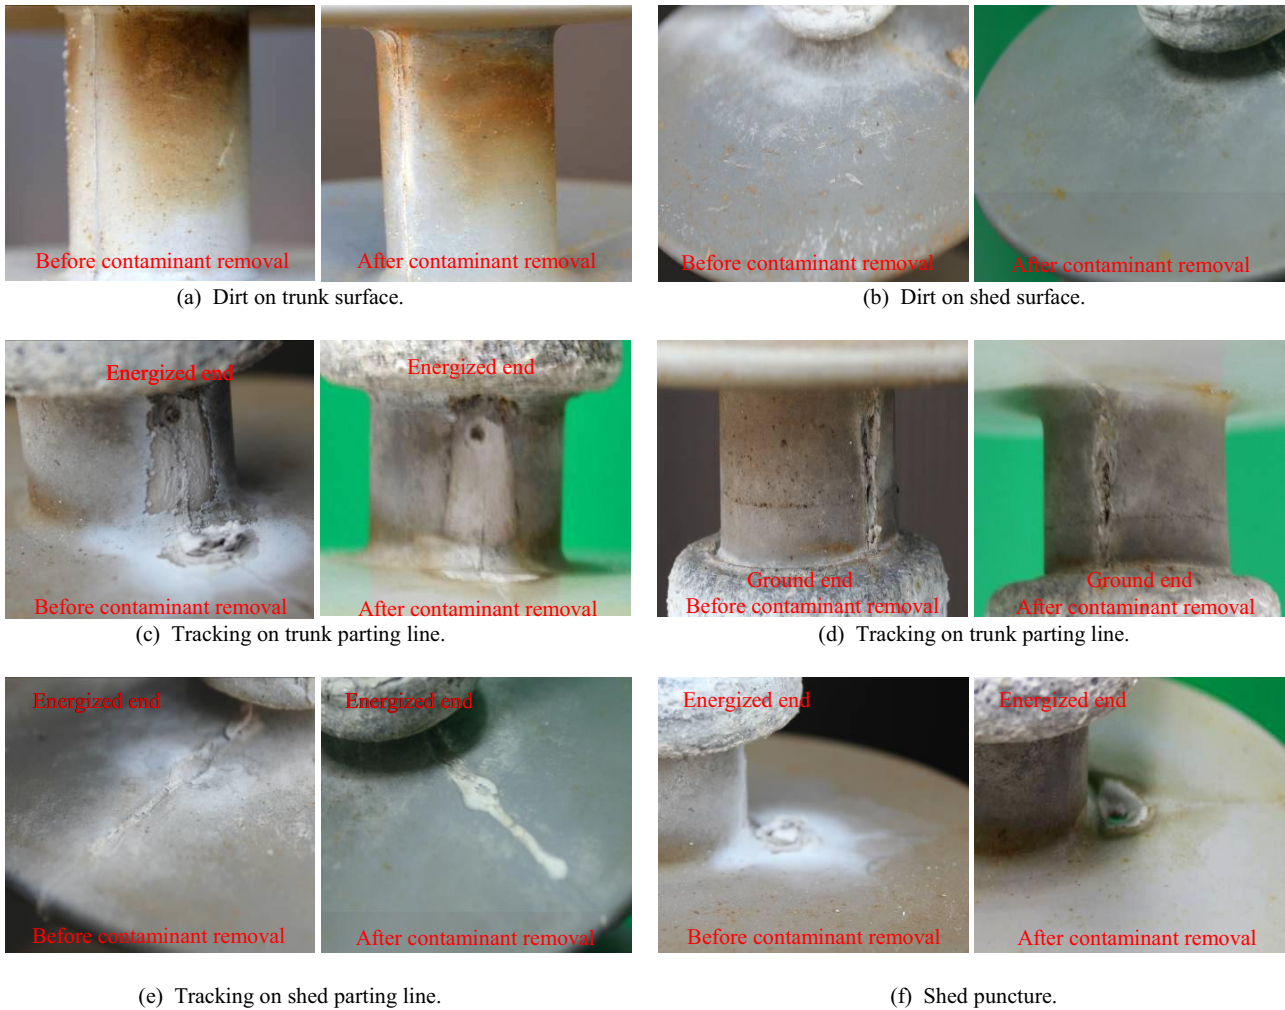
Fig. 5 Surface damage of tested specimens.

After 30,000 test cycles, significant changing on the specimen surface was observed on tested specimen. Many types of surface ageing, such as erosion and tracking etc., were observed.

As show in Fig. 5 (a) and Fig. 5 (b), dirt was observed on both shed and trunk surfaces of tested specimens.

As shown in Fig. 5 (c) and Fig. 5 (d), severe surface tracking was observed on parting line of trunk surface near both energized and ground ends. The occurring of surface tracking on such portion may caused by high electric field stress.

As shown in Fig. 5 (e), surface tracking, also, was observed on parting line of shed surface near energized end

comparing with other shed surface portion. This occurring may caused by higher electric field stress.

Surface tracking along parting line in high electric field stress portion may caused by remaining water droplet during high voltage energized

As shown in Fig. 5 (f), punched of shed near energized end was observed. The puncture was observed on the parting line of shed. Occurring of such surface damage may caused by high power electric discharge [13]. The results show that imperfect of parting line can caused seriously surface damage of polymer insulator under contamination condition.

Silicone rubber polymer insulators were tested under salt water dip wheel test and were subjected to electric field at ac 35 V/mm for 30,000 test cycles. Surface tracking and shed puncture were observed on the specimen surface after 30,000 test cycles. Dry band arc discharge and corona discharge caused surface damaging of the tested specimen. In addition, decreasing of hydrophobicity was measured on tested specimen surface when comparing with the new specimen. UV and heat from the dry band arc discharges
