Seismic Behaviour of Romanian Orthodox Churches, Modeling of Failure Modes by Rigid Blocks

Marius Mosoarca, Victor Gioncu, Ovidiu Cosma

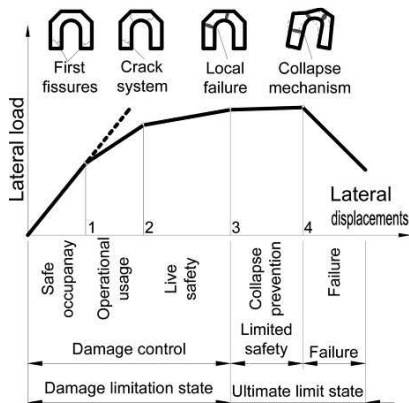
Fig. 1 Behaviour of a masonry triumphal arch

It is well known that masonry structure analysis requires nonlinear modeling accounting for the low tensile capacity and the consequent cracking phenomena. It is well known though that such models cannot be used in the case of very complex structural systems characterized by large number of degree of freedom. In the same time, it is very clearly that the methodologies required for the two limit states differ very much. While for damage limitation state one can use the elastic analysis (with or without considering some fissuration effects), for the ultimate limit state, the methodology must be very different. Therefore, analyzing the behavior of historical buildings, it is need to be adopted a two step procedure as shown in Fig. 1.

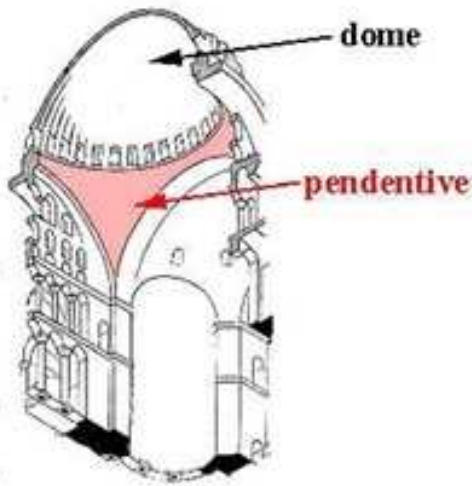
Fig. 3 Pendentive in Byzantine churches

The buildings of Romanian Orthodox churches are based on the Byzantine style, being characterized by the using pendentives and dome on pendentives as in Fig. 3. It must be pointed that the main structural characteristic of Byzantine architecture is the use of pendentive domes, dome on pendentives, and tower on pendentives. This is unique way of adjusting the circular form of a dome or tower to a square plan. The pendentive dome is derived by trimmer the sides of a circular dome over a square plan as in Fig. 4. The pendentives dome enables to transfer the total load of the roof to the four corners of the building.

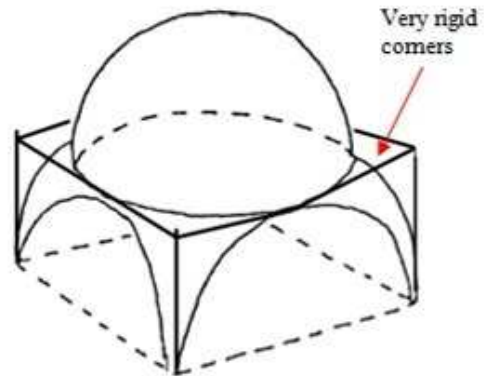
Fig. 5 Rigid corner pendentives, including the surrounding walls

Windows can then be introduced in the cylindrical tower enabling architects to create interior light effects. The surrounding infilled and exterior masonry walls also contribute to carry out the loads, forming very rigid corner pendentives as in Fig. 5.

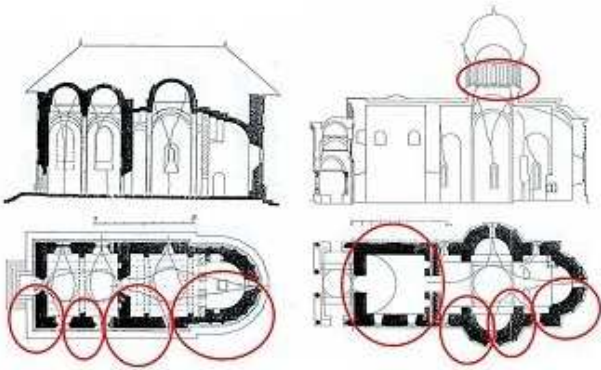
Fig. 7 Damage of Borzesti and Cozia churches due to 1977 Vrancea Earthquake [2]

Analyzing the occurred system of fissures and cracks it is very clear that the spatial collapse mechanism is formed by a longitudinal fracture and multiple transversal fractures which round the pendentives, due to the great rigidity of these ones.

In addition, cracks occurred at the base of tower. The cracks start always from the windows, due to reduced rigidity in these zones. Considering the system of fractures, it is very clear that, in the ultimate limit state, the churches form a block system, working independently each other's as in Fig. 8.

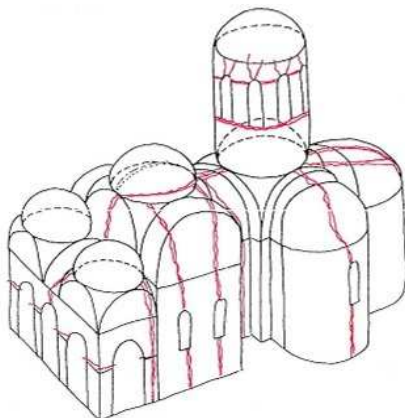
The blocks are formed by the wall delimited by two indows and the corresponding corner pendentives. Due to the seismic actions, the blocks rotate around a basis axis. This rotation is equilibrated by the gravity loads, mainly due to the masonry weight.

The ration between overturning and stabilizing forces gives the possibility to determine the ultimate limit loads, this one being the minimum of all the values [12], determined for each block [5].

Fig. 8 Blocks system in ultimate limit state [2]

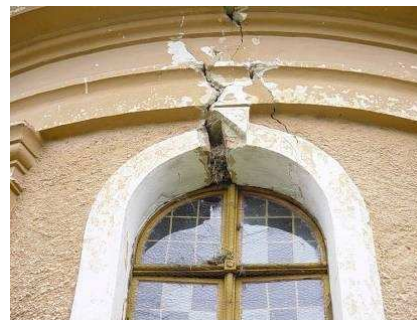
Brick walls are 75 cm thick, reinforced with brick pillars in front of the roof arches. Masonry structure has a longitudinal symmetry, except the West side where the presence of the stair has introduced an asymmetry characterized by walls with a thickness of 40-45 cm. The window openings on the altar apse and reduced thickness of the wall under the windows have caused cracks in Fig. 14.

Fig. 14 Cracks at the eastern wall

i. The biggest cracks are developed in the eastern wall next to the altar, in full compliance with the structural issues outlined above in Fig.8.

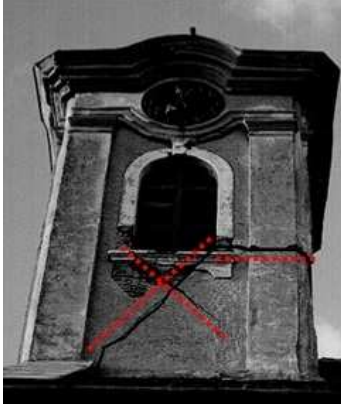
The cover in the central area is made of two domes on brick pendants resting on arches. One of the vaults supports a tower with circular section. Rectangular bell tower section is being supported on one side of the church walls, and on the opposite side of a brick arch that has no tie to the beginning and shows cracks. Under the bell tower windows, X cracks were found on the South and North facades, damages characteristic of seismic actions in Fig. 15.

Fig. 15 Cracks at bell tower

iii. Asymmetrical turning tendency can be seen on the walls of the western tower, south wall is much more cracked than the northern, while at the western and eastern walls, cracks were insignificant;

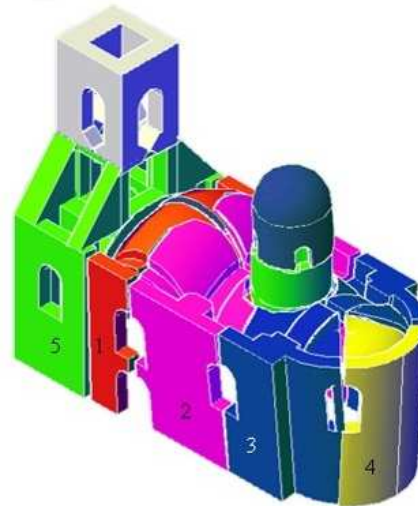
i. The church was divided into rigid blocks based on observations recorded after earthquakes cracks in the Banat area since 1991. Transfer blocks are shown in Fig. 17, based on 3D drawing. Global system of axes is shown in Fig. 10.

ii. Because the greatest damages were recorded in the nave and apse altar, a special attention was given to these areas. They were divided into blocks 1, 2, 3 and 4.

Fig. 17 St. George church, blocks system in ultimate limit state

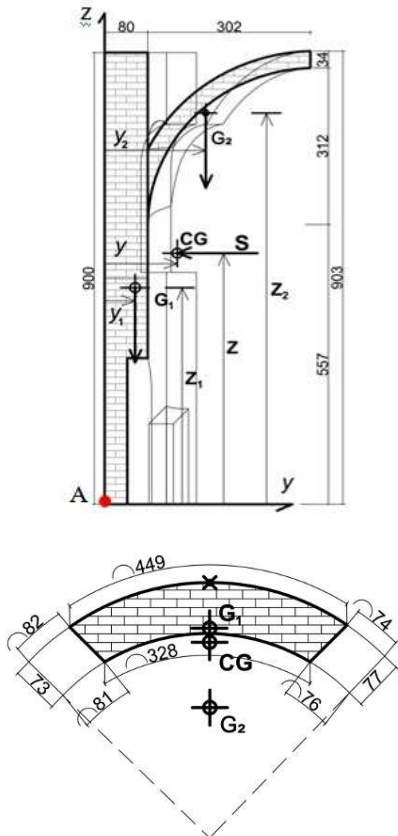
ix. The equilibrium relation between overturning moment and stabilisation moment was written for each failure block in relation to point A from the wall as shown in Fig. 18. It is located at the outer end wall. According to [6] the proportion ratio between the overturning moment and the stabilization moment of the transfer block is called seismic coefficient and is noted by λ . It has subunit value and represents the maximum value of ground acceleration for which the building collapse that occurs outside of the plan of the failure block. Maximum seismic acceleration of ground in the Monastery of St. George is $0.16g$, so $\lambda_{\max \text{ field}} = 0.16g/g = 0.16$. λ values calculated by theoretical modeling for each failure block were compared with this value of $\lambda_{\max \text{ field}}$. Blocks with a value of λ

Because the most damaged transfer block after 1991 earthquakes is block 4, in Figure 18 are presented the dimensions and position of the center of gravity and the point of application of seismic force. There are only two centers of gravity for masonry and bolt and one for the entire block 2. The Name of symbols used in Figure 18 are shown in Table I.

Fig. 18 Dimensions in plan and positions of centers of gravity for block 4

For failure block 4, who was the most damaged after earthquake, λ is determined with (1) [9]. Calculations are presented in Table II. The value of λ is calculated in (2).

$$\lambda_4 = 0,168 \quad (2)$$

- i. $\lambda_4 < \lambda_2 < \lambda_3$ although the theoretical modeling, predicts that the limit state will be achieved by the collapse of block 4, that will yield before blocks 2 and 3 for the same value of the seismic force. This damage is confirmed by the biggest masonry rupture of the apse area.
- ii. These results provided by theoretical modeling are confirmed with the damage and collapse mechanisms developed by the resistance structure of the Church of St. George after the 1991 earthquakes.

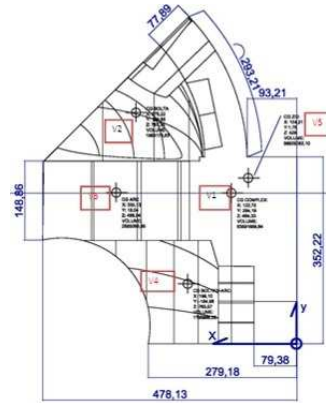
In Fig. 19 and Fig. 20 are shown the dimensions in plan, the positions of the center of gravity and the point of application of seismic force for failure blocks 2 and 3 in 3D coordinates. There are five centers of gravity for each failure block caused by wall, domes and arches. Values of stabilization and overturning moments are presented in Tables III and Table IV. The values are presented in (3) and (4).

Fig. 19 Dimensions in plan and positions of centers of gravity for block 2

$$\lambda_2 = \frac{3167 \text{ kNm}}{11988 \text{ kNm}} = 0,264 \quad (3)$$
