A Secondary Disaster Due To Inhabitant's Action after a Strong Earthquake: a Case Study of the 2008 Sichuan Earthquake

Keywords—Sichuan Earthquake, Secondary Disaster, Inhabitant's Action, inappropriate behavior.

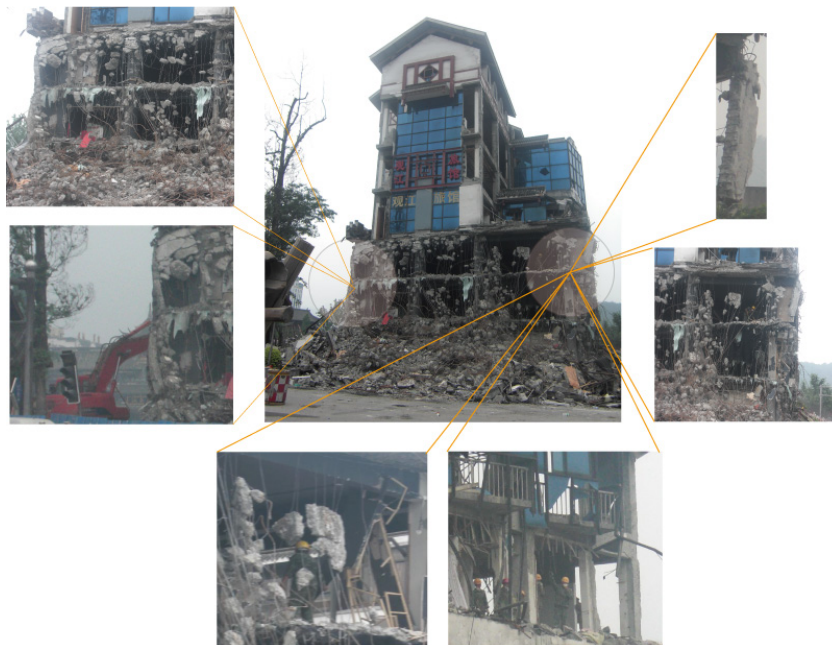
Photograph1. Dangerous Demolition

Photograph1 shows a demolishing of building which used human labor and truck. A whole state of building is severely damaged, all walls are demolished, columns are intense damaged and some columns shifted from central position and glass windows are breaking. At the left side of 1st floor, demolition work is done by a truck and at the 2nd and 3rd floor demolishing work is done by human labor.

In the middle of demolishing, the building can possible to collapse any time, but a housebreaker has used human labor to demolish inside of building along with using truck for demolishing building.

For demolishing of building, should not used human labor and not allow people to go inside demolished building.

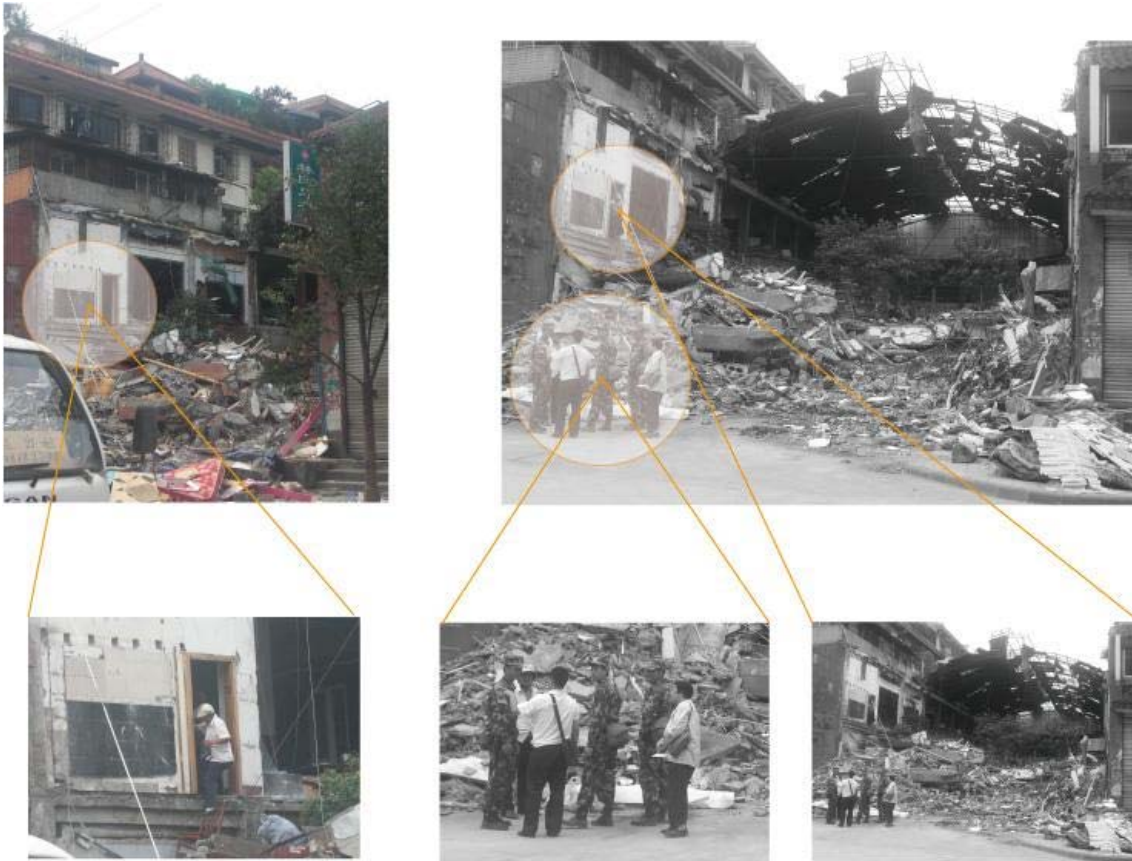
Photograph2. Inappropriate Action

A building quiet old and has a big damage, a fragment of broken buildings has littered surround building and resident possible to injury in the falling objects.

But inhabitants are going inside their house to take properties. Soldieries have watched around area but sound as they recognize those actions. Residents should not entire to the damage building witch not confirming the safety yet. Photograph2 is showing the inappropriate action.

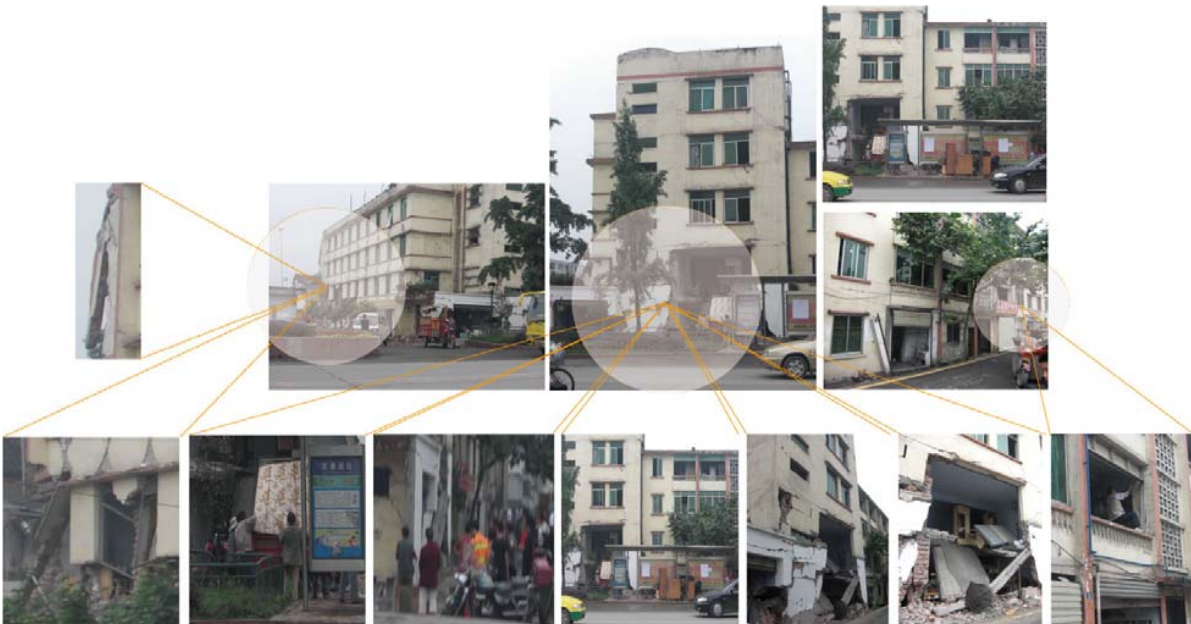
Photograph3. Dangerous Action

An apartment building of brick structure is near collapse state. Have large vertical cracks occur in an edge of L type building and have big diagonal cracks occur in around the walls. The brick columns in first and second floor are collapse and a floor is falling down. The building is losing structural support part and in the state that can't be reinforced. But, residents are going inside for taking their furniture and properties from the apartment for moving out. Moreover, have a man is detaching the window frame work in the next door. The building where structural support part is lost possible to unexpected collapsed by aftershocks and vibrations. Inhabitants should not entire or be around such the building. Photograph3 shows the dangerous action.

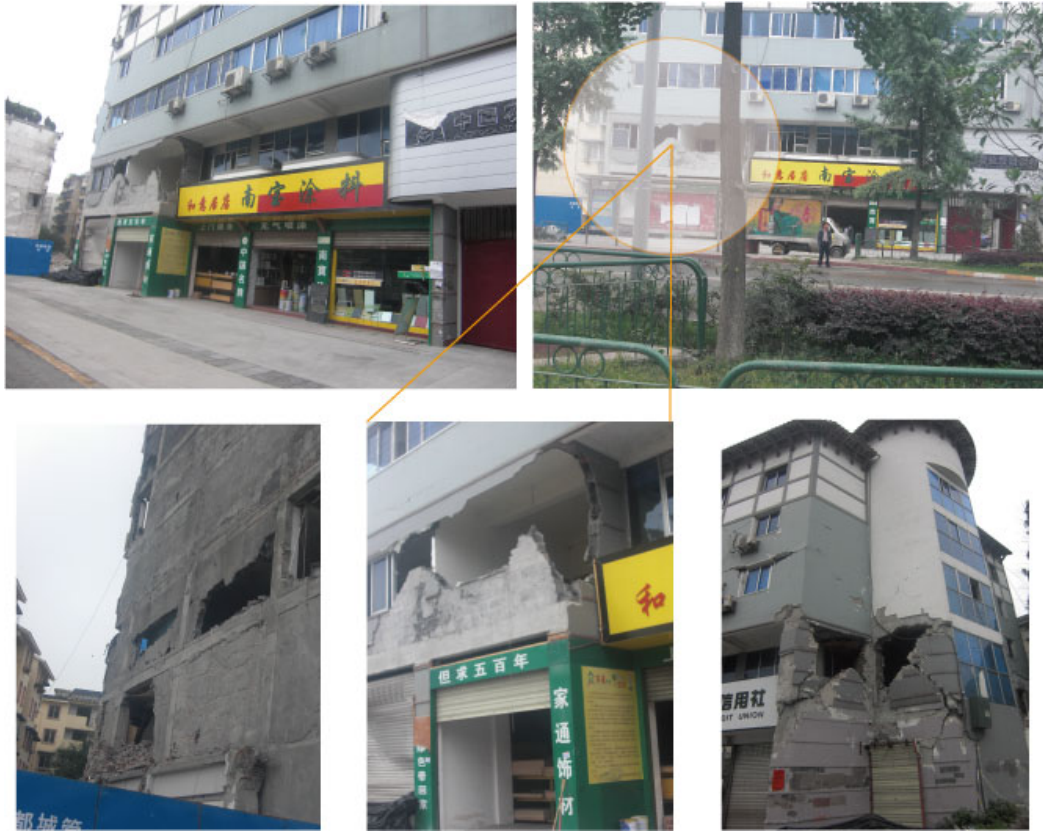
Photograph4. Dangerous Business

The wall has destroyed partially and early reinforcement is needed. Structure type is unconfirmed but bricks are showing at column. Before entire to the building rapid structural checked is needed. But resident is doing shop business in the building which not checked the safety and has intense damage. These actions can be a caused of expanding damage further. Photograph4 shows the dangerous business state.

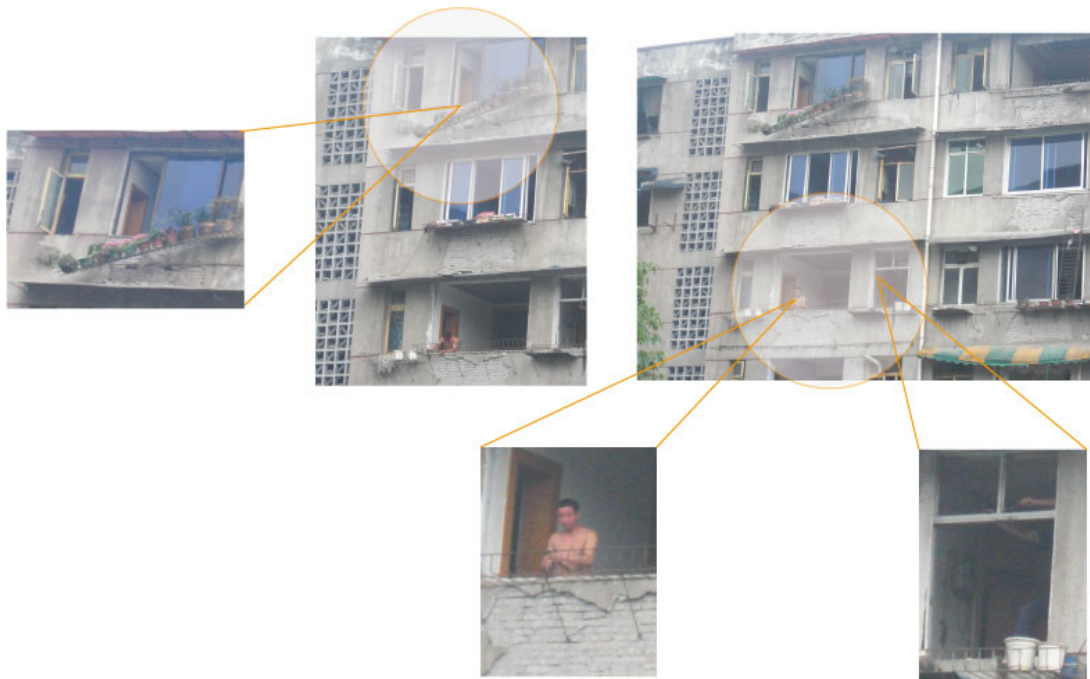
Photograph5. Danger posted by the Falling Objects

During his detaching work, these flower baskets can fall down anytime by the aftershocks or the shakes from the works but he isn't notice it. These actions can possible to make resident injured. A post earthquake quick inspection of damaged building to evaluate the risk of building collapse, fall of exterior walls and window glass and so on are needed.
