Assessment of In-Situ Water Sensitive Urban Design Elements

Niranjali Jayasuriya and Majell Backhausen

Abstract—Water Sensitive Urban Design (WSUD) features are increasingly used to treat and manage polluted stormwater runoff in urbanised areas. It is important to monitor and evaluate the effectiveness of the infrastructure in achieving their intended performance targets after constructing and operating these features overtime. The paper presents the various methods of analysis used to assess the effectiveness of the in-situ WSUD features, such as: on-site visual inspections during operational and non operational periods, maintenance audits and periodic water quality testing. The results will contribute to a better understanding of the operational and maintenance needs of in-situ WSUD features and assist in providing recommendations to better manage life cycle performance.

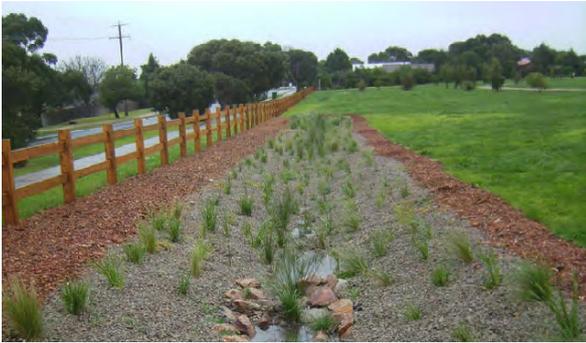
Bio-retention swales provide two main functions: stormwater treatment and the ability to convey stormwater safely (Figure 2). The swale component of the system uses vegetation and gravity to pre-treat the stormwater, removing coarse to medium sediments as well as litter and natural debris. After conveyance through the swale, the stormwater percolates through the prescribed filter media component of

the Bio-retention system located at the base of the swale removing finer particles, nutrients and contaminants. The filter media achieves this through fine filtration, extended detention treatment and some biological uptake. If designed and constructed properly a bio-retention swale system should also have the ability to retard some stormwater flow during large storm events and provide protection to natural receiving waterways from the high flow velocities associated with piped flows. In the occurrence of a large storm event, overflow pits are also incorporated in the design, directly conveying excess water into the stormwater pipe network.

Fig. 2 Bioretention swale Mornington Peninsula Shire Council, Victoria Australia

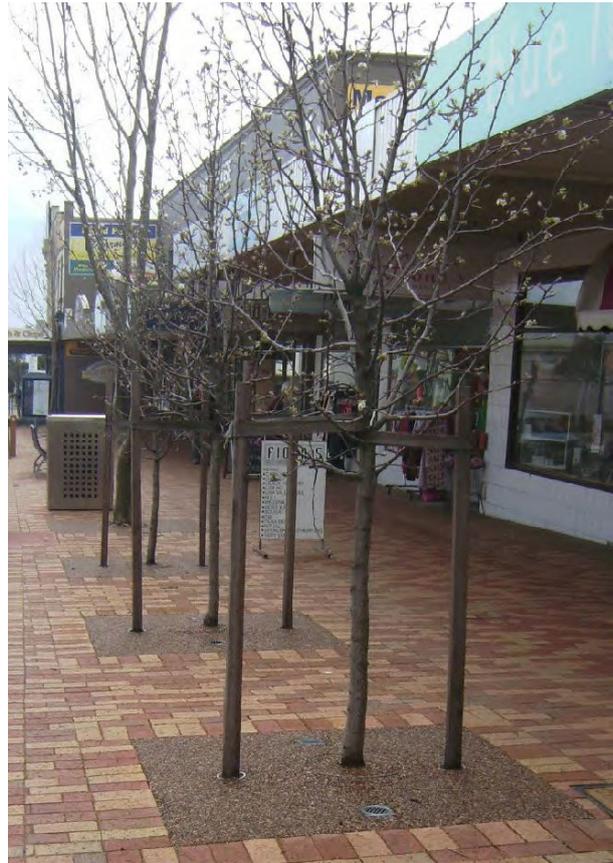
WSUD tree pits are a practical way of introducing WSUD into urban streetscapes where there is limited space to work with and impervious areas dominate the landscape (Figure 3). WSUD tree pits work as small scale bio-retention systems. The entire foot print of a standard tree pit is usually 6.25 square meters and only has to accommodate the health of one plant. This is another credit to its success as it provides treatment options in areas where vegetation is limited and linear swales or larger scale rain gardens simply cannot fit. WSUD tree pits have the ability to remove medium to fine sediment, nutrients, contaminants and litter. With very limited documentation found on the exact design, construction and maintenance of this feature it is assumed that the process of

Fig. 3 In-situ WSUD Street Tree Pit

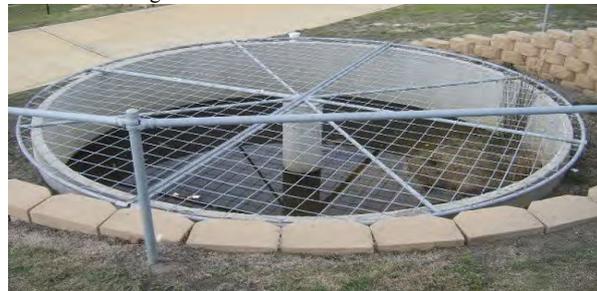
Sedimentation tank and Bio-retention tank systems have dual pollutant extraction ability. The sedimentation tank is the first course of treatment for harvested stormwater (Figure 4). Sedimentation removes gross pollutants, large and medium sized particles (sand, grit, rubbish). Bio-retention tanks will then receive the overflow pre-treated water and allow it to percolate through the filter media, removing finer particles, nutrients and contaminants (the same principles as the Bio-retention treatment in a swale). In the occurrence of a large storm event, allowances for water overflows are also incorporated in the design, directly conveying excess water into alternative pipe networks or creeks. With no documentation found on the exact design, construction and maintenance on this system, it is assumed that the process of implementation from the concept phase to operational phase follows the general guidelines of WSUD feature implementation.

Fig. 4 Hi-Capacity Sedimentation Tank
