Sustainable Development in Disaster Affected Rural Areas: The Case of Dinar Villages

Nese Dikmen

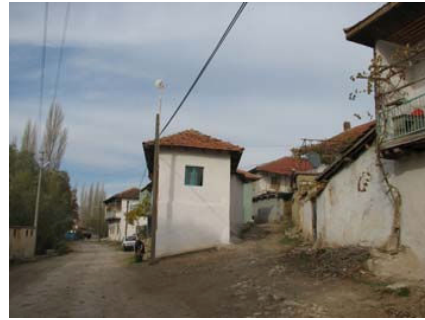
Fig. 1 View from an existing village (Dikici Village)

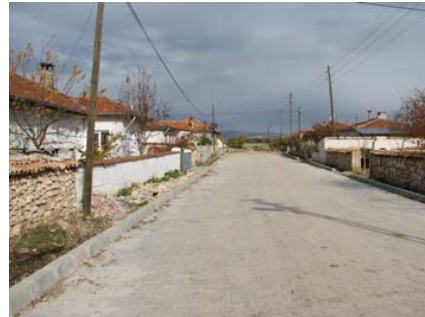
It was observed that the traditional settlements and the houses in the region show the characteristics of rural areas in Turkey. However, there are differences between the settlements erected after the disaster and traditional settlements. In spite of existing villages' organic form, new settlements were erected on a grid pattern. It is very difficult to distinguish the new settlements from each other, however the existing villages and the buildings in them have their own characteristics related to physical, socio-cultural and economical factors. Fig. 1 shows an existing village and Fig. 2 illustrates a new settlement.

Fig. 2 View from a new settlement (Gencali Village)

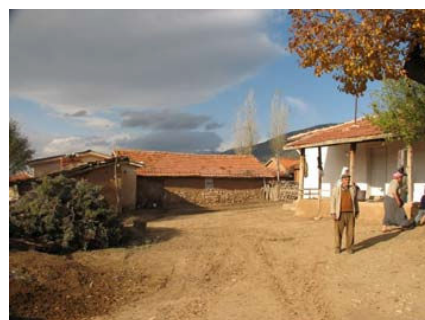
Research reveals that villagers modified the post-disaster houses and the cattle sheds. In addition, some of the beneficiaries constructed new buildings on their lots. Common additions are leans to roofs, storerooms and bread houses (space used for making bread) and most common new buildings are straw houses and cattle sheds (Fig. 3). Economy is dependent on agriculture and animal rearing in this region. Research in the region shows that some of the beneficiaries who rear animals did not get cattle shed, however some villagers who do not have animals got cattle shed during the provision period. Because of this, villagers who rear animals constructed cattle sheds and straw houses, beneficiaries who do not have animals changed the functions of cattle sheds.

Fig. 3 Addition to the post-disaster house and new buildings on the lot (Kızıllı Village)

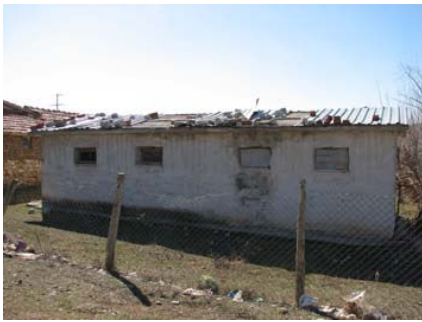
There are workmanship problems on some of the houses. Since metal claddings on the roofs of the cattle sheds were not fixed properly, the claddings have moved up in some of the villages (Fig. 4). Also, drain pipes of some houses and cattle sheds have fallen down. In addition, cracks were observed on the walls of a few houses. Some villagers, who could afford, repaired the buildings. One family left their post-disaster house, on which there are cracks. They said that they did not feel safe in the house.

Fig. 4 Cattle shed with it's moved up roof cladding (Kızıllı Village)

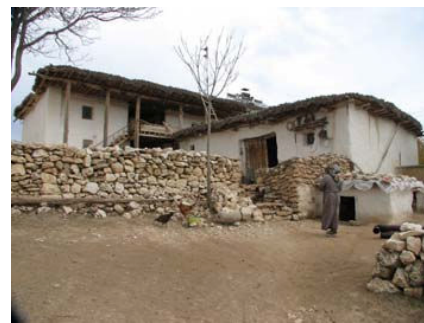
It was seen that the villages and the houses in them are the products of the socio-cultural factors in the study area. The houses in the villages have different characteristics depending on the life styles of the users (Fig. 5). However, the post-disaster houses, designed years ago for any region and any family, do not meet the needs of some of the families. The users had to make additions to the houses and construct new buildings on the lots.

Fig. 5 A traditional house (Karahacılı Village)
