# Hydrophobic Characteristics of EPDM Composite Insulators in Simulated Arid Desert Environment

**Keywords**—EPDM, composite insulators, accelerated aging, hydrophobicity, contact angle.

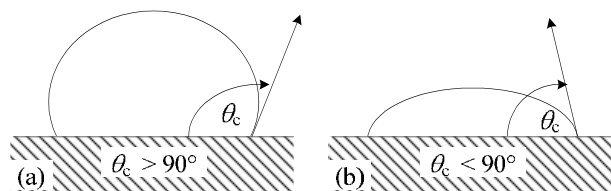
Fig. 1 Schematic diagram of water drop on:  
(a) Hydrophobic surface (b) Hydrophilic surface

weathering and from dry band arcing, suffer from erosion and tracking which may lead ultimately to failure of the insulator, faulty insulators are difficult to detect and life expectancy is difficult to evaluate [1]. The property of high hydrophobicity of the composite insulators assures them better performance in contaminated environments. Hydrophobicity of a material is its resistance to flow of water on its surface or resistance to the formation of continuous film of water. It can be described using contact angle ( $\theta_c$ ) on the material surface that a liquid drop makes on the solid surface when it comes into contact with it. The hydrophobic materials allow less water surface contact and thus make  $\theta_c > 90^\circ$  as shown in Fig. 1(a), whereas materials which are easily wettable allow water to touch a large surface area and hence make  $\theta_c < 90^\circ$  as shown in Fig. 1(b) and is known as hydrophilic. Surface is said to be hydrophobic, when  $\theta_c > 90^\circ$ , hydrophilic when  $\theta_c < 35^\circ$  and partially wettable when  $35 < \theta_c < 90^\circ$  [2].

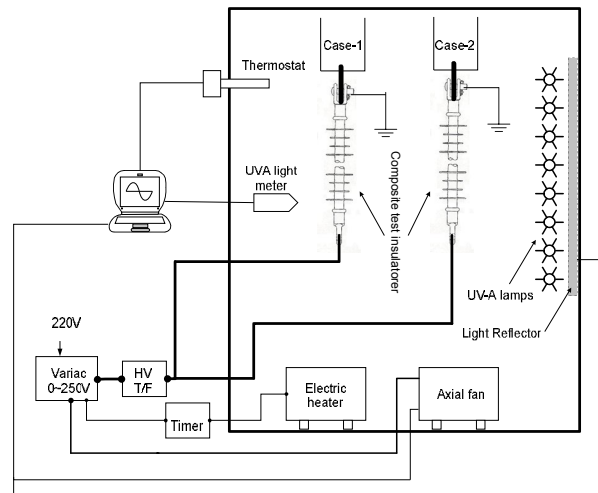
Fig. 2 Schematic diagram of accelerated aging cycle chamber

The actual UV-A radiations level and temperature variations in central region of Saudi Arabia is quite higher as compared to the values recommended in the IEC std. 61109 [9]-[10]. To simulate the ambient conditions of arid desert, a wooden chamber was fabricated for the accelerated aging process for the EPDM test composite insulators. Schematic diagram of the chamber with suspension insulators and other accessories in place is shown in Fig. 2. Based on the above discussion, two types of experimental conditions were created in the accelerated aging test chamber for the tested insulator by applying different stresses mentioned in Table 1, i.e.:

*Case 2:* Modified aging cycle based on the actual UV-A radiations level ( $40 \text{ W m}^{-2}$ ) as shown in Fig. 2.

The schematic diagram of the composite insulator aged in the accelerated aging chamber (Fig. 2) is as shown in Fig. (5). One side of the insulator is always facing the UV lamps whereas, the other side is not. The contact angle for both sides i.e. front as well as back side of the insulator was recorded along the length of the insulator for the points A, B, and C (i.e. top, bottom and core), respectively as shown in Fig. 5. For measurements of the contact angle at desired positions (A, B or C), the insulator was oriented so the surface under consideration was approximately horizontal. The drop is carefully placed on the horizontal surface of the insulator with the help of a hypodermic syringe needle. The photographs of drops are taken quickly with the help of high resolution digital camera just after putting the drop of water on insulator and the data was analyzed by computer software "ImageJ". The drop volume was controlled in the range 10~25 $\mu$ L [12]. Deionized water of ~100 $\mu$ S conductivity was used. Methylene blue was added to change the color of the water to get more clear images.

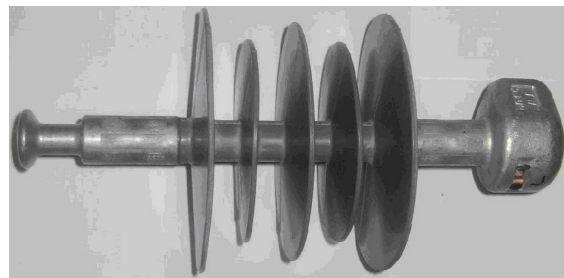
Fig. 3 Suspension EPDM insulator

Three samples of EPDM suspension insulators procured from WT-Henley (UK) were used for accelerated aging for each case-I and case-II. Fig. 3 shows the photograph of the tested insulator. The salient dimensions of the insulators are mentioned in Table 2.

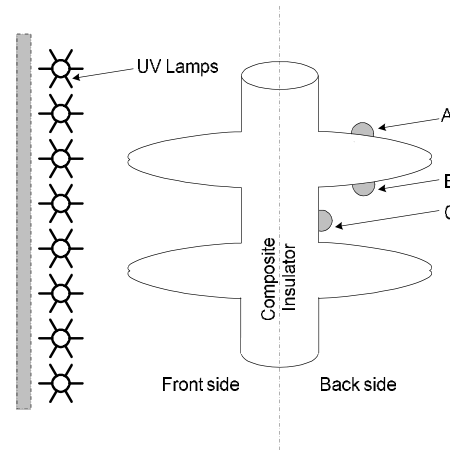
Fig. 5 Schematic diagram of composite insulator showing contact angle measurement positions

The EPDM insulators were placed and aged in the aging chamber as per Case-I (UV-A:1mW/cm<sup>2</sup>) and Case-II (UV-A:4mW/cm<sup>2</sup>) mentioned in Table 1 above and the contact angles were measured by using "ImageJ" software for the New (virgin), Old aged and Newly aged insulators. The results are graphically shown in Figures(6)-(8), that compares the EPDM insulator's shed-wise contact angle characteristics for the positions A (Top), B (Bottom), C (Core) as shown in Fig. 5 above, for:

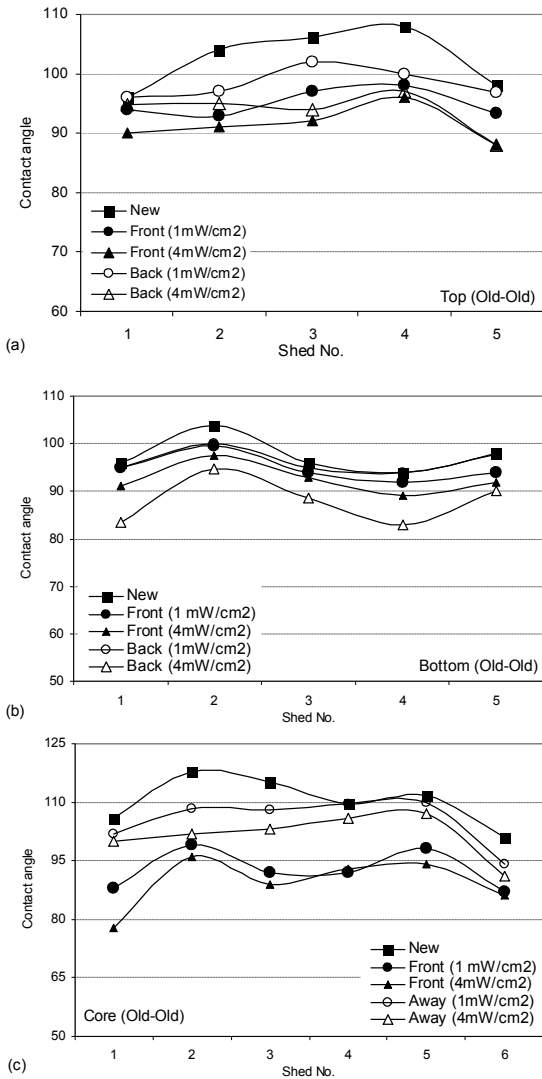
**Fig. 6** compare the shed-wise top, bottom and core contact angle measurement results of front to back side for the old-old aged under UV radiations intensity of 1mW/cm<sup>2</sup> and 4mW/cm<sup>2</sup>. Comparison of these figures clearly shows that contact angle for new (virgin) insulator is highest as compared to old aged insulators. Furthermore, it is also observed that the contact angle of aged insulator under UV radiation intensity of 1 mW/cm<sup>2</sup> is higher as compared to aged insulator under UV radiation intensity of 4mW/cm<sup>2</sup>. It is also found that the part of the insulator facing the UV radiations have lower contact angle as compared to the back side of the tested insulator. Similarly, higher UV radiation intensity deteriorated the insulator surface more [9] and causes less contact angle as compared to lower UV radiation intensity thus the insulator shows a more hydrophilic behavior under higher UV radiation intensity.

Fig. 6 Contact angle characteristics along the insulator sheds for old-old aged (a) Top (Position A, Fig. 5) (b) Bottom (Position B, Fig. 5) (c) Core (Position C, Fig. 5)

The contact angle measurements results depicted in figures (6)-(8) show considerable variations along the insulator surface. Each is considered below before general observations are made.

The contact angle measured on both the front as well as back sides of the insulator were also measured and shown in Fig. (6) & (7). The contact angle measured was smaller on the front side as compared to the back side of the aged insulator. This shows that the front side of aged insulator was more hydrophilic as compared to the back side which suggests that natural environment plays an important role in the aging process. The variation in contact angle between the front and back face is several degrees. The greatest difference between the front and back is seen on the core in the center of the insulator length, may be due to enhanced electrical activity in this region.

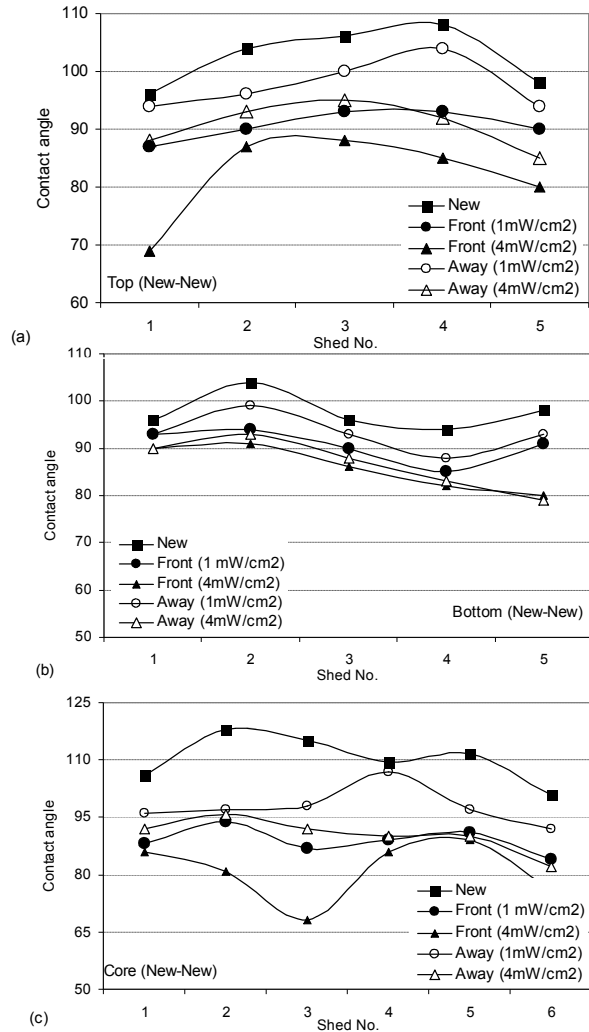
**Fig. 7** compares the shedwise contact angle measurement results of front to back side for the new-new aged under UV radiations intensity of 1mW/cm<sup>2</sup> and 4 mW/cm<sup>2</sup>. Comparison of these figures clearly shows that contact angle for new (virgin) insulator is highest as compared to newly aged insulators. Furthermore, it is also observed that the contact angle of aged insulator under UV radiation intensity of 1mW/cm<sup>2</sup> is higher as compared to aged insulator under UV radiation intensity of 4mW/cm<sup>2</sup>. It is also found that the part of the insulator facing the UV radiations have lower contact angle as compared to the back. Similarly, higher UV radiation intensity that deteriorates the insulator surface has less contact angle as compared to lower UV radiation intensity thus the insulator shows a more hydrophilic behavior under higher radiation intensity. The variation in the contact angle for the

newly aged and virgin insulator is more as compared to the variations depicted in Fig. 6, before.

Fig. 7 Contact angle characteristics along the insulator sheds for New-New aged (a) Top (Position A, Fig. 5) (b) Bottom (Position B, Fig. 5) (c) Core (Position C, Fig. 5)

The contact angle variation between the top and bottom surfaces of the insulator was also marked. The average variation in the contact angles from HV to ground electrode for top (position A) as well bottom (position B) is more consistent, however, the wide variation in contact angle was observed especially under the newly aged insulators when the insulator was aged under high UV radiation intensity (i.e. 4mW/cm<sup>2</sup>) as shown in Fig. 7(a) & 8(a).

On the core the variation in contact angle is about 15°-20° from HV to grounded electrode end. The lowest values were observed in the center as evident from Fig. 7(c) & 8(c). This shows that, this part of the core is more heavily damaged than the sheds. One explanation to this is that this part of the insulator presents a smaller cross-section to the leakage

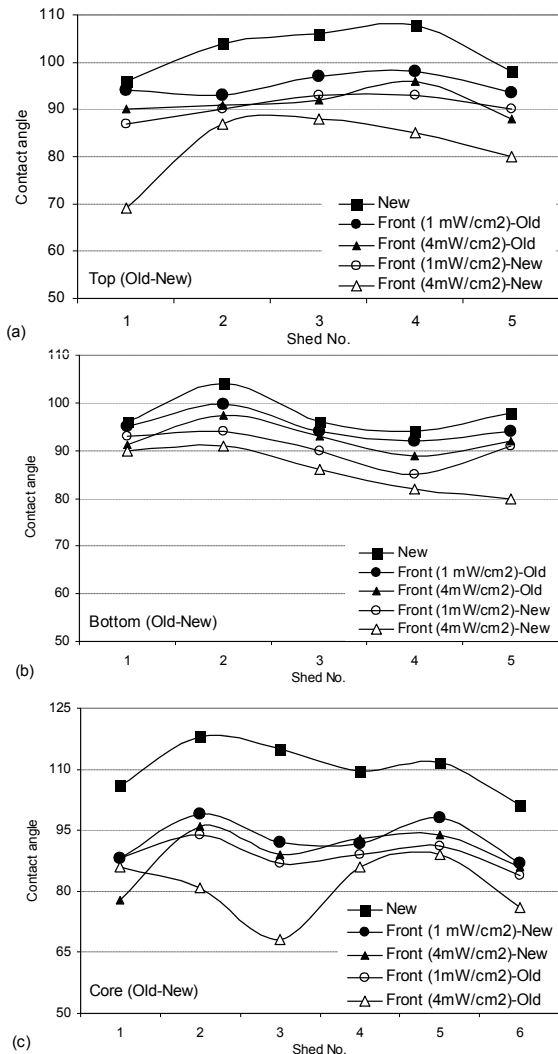
The contact angles data for the old aged insulators was compared with the newly aged insulator, and the result is shown in Fig. 8. Comparison of these figures clearly shows that contact angle for newly aged insulator is lower as compared to old aged insulator under. This result shows that the EPDM insulator also recover some of its hydrophobic properties with the passage of time but this rate of recovery is very slow as compared to SiR which usually recovers very quickly [5], [13].

Fig. 8 Contact angle characteristics along the insulator sheds for Old-Newly aged (a) Top (Position A, Fig. 5) (b) Bottom (Position B, Fig. 5) (c) Core (Position C, Fig. 5)

Scanning Electron Microscopic (SEM) photographs of the EPDM insulators surface were tried to obtain but due to static charges in the samples, the author was unable to get these images. Fig. 8, shows the hydrophobicity recovery of the tested insulators as the contact angle of the old aged insulator is more as compared to the newly aged insulator. It can also be seen that higher the UV-radiation intensity, the EPDM insulator shows more hydrophilic characteristics for the newly aged as well as old aged insulators. This property of EPDM material can be co-related with the static charge on the sample. Hydrophobicity recovery takes place after decaying these static surface charges. Therefore, charge accumulation on EPDM insulator should be considered in hydrophobicity recovery process.
