Structural Performance of a Timber-Concrete Bridge Prototype

Pedro Gutemberg de Alcântara Segundinho, José Antonio Matthiesen, Marcelo Rodrigo Carreira

Keywords—Binding, bridge prototype, timber and concrete.

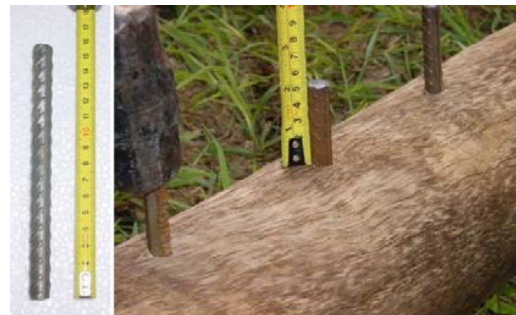
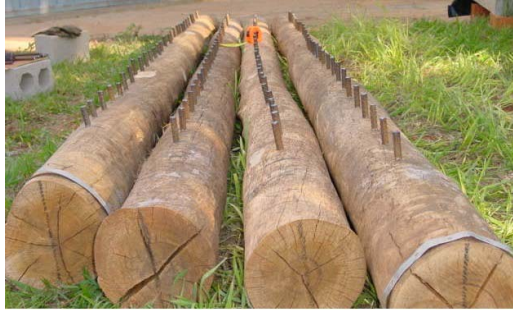
Fig. 1 Metal pins put on the wood beams (a) and (b)

The kind of timber which was used in the timber-concrete bridge construction was *Eucalyptus Urophylla* – *Eucalyptus urophylla*, classified according to [4]. The metal pins used for binding (Figs. 1 (a) and (b)) were made of construction steel bars CA 50, cut on 12.5mm diameter, 150mm length, riveted with 15cm spaces among each other, on pre-drilled holes of 11mm diameter and 100mm depth. A minimum reinforcement was adopted for the concrete slabs, referring to 0.15% of the cross-sectional area to support the efforts, according to [5]. Four timber beams were used for building this bridge prototype. They were characterized through a non-destructive test of static bending, according to [4]. The concrete used for the slab of the timber-concrete bridge prototype was characterized according to compliance with [5].

The study of the timber-concrete bridge prototype also contributes to a better understanding of the binding between these two materials by metal pins tacked with no glue. Certainly, metal pin connectors bounded as an "X", with smaller spacing, may provide greater efficiency for this type of binding. Besides that, further studies about cyclic loading in this type of binding are needed, in order to assess the service life of this structural system.

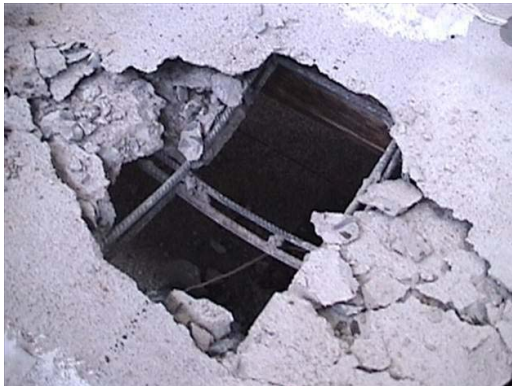
Fig. 5 Rupture of the bridge prototype's central section (a) and (b)

In this experiment, the bridge prototype was taken to rupture by means of the same loading, simulating a load train (Figs. 5 (a) and (b)); the rupture occurred because of a puncture on the concrete slab with a load value of 285kN (142.5kN per wheel) and 8cm vertical displacement. Under these conditions, concrete had also ruptured because of compression on the central cross section of the timber-concrete bridge prototype.
