Detecting Cavitation in a Vertical Sea water Centrifugal Lift Pump Related to Iran Oil Industry Cooling Water Circulation System

Case history: sea water lift pump PJ- 3-P-2102A Thursday, August 23, 2012:

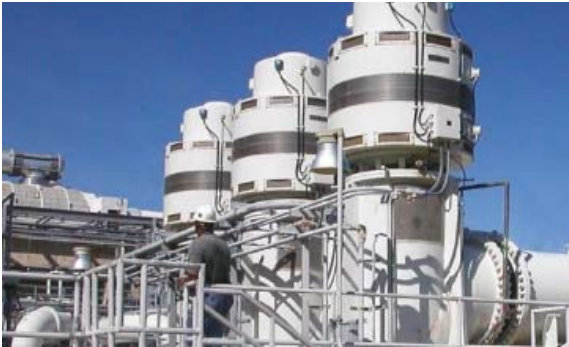
Sea water pump in big industrial plants are usually huge equipment typical sea water vertical Centrifugal lift Pumps shown in Fig. 1 [9].

Fig. 1 Typical sea water vertical Centrifugal lift Pumps

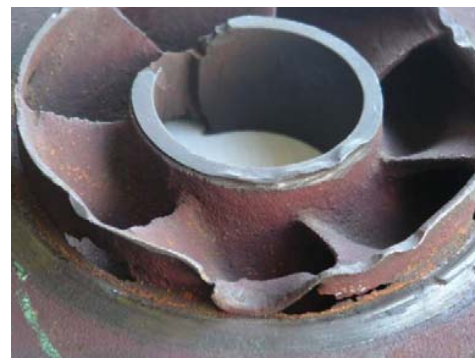
Besides, Fig. 3 representing the effects of cavitation in seawater centrifugal lift pump.

Fig. 3 The effects of cavitation in a sea water centrifugal lift pump impeller
