# The Establishment and Application of TRACE/FRAPTRAN Model for Kuosheng Nuclear Power Plant

**Abstract**—Kuosheng nuclear power plant (NPP) is a BWR/6 type NPP and located on the northern coast of Taiwan. First, Kuosheng NPP TRACE model were developed in this research. In order to assess the system response of Kuosheng NPP TRACE model, startup tests data were used to evaluate Kuosheng NPP TRACE model. Second, the overpressurization transient analysis of Kuosheng NPP TRACE model was performed. Besides, in order to confirm the mechanical property and integrity of fuel rods, FRAPTRAN analysis was also performed in this study.

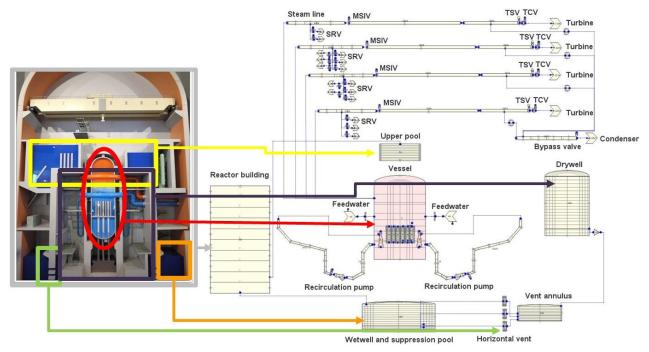
Fig. 1 TRACE/SNAP model of Kuosheng NPP

SNAP v 2.2.7. TRACE v 5.0p3, and FRAPTRAN v1.4 were used in this research. Kuosheng NPP TRACE/SNAP model (Fig. 1) has been built according to FSAR, design documents, and TRACE manuals [1], [3]-[6]. Kuosheng NPP reactor was simulated by the 3-Dvessel component which was divided into two azimuthal sectors, four radial rings, and eleven axial levels. Six channels (one dimensional component) were used for simulating 624 fuel bundles. Full length fuel rods, partial length fuel rods and water rods were also simulated in channel components. Two recirculation loops were set outside the reactor, with a recirculation pump in each loop. 10 groups of jet pumps were merged into an equal jet pump. Four steam lines connected with the vessel and each steam line had one MSIV (main steam line isolation valve), several SRVs (safety relief valves), one TCV (turbine control valve), and one TSV (turbine stop valve). The bypass valve (BPV) was also simulated in this mode. We used valve components to simulate MSIV, SRVs, TCV, TSV and BPV. The critical flow models for MSIVs, SRVs, TCVs, TSVs, and BPV had been considered in our model. The containment of Kuosheng NPP was also simulated in TRACE/SNAP model. The containment was composed of drywell, wet well, suppression pool, vent annulus, horizontal vent, upper pool, and reactor building which were shown in Fig. 1. In Kuosheng NPP TRACE/SNAP model, there were three simulation control systems: (1) feed water flow control system, (2) steam bypass and pressure control system and (3) recirculation flow control system. Besides, in Kuosheng NPP TRACE/SNAP model, "point kinetic" parameters such as delay neutron fraction, Doppler reactivity coefficient, and void reactivity coefficient were provided as TRACE input for power calculations.

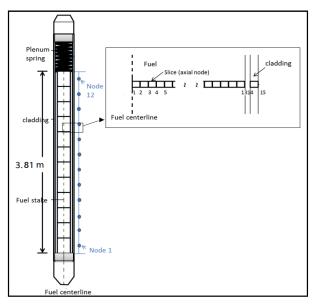
Fig. 2 FRAPTRAN model of Kuosheng NPP

The geometry data of the fuel rod and the results from TRACE analysis (fuel rod power, coolant pressure, heat transfer coefficient data) were inputted into FRAPTRAN to analyze the reliability of fuel rod. In FRAPTRAN model (see Fig. 2), node 1 is the bottom of the fuel rod and node 12 is the top of the fuel rod. Finally, SNAP used TRACE and FRAPTRAN results data to make an animation, such as Fig. 3.

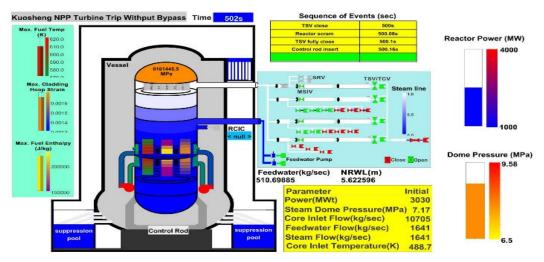
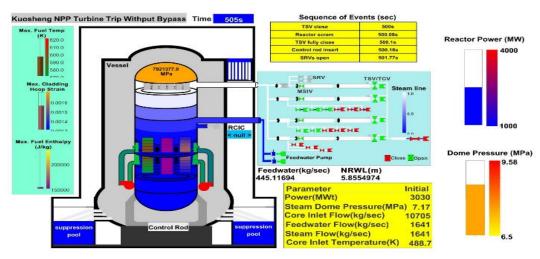
Fig. 26 SNAP animation model of Kuosheng NPP for TSVC case (a) at 502sec (b) at 505 sec

In addition to the cladding hoop strain, the fuel enthalpy is also an important criterion. Fig. 25 shows that the enthalpy peak value of TCVC analysis is about 155000 J/kg (37.08 cal/g). This value is much lower than the criteria 170 cal/g. From these FRAPTRAN results above, it can be inferred that the fuel rods kept good integrity in TCVC hypothetical transient. Finally, by the animation function of SNAP with TRACE and FRAPTRAN analysis results, the animation of TSVC case was presented in Figs. 3 and 26.
