Seasonal Based Pollution Performance of 11kV and 33kV Silicon Composite Insulators

Abstract—This paper presents the experimental results of 11 kV and 33 kV silicon composite insulators under artificial salt and urea polluted conditions. The tests were carried out under different seasons like summer, winter, and monsoon. The artificial pollution is prepared by properly dissolving the salt and urea in the water. The prepared salt and urea pollutions are sprayed on the insulators and dried up for sufficiently large time. The process is continued until a uniform layer is formed on the surface of insulator. For each insulator rating, four samples were tested. The maximum leakage current and breakdown voltage were measured. From experimental data, performance of test specimen is evaluated by comparing breakdown voltage and leakage current during different seasons when exposed to salt and urea polluted conditions. From these results the performance of the insulators can be predicted when they are installed in industrial, agricultural, and coastal areas. The experimental tests were carried out in the High Voltage laboratory using two stage cascade transformer having the rating of 1000 kVA

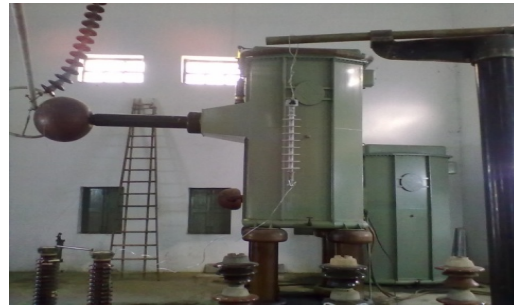
The tests were carried out in the High Voltage laboratory of Jawaharlal Nehru Technological University. The experimental test facility includes Cascade transformer, HV bus bar, control panel. The major technical parameters of cascade transformer are as follows: rated capacity is 1000 kVA, voltage generated per unit is 250kV, maximum current of 200 mA. Schematic arrangement of experimental setup and specimen during test were shown in Figs. 1 and 2. The test specimens were connected in vertical position with one end to high voltage side and the other end to ground side. AC test voltage was applied to the insulator gradually during different polluted conditions and then maximum leakage current and breakdown voltages were measured by measuring meters connected in the system.

Fig. 1 Schematic diagram of experimental setup

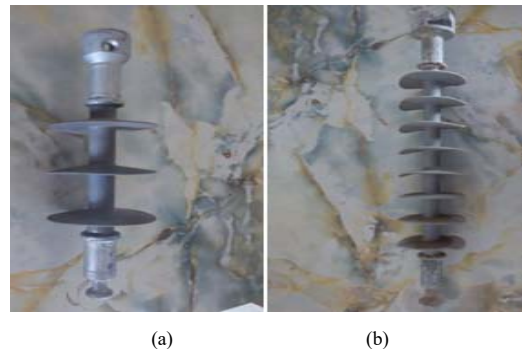
In this paper for each rating four virgin samples were tested. The dimensions for the test specimen were measured as per IEC 61109 [20]. In this work, urea pollution tests are conducted on 11kV silicone composite insulators coded as A11, B11, C11 and D11 whereas salt pollution tests are conducted on 33kV silicone composite insulators coded A33, B33, C33 and D33. Test specimen and dimensions are shown in Figs. 3 (a), (b) and Table I.

Fig. 3 Test Specimens: (a) 11kV Insulator (b) 33kV Insulator

S.No	Particulars	Rating	
		11kV	33kV
1	Length of the insulator (mm)	280	510
2	Dry Arcing Distance (mm)	108	380
3	Creepage Distance(mm)	310	910
4	Specific Creepage Distance (mm/kV)	25	25
5	Shed Diameter (mm)	90	90
6	Number of Sheds	3	8
7	Core diameter (mm)	20.5	20.5
8	Shed Thickness(mm)	3	3
9	Shed Spacing (mm)	52	45

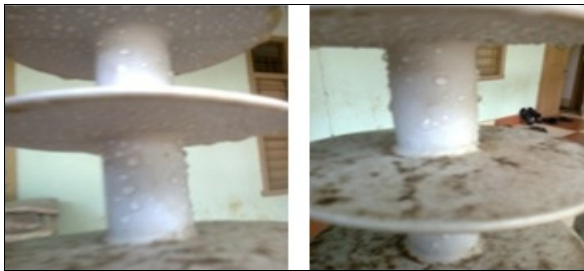
In this investigation, it was observed that in early morning hours, the thin layers of salt and urea deposited on the surface of insulator gets dissolved in to water droplets and flows to the ground. As a result of this, the previously deposited pollution layers become very thin. It took place due to temperature variations in the atmosphere and the cold wind flows on the surface of insulator. Fig. 4 represents water droplets formed on the test specimen.

Fig. 4 Appearance of water droplets on the surface of insulator in the early morning hours

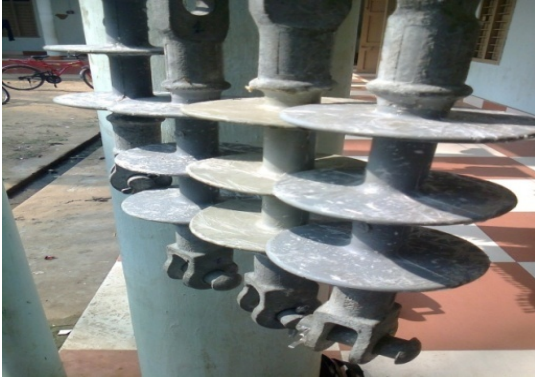
11kV specimens were exhibited to urea pollution. After spraying urea pollution for several days, a thin layer is formed on the insulator surface. The photographs of polluted specimens are given in Fig. 5.

Fig. 5 11kV Specimen under urea pollution

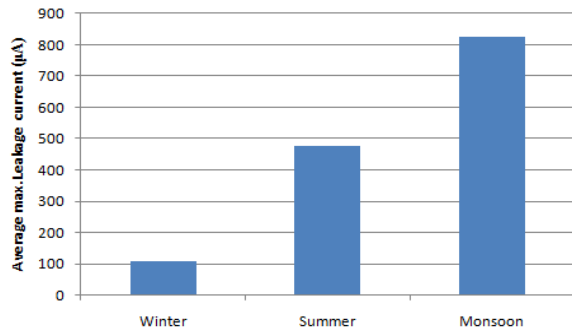
In Table IV, the days between 15 and 75 are in winter season, the days between 90 and 165 are in summer, and from the days between 180 and 240 are in monsoon season. From the data, it is observed that the leakage current increases with number of days. In healthy condition before urea pollution the maximum leakage current of four samples was 62 μ A. During pollution state it is 108 μ A (winter), 476 μ A (summer) and 825(monsoon). This may be due to increase of contamination on the surface of insulator. However, the breakdown voltage is same in summer and monsoon seasons. Fig. 6 represents the relationship between the leakage current and seasons.

Fig. 6 Leakage current at various seasons for 11 kV insulators

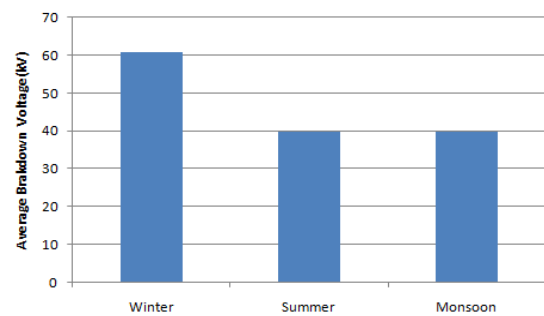
Fig. 7 shows the relation between breakdown voltages among different seasons. And from this, it is observed that the breakdown voltage was gradually decreasing with the number of days in urea pollution. In healthy condition, the BDV measured was 76kV and after applying pollution as the days increased, it is reduced to 61kV in winter season. And it remains almost constant in summer and monsoon season (40 kV). This shows that the effect of urea contamination is less in winter season when compared to summer and monsoon.

Fig. 7 Average breakdown voltage at various seasons for 11 kV insulators

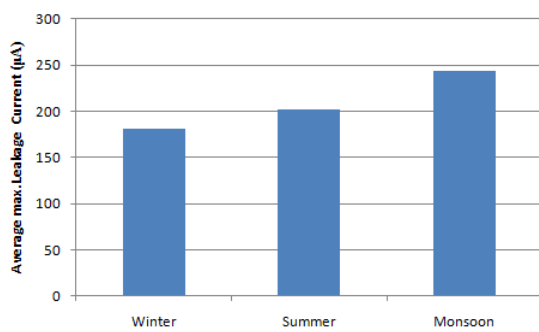
The leakage current (μ A) and breakdown voltage (kV) are measured for every fifteen days during summer, winter and monsoon seasons are recorded and the results are tabulated in Table V. It shows a relation between the maximum leakage current and seasons. It is obtained and shown in Fig. 9. And a relation between breakdown voltage and seasons is shown in Fig 10.

From the results it is observed that, the value of maximum leakage current under healthy condition is 119.25 μ A, whereas under polluted condition it is 181 μ A (winter), 202 μ A (summer) and 244 μ A (winter). Hence, leakage current is

Fig. 9 Leakage current at various seasons for 33 kV insulators

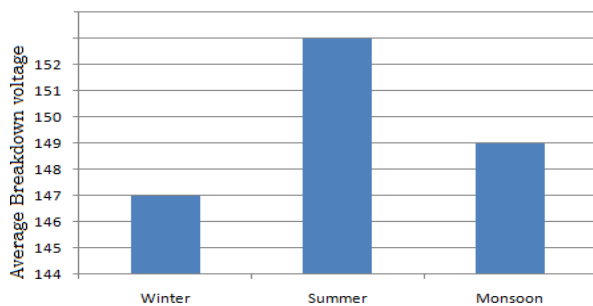
Fig. 10 Breakdown voltage at various seasons for 33 kV insulators

From Fig. 10 it is observed that, there is large change in breakdown voltage among seasons. In healthy condition, the average breakdown voltage of four samples is 157.25 kV but in winter season, it is reduced to 147 kV, in summer season, it raised to 153 kV and in monsoon season, it once again reduced to 149 kV. This shows that the breakdown strength will be higher in summer season, compared to winter and

monsoon seasons. And the effect of salt pollution is less in summer season compared to winter and monsoon.
