Seasonal Based Pollution Performance of 11kV and 33kV Silicon Composite Insulators

Abstract—This paper presents the experimental results of 11 kV and 33 kV silicon composite insulators under artificial salt and urea polluted conditions. The tests were carried out under different seasons like summer, winter, and monsoon. The artificial pollution is prepared by properly dissolving the salt and urea in the water. The prepared salt and urea pollutions are sprayed on the insulators and dried up for sufficiently large time. The process is continued until a uniform layer is formed on the surface of insulator. For each insulator rating, four samples were tested. The maximum leakage current and breakdown voltage were measured. From experimental data, performance of test specimen is evaluated by comparing breakdown voltage and leakage current during different seasons when exposed to salt and urea polluted conditions. From these results the performance of the insulators can be predicted when they are installed in industrial, agricultural, and coastal areas. The experimental tests were carried out in the High Voltage laboratory using two stage cascade transformer having the rating of 1000 kVA

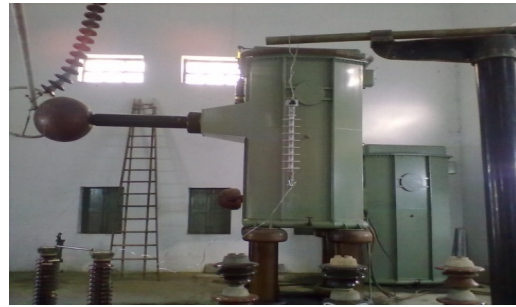
The tests were carried out in the High Voltage laboratory of Jawaharlal Nehru Technological University. The experimental test facility includes Cascade transformer, HV bus bar, control panel. The major technical parameters of cascade transformer are as follows: rated capacity is 1000 kVA, voltage generated per unit is 250kV, maximum current of 200 mA. Schematic arrangement of experimental setup and specimen during test were shown in Figs. 1 and 2. The test specimens were connected in vertical position with one end to high voltage side and the other end to ground side. AC test voltage was applied to the insulator gradually during different polluted conditions and then maximum leakage current and breakdown voltages were measured by measuring meters connected in the system.

Fig. 1 Schematic diagram of experimental setup

Fig. 2 Experimental arrangement of Insulator in the test

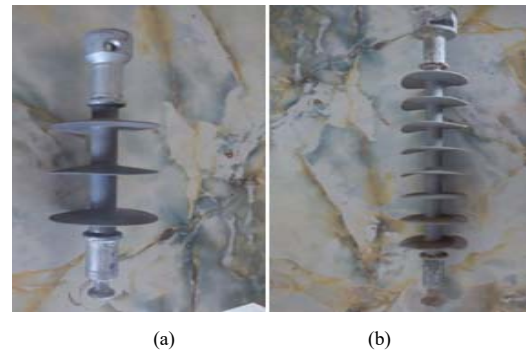
In this paper for each rating four virgin samples were tested. The dimensions for the test specimen were measured as per IEC 61109 [20]. In this work, urea pollution tests are conducted on 11kV silicone composite insulators coded as A11, B11, C11 and D11 whereas salt pollution tests are conducted on 33kV silicone composite insulators coded A33, B33, C33 and D33. Test specimen and dimensions are shown in Figs. 3 (a), (b) and Table I.

Fig. 3 Test Specimens: (a) 11kV Insulator (b) 33kVinsulator

S.No	Particulars	Rating	
		11kV	33kV
1	Length of the insulator (mm)	280	510
2	Dry Arcing Distance (mm)	108	380
3	Creepage Distance(mm)	310	910
4	Specific Creepage Distance (mm/kV)	25	25
5	Shed Diameter (mm)	90	90
6	Number of Sheds	3	8
7	Core diameter (mm)	20.5	20.5
8	Shed Thickness(mm)	3	3
9	Shed Spacing (mm)	52	45

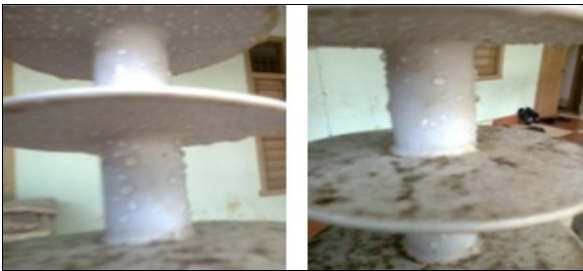
In this investigation, it was observed that in early morning hours, the thin layers of salt and urea deposited on the surface of insulator gets dissolved in to water droplets and flows to the ground. As a result of this, the previously deposited pollution layers become very thin. It took place due to temperature variations in the atmosphere and the cold wind flows on the surface of insulator. Fig. 4 represents water droplets formed on the test specimen.

Fig. 4 Appearance of water droplets on the surface of insulator in the early morning hours

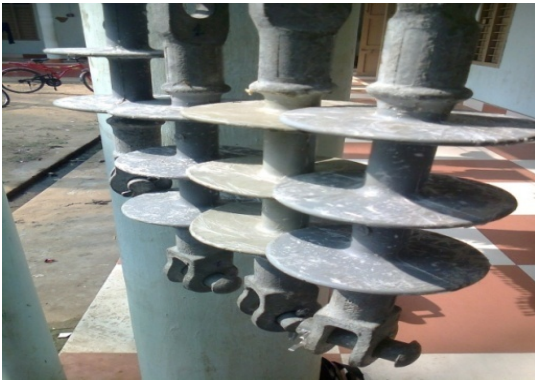
11kV specimens were exhibited to urea pollution. After spraying urea pollution for several days, a thin layer is formed on the insulator surface. The photographs of polluted specimens are given in Fig. 5.

Fig. 5 11kV Specimen under urea pollution

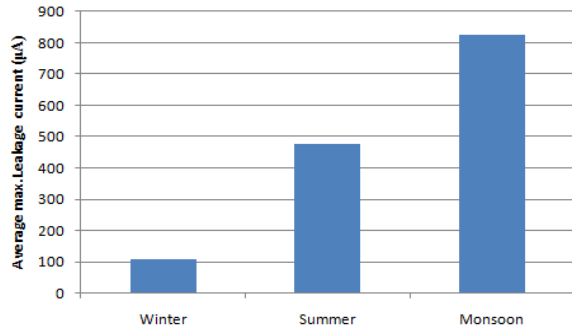
In Table IV, the days between 15 and 75 are in winter season, the days between 90 and 165 are in summer, and from the days between 180 and 240 are in monsoon season. From the data, it is observed that the leakage current increases with number of days. In healthy condition before urea pollution the maximum leakage current of four samples was 62μA. During pollution state it is 108 μA (winter), 476 μA (summer) and 825(monsoon). This may be due to increase of contamination on the surface of insulator. However, the breakdown voltage is same in summer and monsoon seasons. Fig. 6 represents the relationship between the leakage current and seasons.

Fig. 6 Leakage current at various seasons for 11 kV insulators

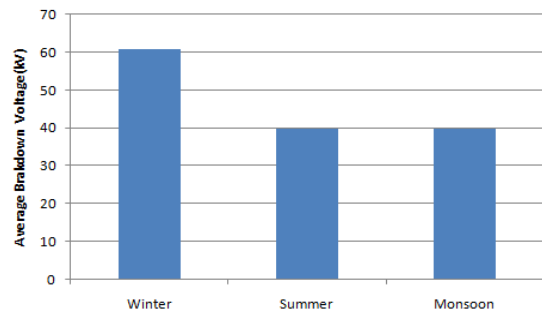
Fig. 7 shows the relation between breakdown voltages among different seasons. And from this, it is observed that the breakdown voltage was gradually decreasing with the number of days in urea pollution. In healthy condition, the BDV measured was 76kV and after applying pollution as the days increased, it is reduced to 61kV in winter season. And it remains almost constant in summer and monsoon season (40 kV). This shows that the effect of urea contamination is less in winter season when compared to summer and monsoon.

Fig. 7 Average breakdown voltage at various seasons for 11 kV insulators

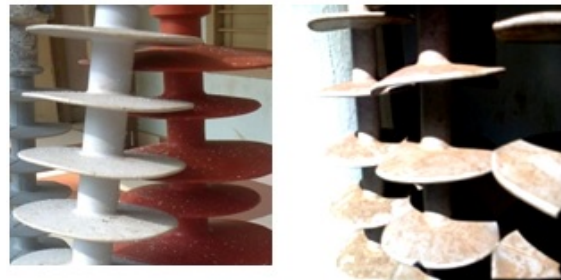
33kV specimens were exhibited to salt pollution. After spraying salt pollution for several days, a thin layer is formed on the insulator surface. Polluted specimens are shown in Fig. 8.

Fig. 8 33 kV Specimens under salt pollution

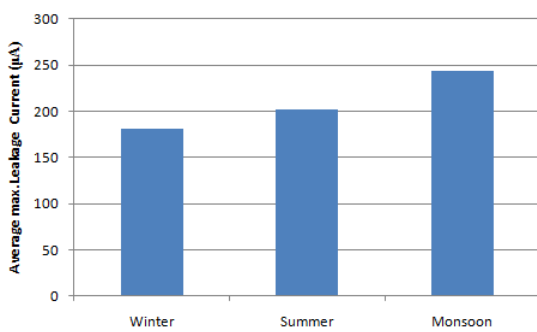
The leakage current (μA) and breakdown voltage (kV) are measured for every fifteen days during summer, winter and monsoon seasons are recorded and the results are tabulated in Table V. It shows a relation between the maximum leakage current and seasons. It is obtained and shown in Fig. 9. And a relation between breakdown voltage and seasons is shown in Fig 10.

From the results it is observed that, the value of maximum leakage current under healthy condition is 119.25μA, whereas under polluted condition it is 181μA (winter), 202μA (summer) and 244μA (winter). Hence, leakage current is

Fig. 9 Leakage current at various seasons for 33 kV insulators

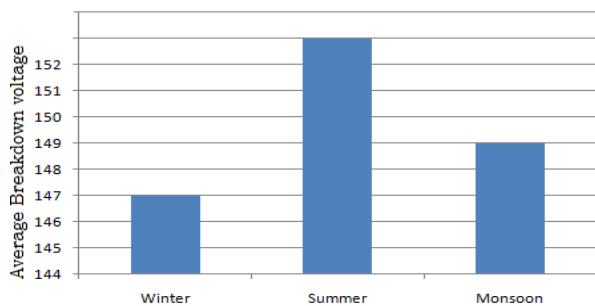
Fig. 10 Breakdown voltage at various seasons for 33 kV insulators

From Fig. 10 it is observed that, there is large change in breakdown voltage among seasons. In healthy condition, the average breakdown voltage of four samples is 157.25 kV but in winter season, it is reduced to 147 kV, in summer season, it raised to 153 kV and in monsoon season, it once again reduced to 149 kV. This shows that the breakdown strength will be higher in summer season, compared to winter and

monsoon seasons. And the effect of salt pollution is less in summer season compared to winter and monsoon.
