Design and Construction Validation of Pile Performance through High Strain Pile Dynamic Tests for both Contiguous Flight Auger and Drilled Displacement Piles

Abstract—Sydney’s booming real estate market has pushed property developers to invest in historically “no-go” areas, which were previously too expensive to develop. These areas are usually near rivers where the sites are underlain by deep alluvial and estuarine sediments. In these ground conditions, conventional bored pile techniques are often not competitive. Contiguous Flight Auger (CFA) and Drilled Displacement (DD) Piles techniques are on the other hand suitable for these ground conditions. This paper deals with the design and construction challenges encountered with these piling techniques for a series of high-rise towers in Sydney’s West. The advantages of DD over CFA piles such as reduced overall spoil with substantial cost savings and achievable rock sockets in medium strength bedrock are discussed. Design performances were assessed with PIGLET. Pile performances are validated in two stages, during constructions with the interpretation of real-time data from the piling rigs’ on-board computer data, and after construct

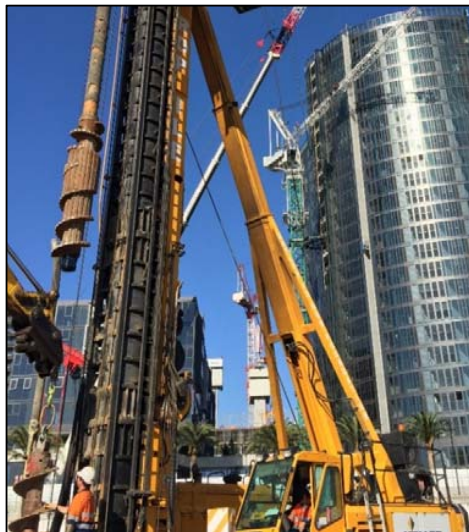
Fig. 7 Keller's modified DD drilling head

effort was made to reduce the volume of spoil generated by piling. A displacement auger capable of drilling through thicker layers of stiff clay and founding in the rock extends the chances of its applications within this site. Fig. 7 shows the modified DD head custom made for this site.

The DD head adopted was a hybrid of the Omega and De Waal heads, utilizing an “Omega-type” head with a 3-m to 6-m auger extension. This guaranteed extending the application of the DD piles within layers up to 6 m of Unit C, while still delivering the required designed minimum pile sockets of up to 1-m length in the MS Sydney Sandstone. Pile design and settlement estimate were carried out in accordance with limit state procedures as outlined in the Australian Standard AS2159-2009 [1], which requires piles to fulfil both serviceability and strength requirements. The geotechnical reduction factor adopted for low and high redundancy piles was 0.65 and 0.71, respectively. The foundation design for this project comprised the design and construction of over 800 piles, the final scheme comprising 55% CFA piles and 45% DD. Pile diameters were 600 mm and 750 mm, with all piles being socketed up to 1 m into MS Sandstone to meet design requirements. The proposed development extends to an area greater than 24 football fields. Different design zones were developed, targeting any significant variability of the soil and bedrock profile. Differences such as thicknesses of soft soil (i.e. Unit B), Unit C, and levels of the MS Sandstone had to be assessed and considered in the design. A typical geotechnical soil profile for this site is presented in Table I.

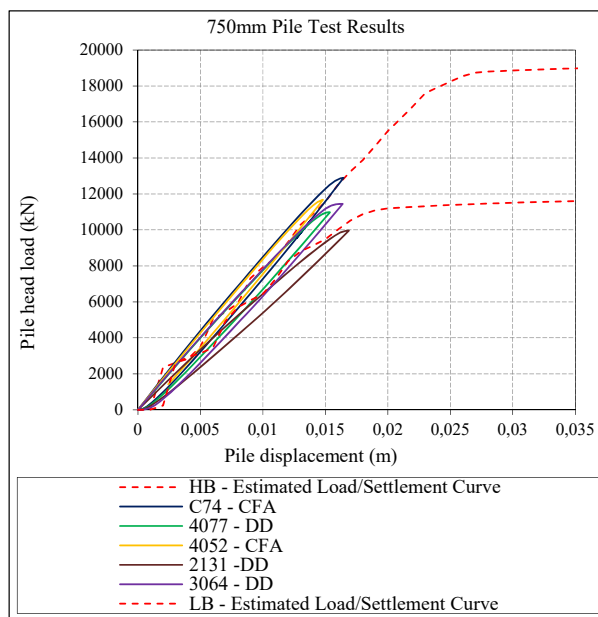
Fig. 101 750-mm estimated vs test load settlement curve

All piles tested were production piles socketed into the sandstone bedrock. A potential disadvantage of dynamic testing of reasonably highly loaded piles is that the hammer drop height must be sufficient to deliver enough energy on the pile to mobilise and prove the required pile resistance whilst not damaging the pile. None of the piles were damaged during the tests as the developed stresses within the piles due to the dynamic impact were continuously monitored. Test signals were recorded on site by means of PDA monitoring and testing devices. Table IV reports the test results. Pile test analyses were carried with CAPWAP, from which the interpreted load displacement curves at construction stage are given in Figs. 10 and 11.
