# A Procedure for Post-Earthquake Damage Estimation Based on Detection of High-Frequency Transients

**Abstract**—In the current research structural health monitoring is considered for addressing the critical issue of post-earthquake damage detection. A non-standard approach for damage detection via acoustic emission is presented -acoustic emissions are monitored in the low frequency range (up to 120 Hz). Such emissions are termed high-frequency transients. Further a damage indicator defined as the Time-Ratio Damage Indicator is introduced. The indicator relies on time-instant measurements of damage initiation and deformation peaks. Based on the time-instant measurements a procedure for estimation of the maximum drift ratio is proposed. Monitoring data is used from a shaking-table test of a full-scale reinforced concrete bridge pier. Damage of the experimental column is successfully detected and the proposed damage indicator is calculated.

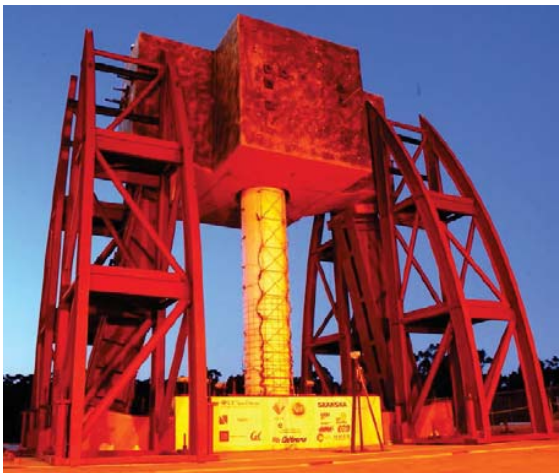
A circular reinforced concrete column was tested on a shaking table. The height of the column was 7,31 meter and the diameter was 1,22 meter. A top weight of 2,32 MN was included by post-tensioned together reinforced concrete blocks. The column was designed according to the Caltrans seismic design guidelines [13]. 10 significant ground motions (EQ's) were induced at the base of the column (Table I). Displacement relative to the base was measured by horizontal spring potentiometers attached to the column and a stiff steel structure which was also mounted on the table. Drift is obtained by dividing the measured relative displacement by the height of the column. Accelerometers and strain-gauges were also installed along the height of the column. The sampling rate of the monitoring system was 240 Hz.

Fig. 3 Test set-up [12]

In this section a case-study calculation of the TRDI is demonstrated on an output data from an experimental reinforced concrete column (Fig. 3) tested on a shaking table [12]. Additionally a step-by-step procedure is provided for the calculation of the TRDI.
