Investigating the Effectiveness of a 3D Printed Composite Mold

Peng Hao Wang, Garam Kim, Ronald Sterkenburg

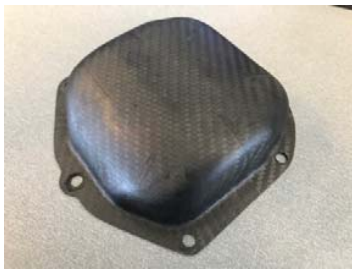
Fig. 7 Completed carbon fiber valve cover

After curing in the autoclave, the carbon fiber valve covers were post processed. Each carbon fiber valve cover was sanded and finished to the dimensions of the original steel valve cover and the mounting holes of the valve covers were also drilled to match the original steel valve cover. Fig. 7 shows a completed carbon fiber valve cover after post processing.

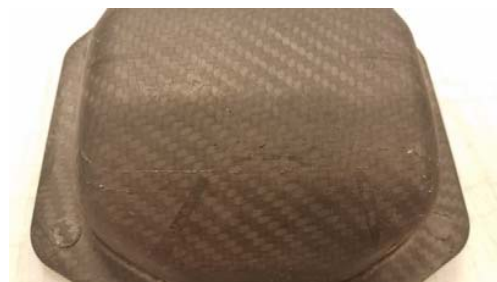
Fig. 9 Surface defects caused by mold surface cracking

A total of six carbon fiber valve covers were fabricated using the 3D printed composite mold. Dimensionally, the six carbon fiber valve covers were very consistent and all the carbon fiber valve covers mounted onto the aircraft reciprocating engine with no issues. The inconsistencies on the carbon fiber valve covers were mainly defects caused by the damages the 3D printed composite mold sustained after every part demolding process; although most of the defects on the carbon fiber valve covers as shown in Figs. 8 and 9 were cosmetic defects that can be easily remedied with some light post processing such as sanding and applying layers of clear coat. The condition of the 3D printed composite mold will continue to deteriorate as the fabricated part count increases. As a result of the deteriorating 3D printed composite mold, the quality of the carbon fiber valve covers will also continue to worsen.

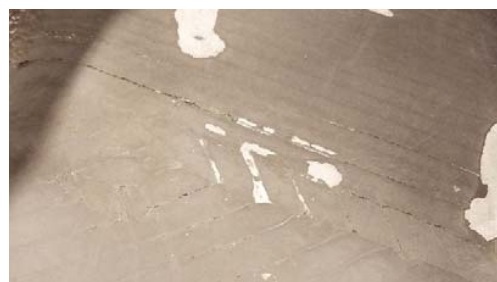
Fig. 11 Mold surface cracking between beads

main defects the 3D printed composite mold had were chipping of the mold surface and some cracking on the mold surface between the bead interfaces as shown in Figs. 10 and 11 respectively.

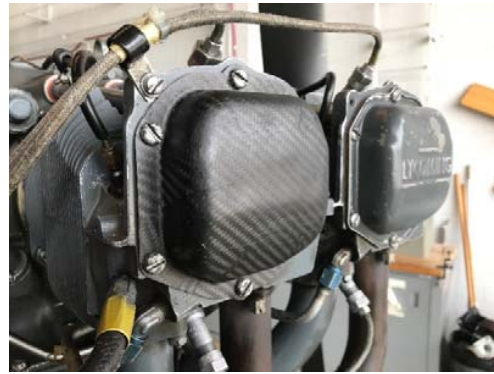
Fig. 14 Test fitting of carbon fiber valve cover

Based on the results from this study, the team was able to investigate the effectiveness of a 3D printed composite mold by producing six identical carbon fiber valve covers from a single 3D printed composite mold. The six carbon fiber valve covers were all test fitted onto the original aircraft reciprocating engine and all six carbon fiber valve covers fitted perfectly with no issues as shown in Fig. 14. The six carbon fiber valve covers however did have various surface defects that were caused by the mold surface gradually deteriorating from each part production, raising durability concerns for the 3D printed composite mold. There can be an abundance of factors that may have caused the deterioration of the mold surface. Some examples of these factors include porosity within the 3D printed composite mold, the 3D printing tool path of the 3D printed composite mold, and weak interfaces between printed beads of the 3D printed composite mold [1]. Many of these factors can essentially be removed by changes to the design and fabrication technique of the 3D printed composite mold. For example, the issue of porosity within the 3D printed composite mold can be rectified by heat treatments to the mold or by the application of surface coatings. Advance approaches forming molds with varying material composition also known as gradient materials may also be a suitable solution [6]. Other factors such as the printing tool path and weak interfaces between the printed beads may be solved by performing further tool-path optimization for the printing process of the 3D printed composite mold [7].
