# A Current Problem for Steel Bridges: Fatigue Assessment of Seams' Repair

**Abstract**—The paper describes the results from a research project about repair of welds. The repair was carried out by grinding the flawed seams and re-welding them. The main task was to determine the FAT classes of original state and after repair of seams according to the assessment procedures, such as nominal, structural and effective notch stress approach. The first part shows the results of the tests, the second part encloses numerical analysis and evaluation of results to determine the fatigue strength classes according to three assessment procedures.

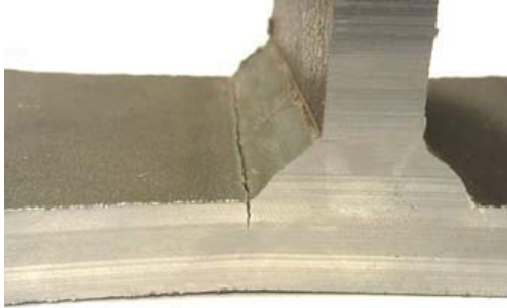
For such geometry of specimen, a fatigue crack is expected to occur at weld toe and is mostly caused by concentration of notch stresses (Fig. 2). To make possible a comparison the results of fatigue strength for the welds after seams' repair and additionally seams' re-working methods, the fatigue strength test analyses were divided into three groups:

Fig. 2 Crack at weld toe [1]

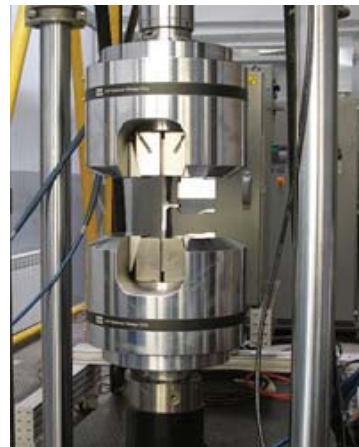
The fatigue tests were carried out with frequency of loading 30 Hz by using a servo hydraulic fatigue test machine (Fig. 5). According to recommendation for fatigue tests the specimens were loaded in five different load levels. To determine a Wöhler (S-N) curve, just the specimens with the crack at weld toe were taken into consideration. The run-out samples were indicated on diagrams by data points with arrow marks. The fatigue loading was alternating the axial tensile with the assumption of stress ratio  $R = 0.1$  and fixed slope of Wöhler curve  $m = -3$ .

Fig. 5 Hydraulic fatigue test machine [1]

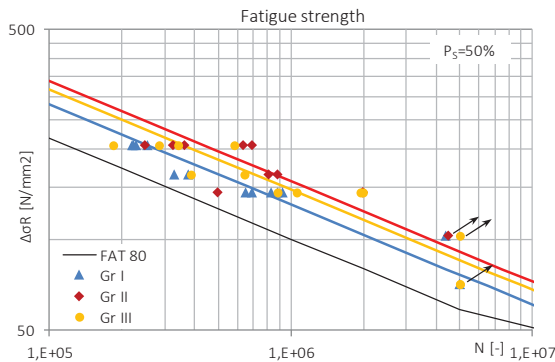
The following numbers of specimens were investigated: 29 for group I (original state), 13 for group II (after seams' repair) as well as 13 for group III (with post-weld treatment). The data points were presented in Wöhler diagram (Fig. 6). For the group I the fatigue strength has a value of  $104 \text{ N/mm}^2$ , for the group II  $124.5 \text{ N/mm}^2$  and accordingly for group III  $116.5 \text{ N/mm}^2$ . It concerns a probability of survival of 50 %, i.e. regression line. The results show that the weld seams after repairing process could easily achieve the fatigue strength of those in initial state. In some cases, even the considerable enhancement of fatigue life is observed. But, it should be

mentioned that such repair procedures can lead to the increase of misalignments of specimen geometry. The post weld treatment, i.e. the high frequency hammer delivered in this case negligible effects on the fatigue strength to compare with the original ones.

Fig. 6 Comparison of results from three states [5]

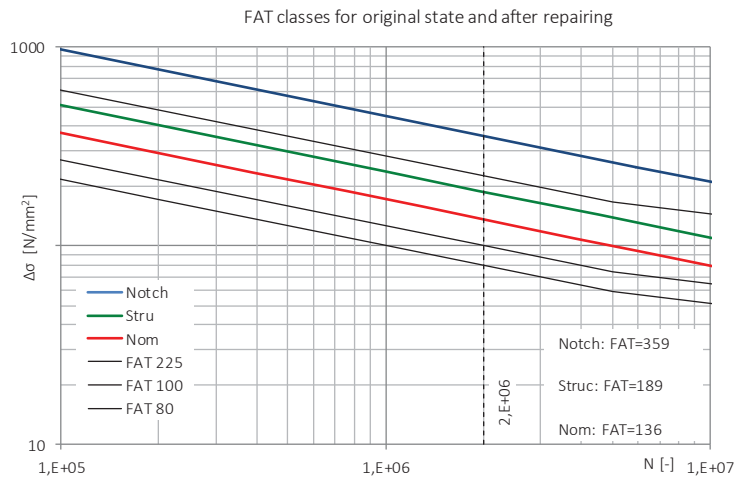
Fig. 9 shows determined FAT classes for three assessment concepts. For each approach, the value of calculated FAT notch detail is considerably higher than in the currently valid guidelines [3] or standards [6]. Additionally, the results confirm a conservatism of notch class according to EC3 [6] for detail of transverse attachment with fillet welds. This applies in particular to the nominal and structural stress concept, whereby value of improvement reaches even till 20 %.

Fig. 9 FAT categories of original state and after seams' repair [5]
