A Secondary Disaster Due To Inhabitant's Action after a Strong Earthquake: a Case Study of the 2008 Sichuan Earthquake

A. A Survey in DujiangYan City

B. Site of Photographs

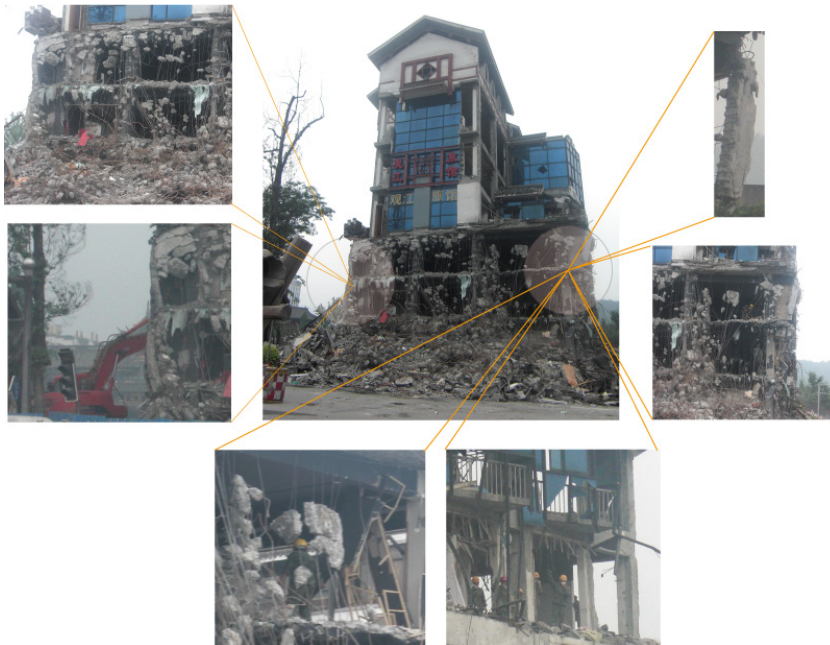
Photograph1. Dangerous Demolition

(1) Photograph1: Dangerous Demolition

Photograph1 shows a demolishing of building which used human labor and truck. A whole state of building is severely damaged, all walls are demolished, columns are intense damaged and some columns shifted from central position and glass windows are breaking. At the left side of 1st floor, demolition work is done by a truck and at the 2nd and 3rd floor demolishing work is done by human labor.

In the middle of demolishing, the building can possible to collapse any time, but a housebreaker has used human labor to demolish inside of building along with using truck for demolishing building.

For demolishing of building, should not used human labor and not allow people to go inside demolished building.

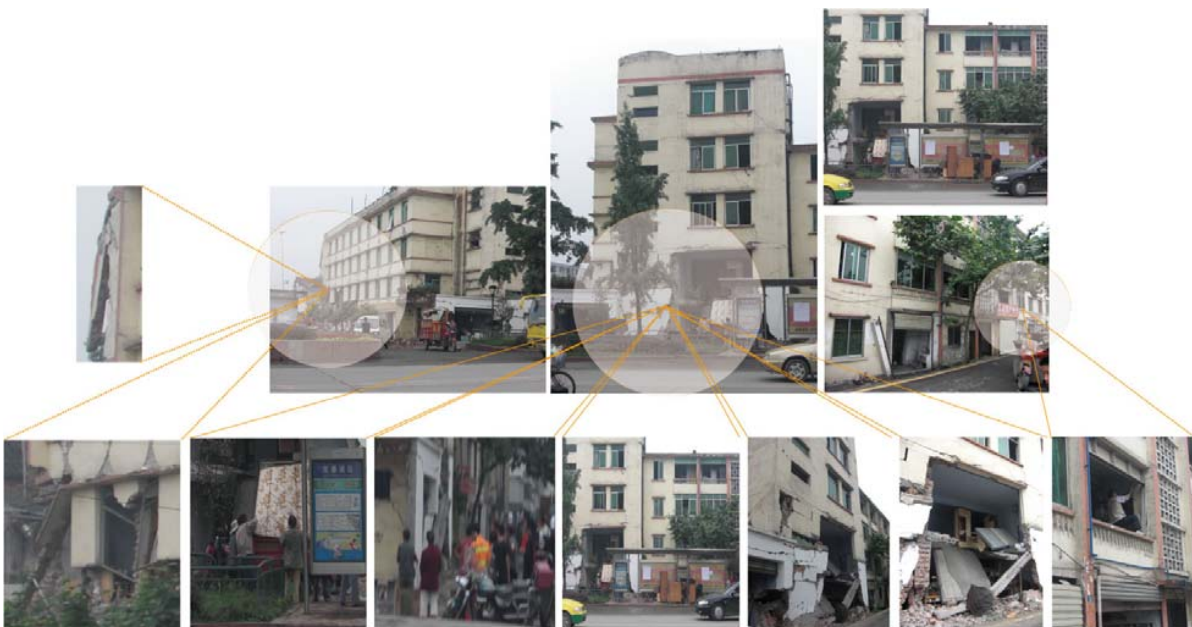
Photograph3. Dangerous Action

(3) Photograph3: Dangerous Action

An apartment building of brick structure is near collapse state. Have large vertical cracks occur in an edge of L type building and have big diagonal cracks occur in around the walls. The brick columns in first and second floor are collapse and a floor is falling down. The building is losing structural support part and in the state that can't be reinforced. But, residents are going inside for taking their furniture and properties from the apartment for moving out. Moreover, have a man is detaching the window frame work in the next door. The building where structural support part is lost possible to unexpected collapsed by aftershocks and vibrations. Inhabitants should not entire or be around such the building. Photograph3 shows the dangerous action.

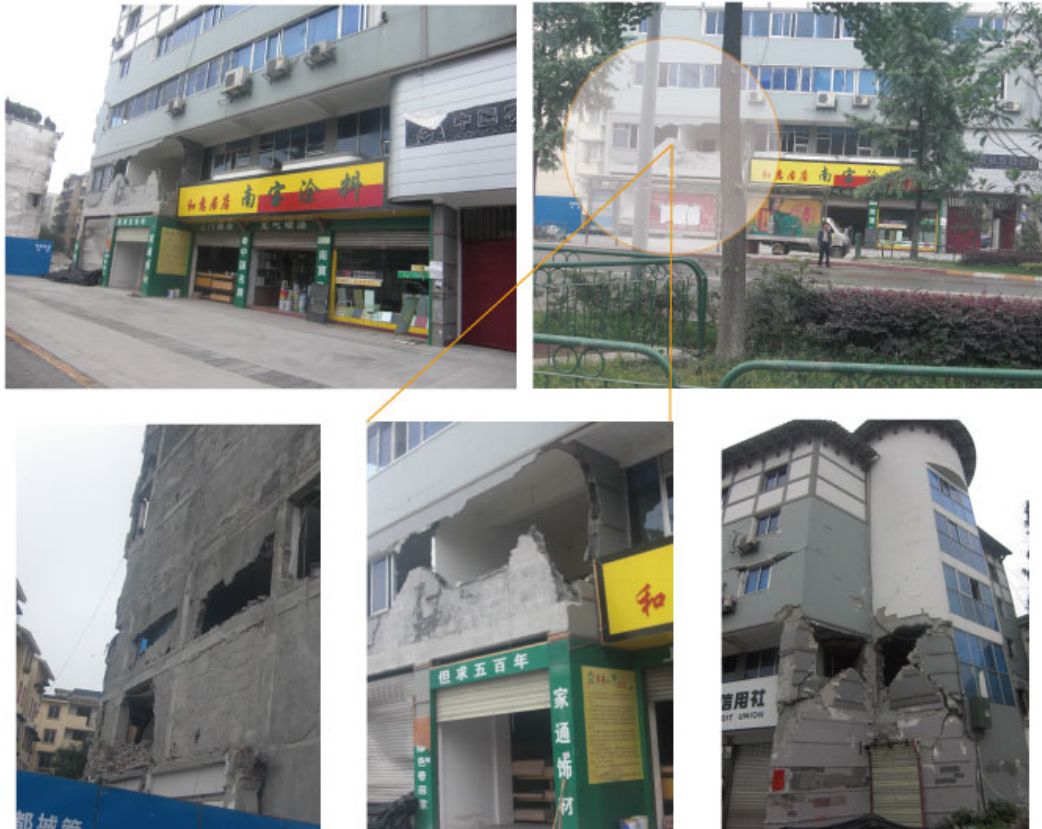
Photograph4. Dangerous Business

(4) Photograph4: Dangerous Business

The wall has destroyed partially and early reinforcement is needed. Structure type is unconfirmed but bricks are showing at column. Before entire to the building rapid structural checked is needed. But resident is doing shop business in the building which not checked the safety and has intense damage. These actions can be a caused of expanding damage further. Photograph4 shows the dangerous business state.

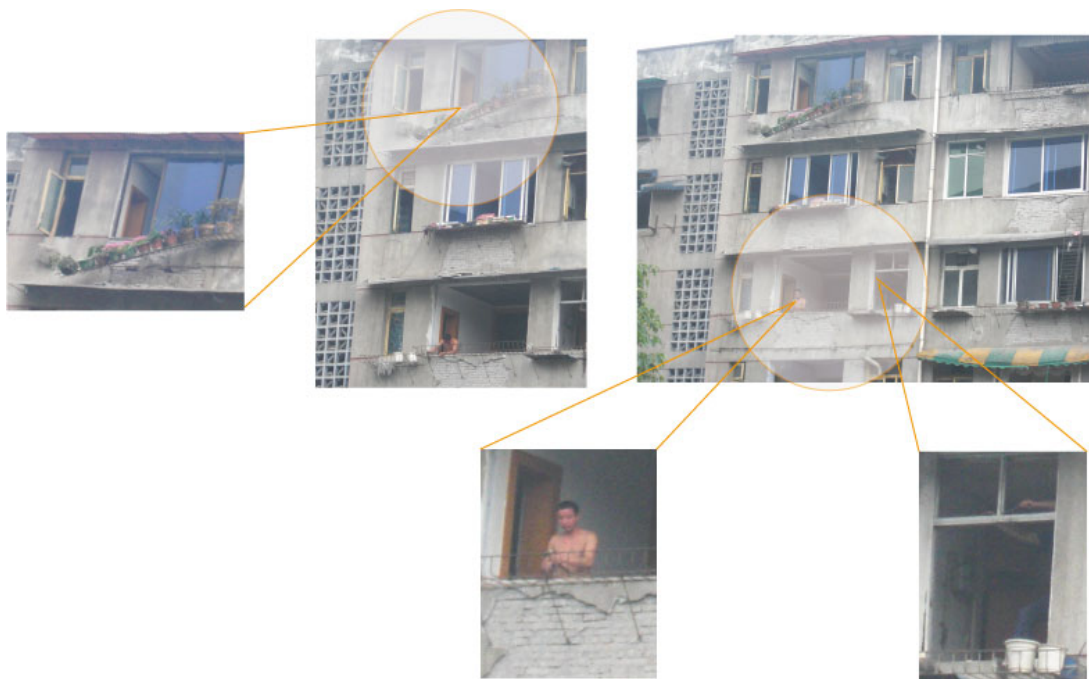
Photograph5. Danger posted by the Falling Objects

(5) Photograph5: Danger posted by the Falling Objects

During his detaching work, these flower baskets can fall down anytime by the aftershocks or the shakes from the works but he isn't notice it. These actions can possible to make resident injured. A post earthquake quick inspection of damaged building to evaluate the risk of building collapse, fall of exterior walls and window glass and so on are needed.

- (1) Do not use human labor for interior with upper stairs demolishing work.
- (2) Execute a post earthquake quick inspection of damage building immediately.
- (3) Post-evaluation placards posted on damaged building inform the risks not only for inhabitants but also for passersby.
- (4) Do not allow people to go inside, living or running any business in the building which not confirming the safety yet.
- (5) Never enter the building unknowing of its hazard.
- (6) Keep people out from the unsafe building.
- (7) Reinforce the damaged building which has a possibility of reuse as soon as possible.
- (8) To improve awareness of disaster prevention must educated and train and make a conscious effort to inhabitants.
