Assessment of In-Situ Water Sensitive Urban Design Elements

Niranjali Jayasuriya and Majell Backhausen

Keywords—Bio-retention swales, Maintenance plan, Operational plan, Water Sensitive Urban Design, Water quality improvement.

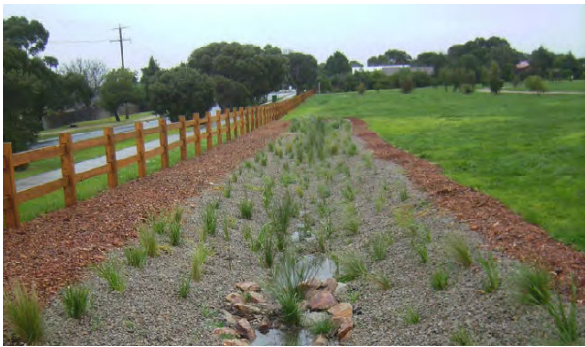
Bio-retention swales provide two main functions: stormwater treatment and the ability to convey stormwater safely (Figure 2). The swale component of the system uses vegetation and gravity to pre-treat the stormwater, removing coarse to medium sediments as well as litter and natural debris. After conveyance through the swale, the stormwater percolates through the prescribed filter media component of

the Bio-retention system located at the base of the swale removing finer particles, nutrients and contaminants. The filter media achieves this through fine filtration, extended detention treatment and some biological uptake. If designed and constructed properly a bio-retention swale system should also have the ability to retard some stormwater flow during large storm events and provide protection to natural receiving waterways from the high flow velocities associated with piped flows. In the occurrence of a large storm event, overflow pits are also incorporated in the design, directly conveying excess water into the stormwater pipe network.

Fig. 2 Bioretention swale Mornington Peninsula Shire Council, Victoria Australia

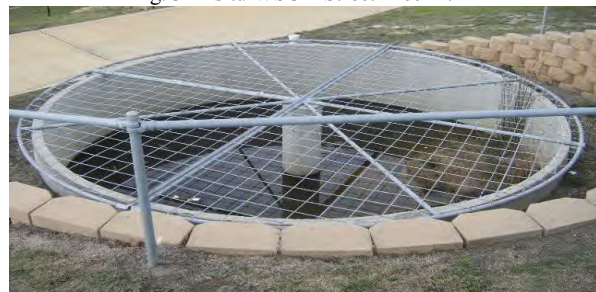
Sedimentation tank and Bio-retention tank systems have dual pollutant extraction ability. The sedimentation tank is the first course of treatment for harvested stormwater (Figure 4). Sedimentation removes gross pollutants, large and medium sized particles (sand, grit, rubbish). Bio-retention tanks will then receive the overflow pre-treated water and allow it to percolate through the filter media, removing finer particles, nutrients and contaminants (the same principles as the Bio-retention treatment in a swale). In the occurrence of a large storm event, allowances for water overflows are also incorporated in the design, directly conveying excess water into alternative pipe networks or creeks. With no documentation found on the exact design, construction and maintenance on this system, it is assumed that the process of implementation from the concept phase to operational phase follows the general guidelines of WSUD feature implementation.

Fig. 4 Hi-Capacity Sedimentation Tank
