Assessment of Rehabilitation Possibilities in Case of Budapest Jewish Quarter Building Stock

Viktória Sugár, Attila Talamon, András Horkai, Michihiro Kita

Abstract—The dense urban fabric of the Budapest 7th district is known as the former Jewish Quarter. The majority of the historical building stock contains multi-story tenement houses with courtyards, built around the end of the 19th century. Various rehabilitation and urban planning attempt occurred until today, mostly left unfinished. Present paper collects the past rehabilitation plans, actions and their effect which took place in the former Jewish District of Budapest. The authors aim to assess the boundaries of a complex building stock rehabilitation, by taking into account the monument protection guidelines. As a main focus of the research, structural as well as energetic rehabilitation possibilities are analyzed in case of each building by using Geographic Information System (GIS) methods.

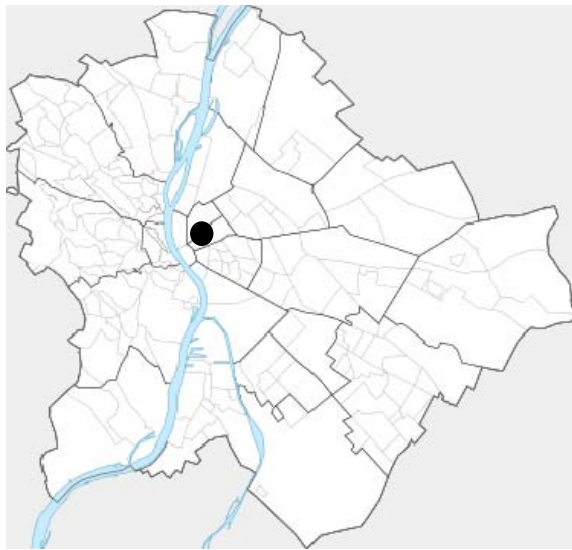
Fig. 1 The Old Jewish Quarter of Pest, in today's District 7 of Budapest [3]

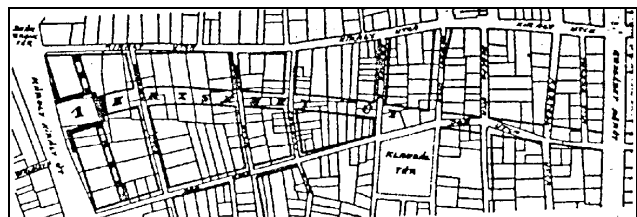
Fig. 9 Plan of Madách Boulevard – only the opening on the left part was finished [7]

The project of Madách Sugárút (Madách Boulevard) has been the most grandiose intervention in the mainly organic structure. The idea of the first so called Erzsébet (referring to Queen Elisabeth again) then later Madách Boulevard was first introduced in the beginning of the 20th century. The concept was to open a main road to rival the nearby Andrásy Boulevard, which is ever since its opening has been the most important avenue of the area. Several plans were created, from which in 1930's, the complex of 11 interlocking buildings were built with a great gate motif to open up the densely built in inner parts. The plan however halted here, and only the beginning of the boulevard was built (Figs. 8, 9) [8].

Since the 1940's, various plans had been created and many suggestions were made to finish the project. Some critics pointed out that the plan is disregarding the current structure of the city [8] – the plan would have demolished significant early buildings and monuments, and would have brought a different scale of road and building stock to the area.
