Design and Construction Validation of Pile Performance through High Strain Pile Dynamic Tests for both Contiguous Flight Auger and Drilled Displacement Piles

S. Pirrello

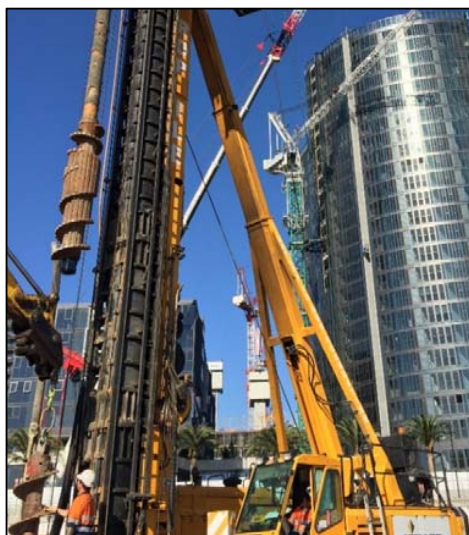
Fig. 7 Keller's modified DD drilling head

The DD head adopted was a hybrid of the Omega and De Waal heads, utilizing an “Omega-type” head with a 3-m to 6-m auger extension. This guaranteed extending the application of the DD piles within layers up to 6 m of Unit C, while still delivering the required designed minimum pile sockets of up to 1-m length in the MS Sydney Sandstone. Pile design and settlement estimate were carried out in accordance with limit state procedures as outlined in the Australian Standard AS2159-2009 [1], which requires piles to fulfil both serviceability and strength requirements. The geotechnical reduction factor adopted for low and high redundancy piles was 0.65 and 0.71, respectively. The foundation design for this project comprised the design and construction of over 800 piles, the final scheme comprising 55% CFA piles and 45% DD. Pile diameters were 600 mm and 750 mm, with all piles being socketed up to 1 m into MS Sandstone to meet design requirements. The proposed development extends to an area greater than 24 football fields. Different design zones were developed, targeting any significant variability of the soil and bedrock profile. Differences such as thicknesses of soft soil (i.e. Unit B), Unit C, and levels of the MS Sandstone had to be assessed and considered in the design. A typical geotechnical soil profile for this site is presented in Table I.

effort was made to reduce the volume of spoil generated by piling. A displacement auger capable of drilling through thicker layers of stiff clay and founding in the rock extends the chances of its applications within this site. Fig. 7 shows the modified DD head custom made for this site.

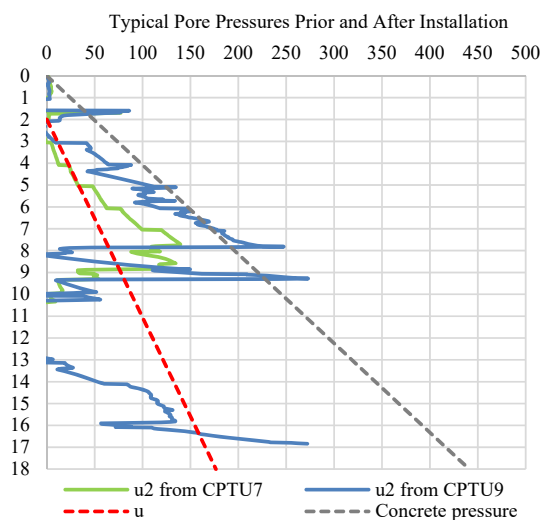
Fig. 9 Pore pressure results from CPTu7 and CPTu9, prior and after installation

The increase of pore pressure after installation can be appreciated in CPTu7 at 8-m and 9.5-m depth. However, this increase is very close to the concrete head pressure at the same depth in the worst case or less, and therefore the integrity of the newly formed pile shafts is not a concern. A substantial increase in pore pressure with depth greater than the concrete head pressure would be a potential indicator of damage to the pile, e.g. pile “necking” at the depths where the pore pressures exceeded concrete pressures.

Typical CPTu results prior and after the installation are given in Fig. 9.
