Effect of Stirrup Corrosion on Concrete Confinement Strength

Mucip Tapan, Ali Ozvan, Ismail Akkaya

Abstract—This study investigated how the concrete confinement strength and axial load carrying capacity of reinforced concrete columns are affected by corrosion damage to the stirrups. A total of small-scale 12 test specimens were cast for evaluating the effect of stirrup corrosion on confinement strength of concrete. The results of this study show that the stirrup corrosion alone dramatically decreases the axial load carrying capacity of corroded reinforced concrete columns. Recommendations were presented for improved inspection practices which will allow estimating concrete confinement strength of corrosion-damaged reinforced concrete bridge columns.

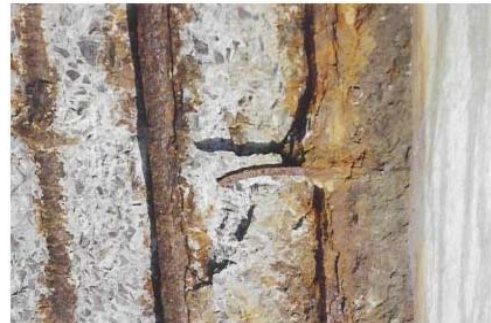
Fig. 1 Close-up of corroded rebars [5]

The deteriorating effects of corrosion are evident but stirrup corrosion has significant effects on load carrying capacity of the reinforced concrete columns (i.e. relatively larger cross-section reduction, loss of concrete confinement because of loss of bond and loss of anchorage). These significant effects are expected because stirrups start corroding earlier than the longitudinal reinforcement and since they are smaller in diameter, same corrosion rate leads to larger relative reductions in stirrup cross-sections (Fig. 1).

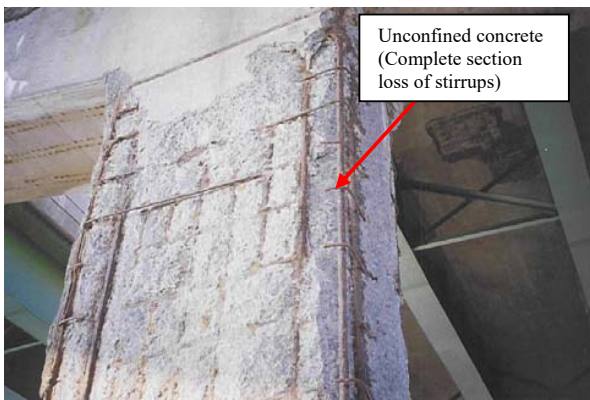
Fig. 2 Effect of corrosion on reinforced concrete column [5]

When the stirrup starts to corrode, the confinement effect of stirrups is reduced because of the loss of bond between reinforcement and concrete (Fig. 2). When the cover to the longitudinal reinforcement cracks, the load carrying capacity starts to decrease at a faster rate due to the reduction of stirrup anchorage. Loss of transverse reinforcement, as shown in Fig. 2, leaves the column section unconfined. In addition, loss of bond between the corroded bars and the surrounding concrete, as shown in dramatically decreases the axial load carrying capacity of the column (Figs. 3 (a) and (b)).

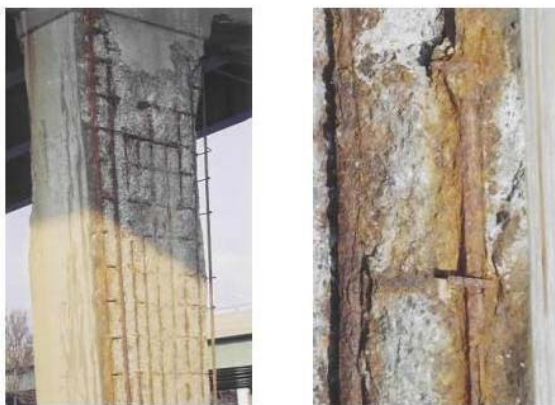
Fig. 3 Corrosion damage of tall concrete bridge pier columns [5]

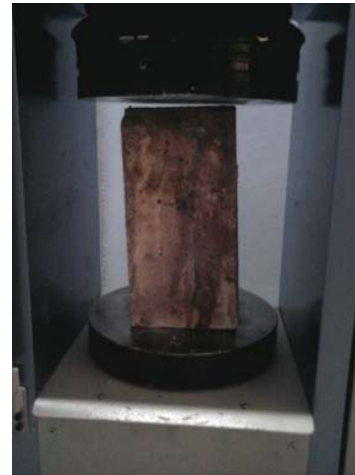
Fig. 6 A corroded column specimen before compressive testing

Fig. 6 shows a tested column and Fig. 7 shows a typical corroded column stirrup after cleaning from rust and concrete remains. In some cases, complete section-loss was also observed.

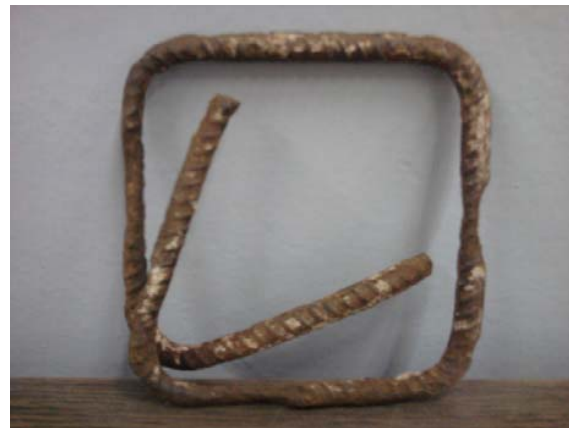
Fig. 7 Typical corroded column stirrup

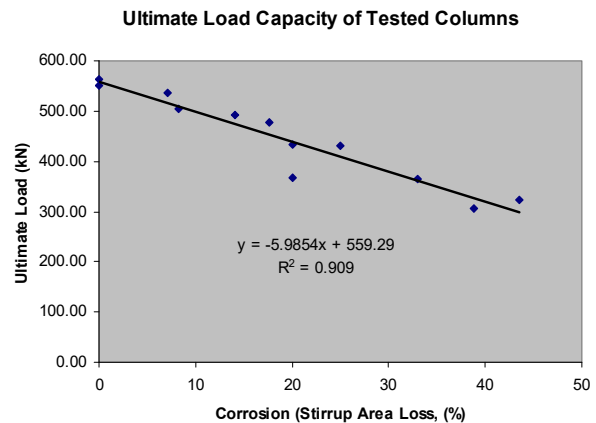
Fig. 8 Effect of stirrup corrosion on axial load carrying capacity of reinforced concrete columns

The load carrying capacity of tested columns is given in Table II. The reduction in ultimate capacity with increasing levels of corrosion damage was obvious. The major findings of these tests are the importance of effect of stirrup corrosion, stirrup debonding from the concrete and cover cracking because of stirrup corrosion on concrete confinement strength and consequently on axial load carrying capacity of corroded reinforced concrete columns. Section loss corrosion is determined calculating the average weight loss of corrosion damaged stirrups in the tested column. For the sake of simplicity pitting corrosion is not taken into consideration. Results indicate that, the axial load carrying capacity of corroded reinforced concrete columns significantly decreases as the rate of stirrup corrosion increases. Therefore, in order to avoid unsafe/over-conservative ratings the inspection procedures shall identify stirrup section-loss and incorporate in the analysis phase.
