Effects of Polluted Water on the Metallic Water Pipelines

Abdul-Khaliq M. Hussain, Bashir A. Tantosh and El-Sadeg A. Abdalla

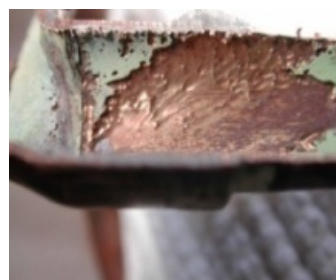
Fig. 9 Copper pitting corrosion

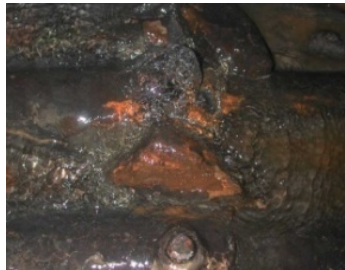
Fig. 13 Chloride stress corrosion cracks

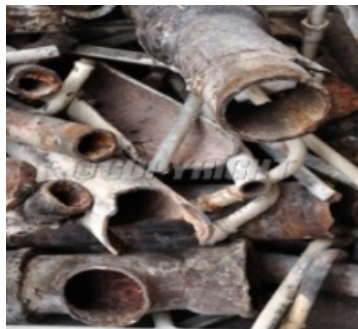
Fig. 15 Corroded water pipe
