# Evaluation of Performance Requirements for Seismic Design of Piping System

Bu Seog Ju and Woo Young Jung

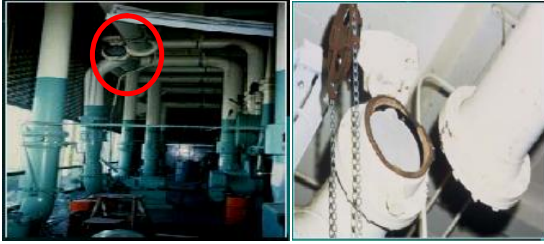
Fig. 1 showed the failures of piping systems during the 1971 San Fernando Earthquake turning point in seismic design of buildings and nonstructural components. It was following this earthquake that the California Office of Statewide Health Planning and Development (OSHPD) started requiring that the hospital buildings remain fully operational following an earthquake.

Fig. 1 Piping Failures in 1971 San Fernando Earthquake (Gates, 2005)

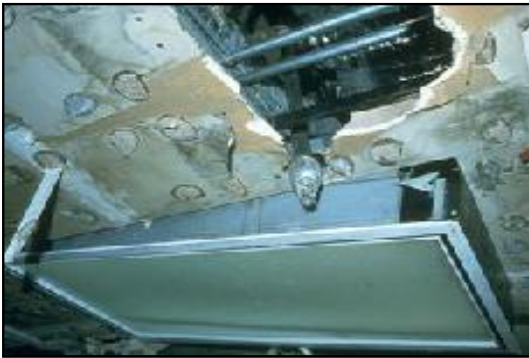
wide spread failures [6]. Fig. 2 illustrated a typical failure of fire sprinkler piping system in the Northridge Earthquake. Fig. 3 showed an example of a failure of fire sprinkler head due to vertical acceleration.

Fig. 2 Piping Failures in 1994 Northridge Earthquake (Miranda, 2004)

During the 1994 Northridge earthquake, failures were observed in several different piping systems such as HVAC systems, sprinkler piping systems, and water piping systems. The major reason of the damage to fire sprinkler piping systems has been identified as the excessive vertical acceleration. Vertical acceleration led to impact of piping with ceiling and caused the failures in fire sprinkler piping systems. Another reason for significant damage in sprinkler systems was attributed to bracing type and brace spacing of pipe lines. Unbraced pipe lines, less than 1 inch diameter, experienced

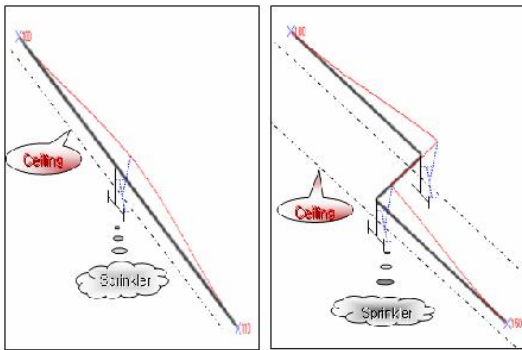
Fig. 3 Failure of Fire Sprinkler Due to Vertical Acceleration

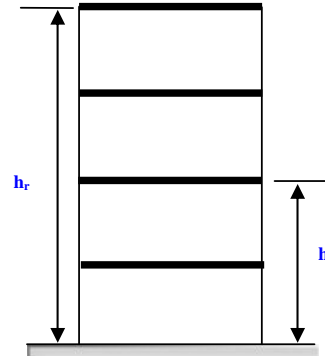
Fig. 4 4-Story Building

When  $h_x$  is equal to  $h_r$ , the maximum amplification in any building is 4.0, and  $R_p$  is 3.0 for piping systems.

$h$ : The total building height,  $h_r$  in fig. 4

$z$ : The component elevation at point of attachment,  $h_x$  in fig. 4

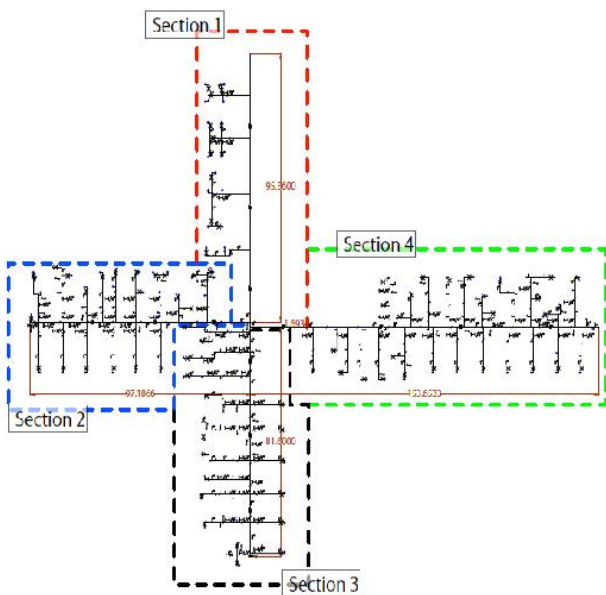
The hospital piping system shown in Fig. 5 consists of main piping runs along 4 sections with a total of 64 branches in all. Essentially, main piping system is made of 2-inch and 4-inch pipes while the branches comprise of pipes with smaller diameter than those of main pipes. This system is supported by unbraced single hangers, transverse braced hangers and longitudinal braced hangers. There are 4 anchors at the ends of the main piping system.

Fig. 5 Full Scale Piping System Layout

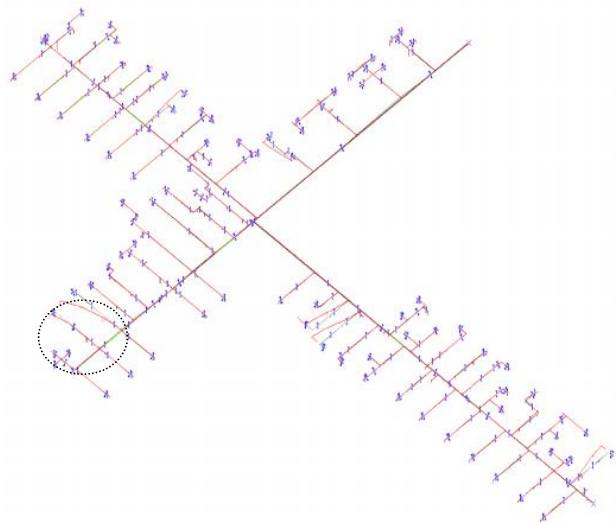
Fig. 6 Displacements of Piping System Subjected to the Lateral Force

Fig. 6 showed the displacements of piping system due to the lateral force. The maximum displacement (31.76 cm) caused in the circle area of piping system and additional results were given in Table II.

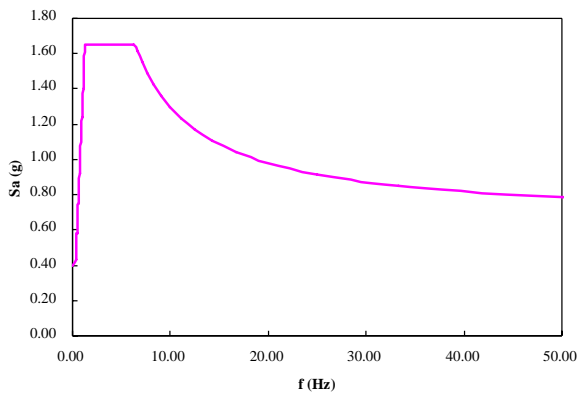
Next, in order to understand the dynamic characteristics of piping system, the design spectrum (Fig. 7) based on UBC-97 was created for the piping system.

Fig. 7 Design Spectrum Based on UBC-97

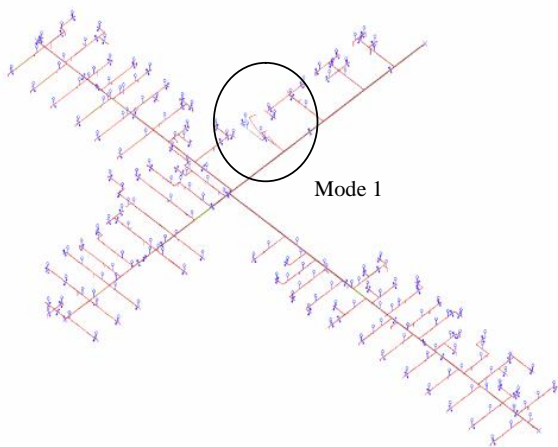
Fig. 8 Piping System Mode Shapes

Furthermore, the fundamental and second frequency of the piping system in fig. 8 was 0.6450 Hz and 0.8384 Hz, respectively. The design spectrum also was applied to the horizontal direction at the piping system. The maximum displacement was 70.13 cm at a branch piping system. Table III also was given the forces and moments in the dynamic analysis.

As can be seen in the results, the static and dynamic performance of piping system was significantly different. In the case of dynamic analysis, although the piping system was designed by NFPA-13 and SMACNA guideline, the maximum displacement was excessively large and the maximum moment ( $M_y$ ) was almost doubled.
