# Experimental Investigation on Cold-formed Steel Wall Plate System

A. L. Y. Ng, W. H. Hii

**Keywords**—Cold-formed steel, wall plate system, distortional buckling, full scale laboratory test.

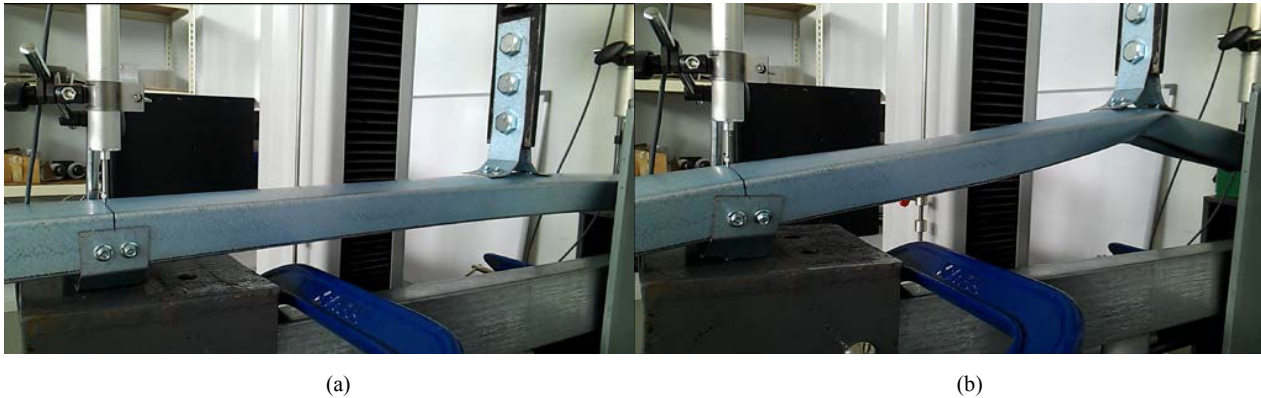
of the bolt head. At around 4.5 kN, the connecting plates were fully stressed as shown in Fig. 7 (a) and distortional buckling began to develop in the channel. The connecting plates at the supports were pulled closer and screws connection at the supports began to tilt. Upon reaching the ultimate load, distortional buckling was fully developed at the mid span of the wall plate as shown in Fig. 7 (b).

Fig. 7 (a) First observed failure mode and (b) second observed failure mode in the first parametric study

Tests were conducted on CFS wall plate system with and without clearance for comparison. Comparison was made between configurations namely 100/1.2/1.2/wc and 100/1.2/1.2/woc. Both of the specimens with (wc) and without (woc) clearance behaved similarly. Failure began with the yielding of the connectors followed by distortional buckling of the wall plate. When a load was applied, the legs of the connecting plates were pulled. The shorter leg of the L-brackets and the web of U-brackets moved upwards. At a load of 2.7 kN, yielding on U and L brackets occurs along the edge
