# FEM and Experimental Modal Analysis of Computer Mount

Vishwajit M. Ghatge, David Looper

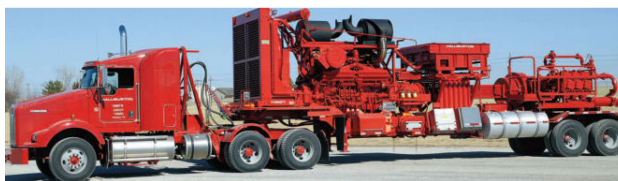
Fig. 1 Typical fracturing pump trailer

**O**IL and gas stimulation equipment consists of pump trailers, blenders, proppant handling systems, etc., which are designed to achieve maximum reliability with minimal maintenance, even in extremely harsh oilfield environments [1]. A typical fracturing pump trailer is shown in Fig. 1. To

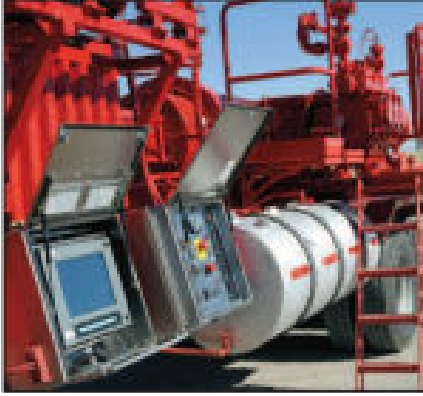
Fig. 2 Location of Daisy Data Displays computer on trailer

still suitable for this new computer, until the newest version was introduced, which is 10 lbm heavier. Some failures of internal parts have been reported when exposed to vibration in the field resulting from the two brackets colliding under off-road conditions, which causes a high shock input to the computer parts. The location of the Daisy Data Display computer is shown in Fig. 2.

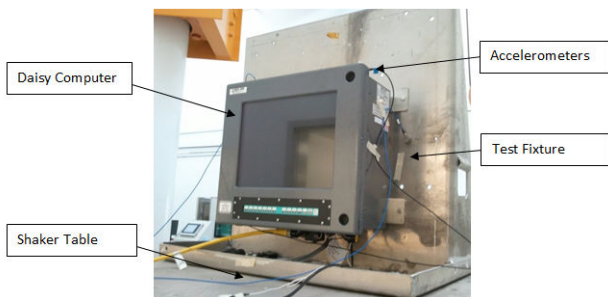
The Daisy Data Displays computer was experimentally tested by hard-mounting it to the test fixture, as per the manufacturer's suggestions and guidelines, to duplicate the manufacturer's testing. Fig. 3 shows the test setup, in which the Daisy Data Displays computer was hard-mounted to the test fixture and the fixture was hard-mounted on the shaker table.

Fig. 3 Test setup for Daisy Data Displays computer

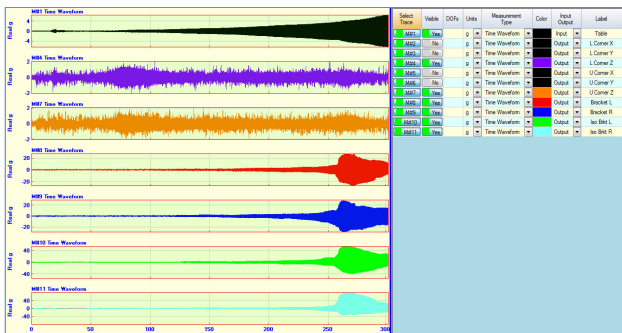
Accelerometers were placed on different locations of the bracket to measure the response. Dytran Model 3023A2 type accelerometers were used. Four single-axis accelerometers were placed at the outside edge of both the fixed and suspended brackets. In FFT output of the tests, shown in Figs. 15 and 16, the Bracket L, Bracket R, Iso Brkt. L and Iso Brkt R correspond to accelerometer locations on Left and right side of the fixed brackets and suspended brackets respectively. As per IEC standards for vibration testing, vertical input sine sweep tests were planned with a 1g peak and 5 to 500 Hz input for two full cycles. In the data acquisition system, the frequency response function was plotted with the obtained signals.

Fig. 16 Real g's recorded over the 5 to 45 Hz sweep up

The frequency obtained from FEM analysis was 39.267 Hz, and experimental output from FFT analyzer for modal analysis resulted in a hammering frequency approximately 41 Hz. The percentage variation between the experimental and FEM results was 4.41%. These results showed that a close correlation was established between both analyses. Therefore, closely duplicating the experimental conditions into the FEM model was successful. The modified design reduced the colliding of the two brackets, which in turn helped reduce the internal failure of computer parts.
