# Hydrophobic Characteristics of EPDM Composite Insulators in Simulated Arid Desert Environment

**Keywords**—EPDM, composite insulators, accelerated aging, hydrophobicity, contact angle.

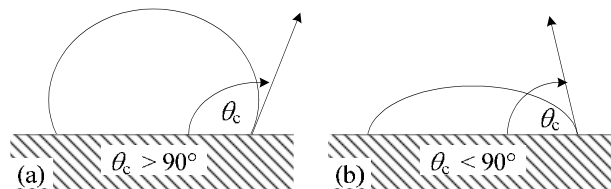
Fig. 1 Schematic diagram of water drop on:  
(a) Hydrophobic surface (b) Hydrophilic surface

weathering and from dry band arcing, suffer from erosion and tracking which may lead ultimately to failure of the insulator, faulty insulators are difficult to detect and life expectancy is difficult to evaluate [1]. The property of high hydrophobicity of the composite insulators assures them better performance in contaminated environments. Hydrophobicity of a material is its resistance to flow of water on its surface or resistance to the formation of continuous film of water. It can be described using contact angle ( $\theta_c$ ) on the material surface that a liquid drop makes on the solid surface when it comes into contact with it. The hydrophobic materials allow less water surface contact and thus make  $\theta_c > 90^\circ$  as shown in Fig. 1(a), whereas materials which are easily wettable allow water to touch a large surface area and hence make  $\theta_c < 90^\circ$  as shown in Fig. 1(b) and is known as hydrophilic. Surface is said to be hydrophobic, when  $\theta_c > 90^\circ$ , hydrophilic when  $\theta_c < 35^\circ$  and partially wettable when  $35 < \theta_c < 90^\circ$  [2].

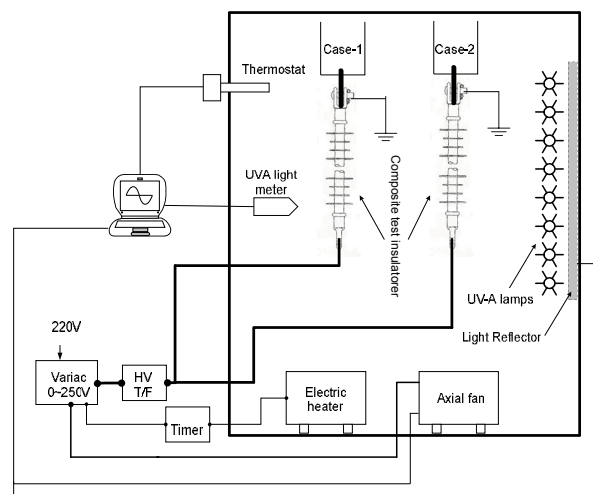
Fig. 2 Schematic diagram of accelerated aging cycle chamber

The actual UV-A radiations level and temperature variations in central region of Saudi Arabia is quite higher as compared to the values recommended in the IEC std. 61109 [9]-[10]. To simulate the ambient conditions of arid desert, a wooden chamber was fabricated for the accelerated aging process for the EPDM test composite insulators. Schematic diagram of the chamber with suspension insulators and other accessories in place is shown in Fig. 2. Based on the above discussion, two types of experimental conditions were created in the accelerated aging test chamber for the tested insulator by applying different stresses mentioned in Table 1, i.e.:

*Case 2:* Modified aging cycle based on the actual UV-A radiations level ( $40 \text{ W m}^{-2}$ ) as shown in Fig. 2.

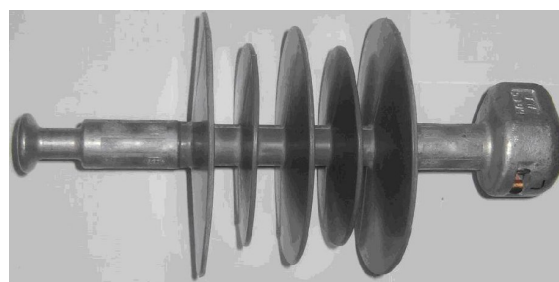
Fig. 3 Suspension EPDM insulator

Three samples of EPDM suspension insulators procured from WT-Henley (UK) were used for accelerated aging for each case-I and case-II. Fig. 3 shows the photograph of the tested insulator. The salient dimensions of the insulators are mentioned in Table 2.

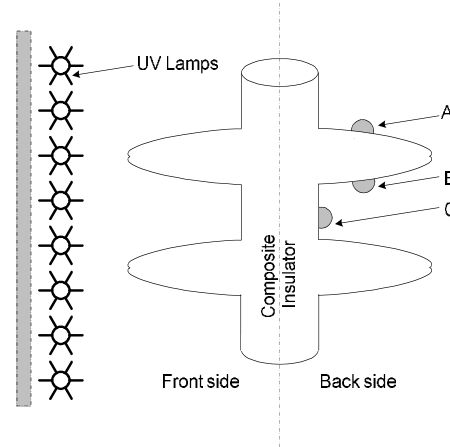
Fig. 5 Schematic diagram of composite insulator showing contact angle measurement positions

The schematic diagram of the composite insulator aged in the accelerated aging chamber (Fig. 2) is as shown in Fig. (5). One side of the insulator is always facing the UV lamps whereas, the other side is not. The contact angle for both sides i.e. front as well as back side of the insulator was recorded along the length of the insulator for the points A, B, and C (i.e. top, bottom and core), respectively as shown in Fig. 5. For measurements of the contact angle at desired positions (A, B or C), the insulator was oriented so the surface under consideration was approximately horizontal. The drop is carefully placed on the horizontal surface of the insulator with the help of a hypodermic syringe needle. The photographs of drops are taken quickly with the help of high resolution digital camera just after putting the drop of water on insulator and the data was analyzed by computer software "ImageJ". The drop volume was controlled in the range 10~25 $\mu$ L [12]. Deionized water of ~100 $\mu$ S conductivity was used. Methylene blue was added to change the color of the water to get more clear images.

The EPDM insulators were placed and aged in the aging chamber as per Case-I (UV-A:1mW/cm<sup>2</sup>) and Case-II (UV-A:4mW/cm<sup>2</sup>) mentioned in Table 1 above and the contact angles were measured by using "ImageJ" software for the New (virgin), Old aged and Newly aged insulators. The results are graphically shown in Figures(6)-(8), that compares the EPDM insulator's shed-wise contact angle characteristics for the positions A (Top), B (Bottom), C (Core) as shown in Fig. 5 above, for:

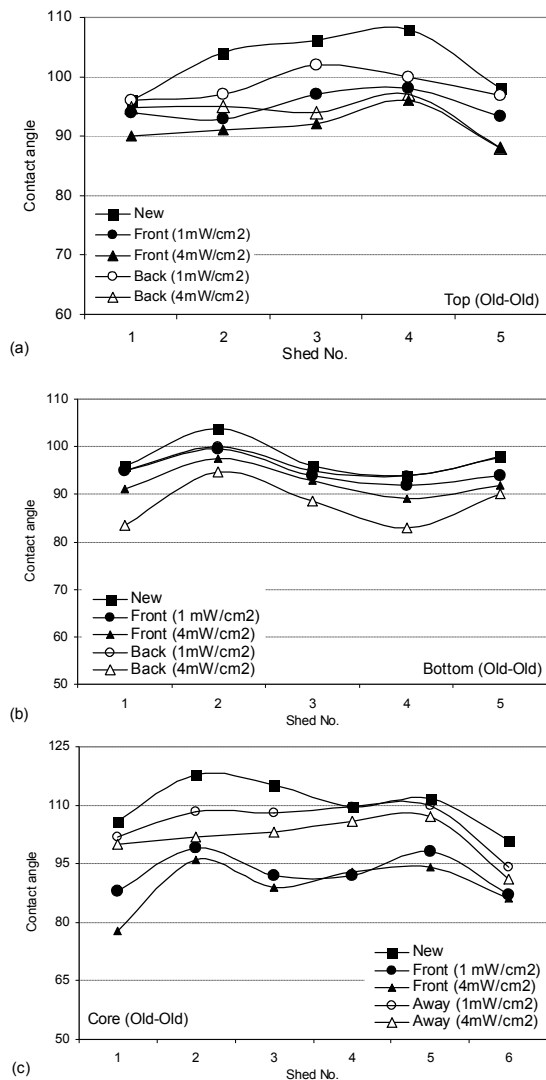
**Fig. 6** compare the shed-wise top, bottom and core contact angle measurement results of front to back side for the old-old aged under UV radiations intensity of 1mW/cm<sup>2</sup> and 4mW/cm<sup>2</sup>. Comparison of these figures clearly shows that contact angle for new (virgin) insulator is highest as compared to old aged insulators. Furthermore, it is also observed that the contact angle of aged insulator under UV radiation intensity of 1 mW/cm<sup>2</sup> is higher as compared to aged insulator under UV radiation intensity of 4mW/cm<sup>2</sup>. It is also found that the part of the insulator facing the UV radiations have lower contact angle as compared to the back side of the tested insulator. Similarly, higher UV radiation intensity deteriorated the insulator surface more [9] and causes less contact angle as compared to lower UV radiation intensity thus the insulator shows a more hydrophilic behavior under higher UV radiation intensity.

Fig. 6 Contact angle characteristics along the insulator sheds for old-old aged (a) Top (Position A, Fig. 5) (b) Bottom (Position B, Fig. 5) (c) Core (Position C, Fig. 5)

The contact angle measurements results depicted in figures (6)-(8) show considerable variations along the insulator surface. Each is considered below before general observations are made.

The contact angle measured on both the front as well as back sides of the insulator were also measured and shown in Fig. (6) & (7). The contact angle measured was smaller on the front side as compared to the back side of the aged insulator. This shows that the front side of aged insulator was more hydrophilic as compared to the back side which suggests that natural environment plays an important role in the aging process. The variation in contact angle between the front and back face is several degrees. The greatest difference between the front and back is seen on the core in the center of the insulator length, may be due to enhanced electrical activity in this region.

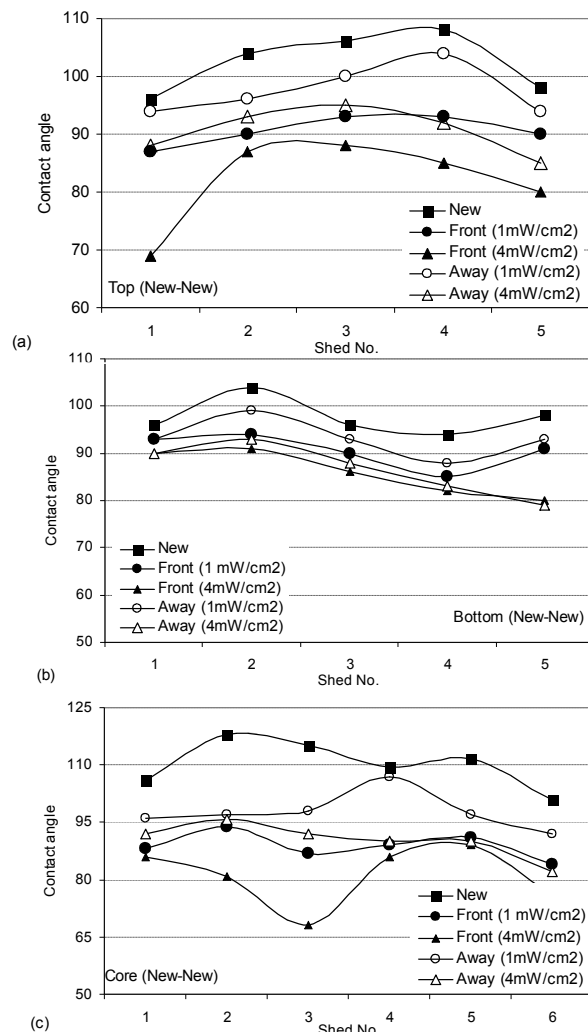
**Fig. 7** compares the shedwise contact angle measurement results of front to back side for the new-new aged under UV radiations intensity of 1mW/cm<sup>2</sup> and 4 mW/cm<sup>2</sup>. Comparison of these figures clearly shows that contact angle for new (virgin) insulator is highest as compared to newly aged insulators. Furthermore, it is also observed that the contact angle of aged insulator under UV radiation intensity of 1mW/cm<sup>2</sup> is higher as compared to aged insulator under UV radiation intensity of 4mW/cm<sup>2</sup>. It is also found that the part of the insulator facing the UV radiations have lower contact angle as compared to the back. Similarly, higher UV radiation intensity that deteriorates the insulator surface has less contact angle as compared to lower UV radiation intensity thus the insulator shows a more hydrophilic behavior under higher radiation intensity. The variation in the contact angle for the

newly aged and virgin insulator is more as compared to the variations depicted in Fig. 6, before.

Fig. 7 Contact angle characteristics along the insulator sheds for New-New aged (a) Top (Position A, Fig. 5) (b) Bottom (Position B, Fig. 5) (c) Core (Position C, Fig. 5)

The contact angle variation between the top and bottom surfaces of the insulator was also marked. The average variation in the contact angles from HV to ground electrode for top (position A) as well bottom (position B) is more consistent, however, the wide variation in contact angle was observed especially under the newly aged insulators when the insulator was aged under high UV radiation intensity (i.e. 4 mW/cm²) as shown in Fig. 7(a) & 8(a).

On the core the variation in contact angle is about 15°-20° from HV to grounded electrode end. The lowest values were observed in the center as evident from Fig. 7(c) & 8(c). This shows that, this part of the core is more heavily damaged than the sheds. One explanation to this is that this part of the insulator presents a smaller cross-section to the leakage
