Identifying Karst Pattern to Prevent Bell Spring from Being Submerged in Daryan Dam Reservoir

H. Shafaattalab Dehghani, H. R. Zarei

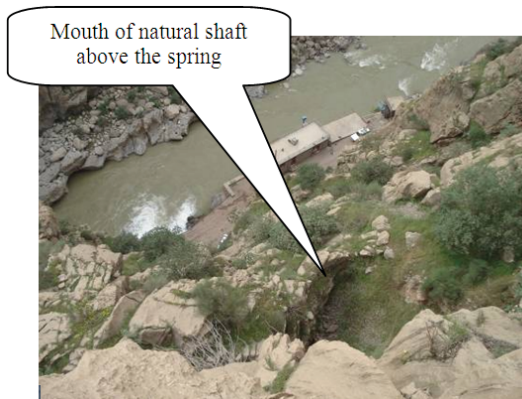
Fig. 6 Mouth of natural shaft before removing the infilling materials

An about 4 m diameter shaft with the height of about 52 m is another karstic feature around Bell Spring. The shaft was filled by angular materials (Fig. 6). After removing the materials, it was realized that the shaft is actually the remains of the old siphon conduit of the spring which has dried as a results of the formation of new outlets at lower levels (Fig. 7). The shaft is located in the intersection of CBF and F7. The shaft outlet is located at el. 770 masl.

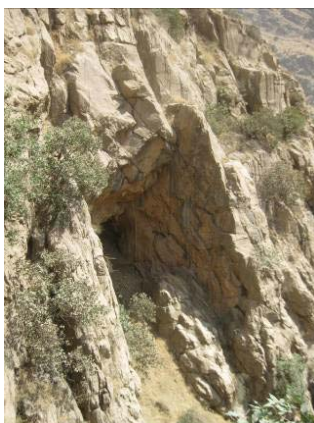
Fig. 8 Old spring conduit

The old outlet of the spring is located in about 28.5 m above the bottom of the present spring outlet at el. 746 masl (Fig. 8). After removing the materials via excavating G3 Gallery (Fig. 9), it was realized that the old conduit is a branch of the natural and vertical conduit of the spring or the natural shaft.
