# Improvement in Mechanical Behavior of Expulsion with Heat treated Thermite Welded Rail Steel

S.Rajanna, H.K.Shivanand, Akash Deep B.N

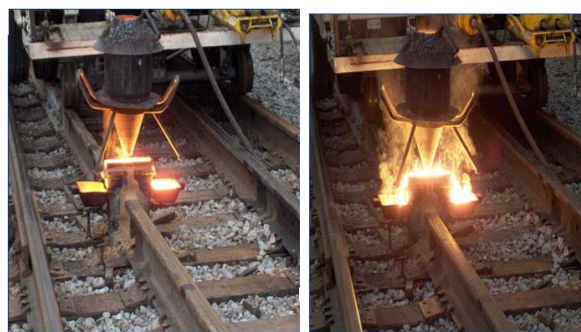
Fig.1 Thermite welding

It is a combined technique of expulsion and heat treatment. First expulsion was carried out ie this expulsion was caused by applying an axial force to the rails to move their ends together. In which thermite steel that normally comprises the filler metal of a full fusion thermite rail weld was expelled from between the rail ends while in a liquid or partially solidified state. The excess Thermite steel over the head of the rail (head riser) removed after solidification (but when the metal is still red hot) by either manual chiseling or using hydraulic weld trimmers and the railhead ground using grinding machines. The thermite welded rail was subjected to ultrasonic test to ensure the quality of weld. The heat treatment involved annealing was carried out at 820°C for 45 min and air cooling to room temperature (normalized condition). In order to know the mechanical properties like tensile, Charpy impact and Hardness, specimens were prepared as per AWS. Standard and subjected to tensile test, Impact test and hardness test.

completed, the Thermite reaction initiated by igniting a sparkler and putting it into the crucible, the reaction is allowed and the slag is allowed to be separated from the molten metal. Thereafter, the closing pin is tapped from the outside, thus discharging the metal into the top central cavity of the mould. Thereafter, the crucible and torch stands were removed. Here two techniques were used to improve the quality of weldment. Initially heat treatment technique was adopted

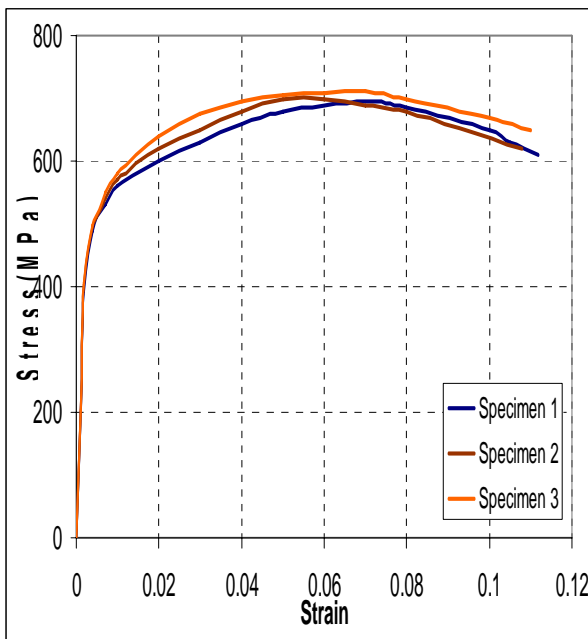
Fig. 2 Stress v/s Strain Curve of Heat treated Thermite welded rail

mechanical properties of yield strength, Ultimate tensile strength and ductility mentioned in Table 1 and 2 for above mentioned two different techniques condition of thermite welded rail. The stress is calculated based on the original cross sectional area before testing. The summary of these mechanical properties for two different techniques conditions of thermite welded rails are also given in Fig 2 to 3.. Expulsion and heat treated rail exhibits increase in ultimate tensile strength, yield strength and elongation as compared to heat treated thermite welded rail. The result of present work shows the significant improvement in mechanical properties. In heat treatment causes the replacement of very coarse ferritic-pearlitic structure[6] by much finer structure very thin cementite lamellae appears in the pearlite were as the fine ferrite network on the grain boundaries indicates the size of the prior austenite grains from which the fine ferritic pearlitic structure has evolved. And also changes from brittle to ductile nature. In expulsion process comprises the filler metal in weldment. Thermite welded rail was expelled from between the rail ends helps in fill the cavity formation during welding due to aluminium oxide in partially solid state. This expulsion would alter the solidification microstructure and decrease the number and size of the metallurgical discontinuity in the fusion zone by decreasing the volume of metal thus improving the mechanical properties.

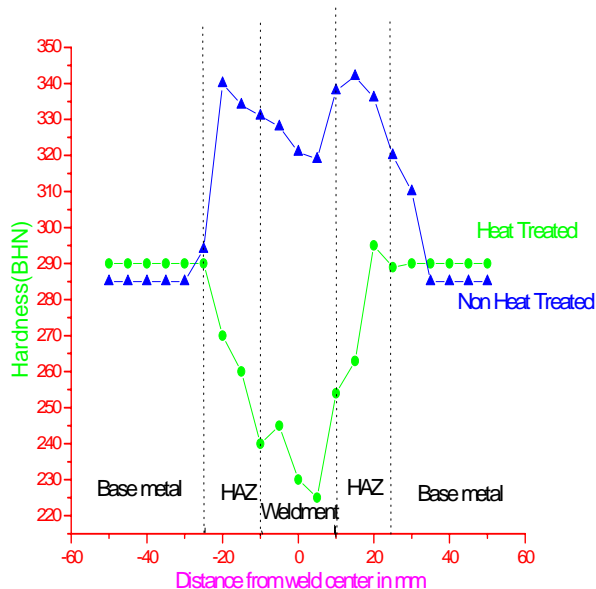
Fig. 4. Brinell Hardness number of thermite welded rail steel

Wear resistance is strongly dependent on the microstructure of metals. In case of rail steels, wear resistance is advanced through the pearlite microstructure. From the above hardness profile of the thermite welded rail steel after heat treatment shows that their significant difference in hardness of thermite welded rail steel and exhibits same hardness profile of Expulsion and heat treated thermite welded rail.. Nonsymmetrical hardness traversing along the longitudinal direction has been observed in this work as shown in the fig 4. After heat treatment, minimum hardness in the weld metal and on the boundary between the heat affected zone and the base metal was observed this could indicate that faster wear will occur on the weld metal softening of heat affected zones of welded rails may deteriorate their fatigue and wear behaviour. This can lead to depressions on the running surface of the rail, disturbing the train passenger comfort.. Minimum hardness existence at heat affected zone nearer to the base metal finer ferritic pearlitic structure existence in post weld treated thermite welded rail. In Expulsion with heat treated techniques normally comprises the filler metal of a full fusion thermite rail weld was expelled from between the rail ends while in a liquid or partially solidified state. This expulsion

was caused by applying an axial force to the rails to move their ends together. It was believed that the expulsion would alter the solidification microstructure and decrease the number and size of metallurgical discontinuities in the fusion zone by decreasing the volume of filler metal, thus improving the joint's strength without changing the hardness.

- Hardness profile of both expulsion with heat treated heat treated thermite welded rails exhibits almost same profile.
- Failure of thermite welded rail at weldment in both due to lower hardness at weldment after heat treatment expulsion with heat treated heat treated.
- Microstructures exhibits more porosity and inclusion in heat treated as compared to expulsion with heat treatment.
- Heat treatment changes the property of weldment from Brittle to ductile in both. I.e Changes in Microstructure from coarse grain to fine grain structure.manganese sulphide precipitate on grain boundary of ferrite and cementite in heat treated thermite welded rail.
