Influence of Thermal Damage on the Mechanical Strength of Trimmed CFRP

Guillaume Mullier, Jean François Chatelain

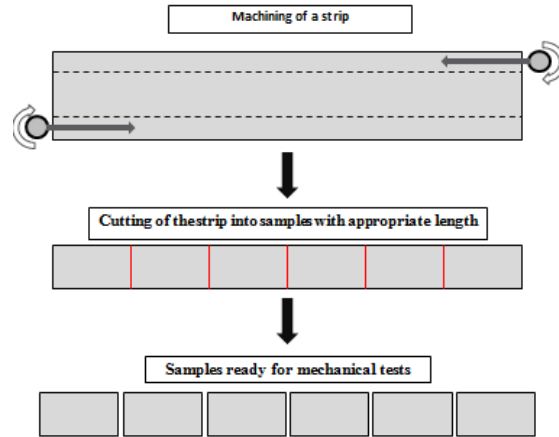
Fig. 2 Trimming of samples

The machined samples were rectangular strips of constant width, cut into smaller test samples of desired length using an abrasive diamond saw (Fig. 2). The final samples will exhibit symmetrical damage (thermal and mechanical) on both bending edges (Fig. 3). Damage which may have been introduced by abrasive cutting have no particular impact as it is out from the supports.

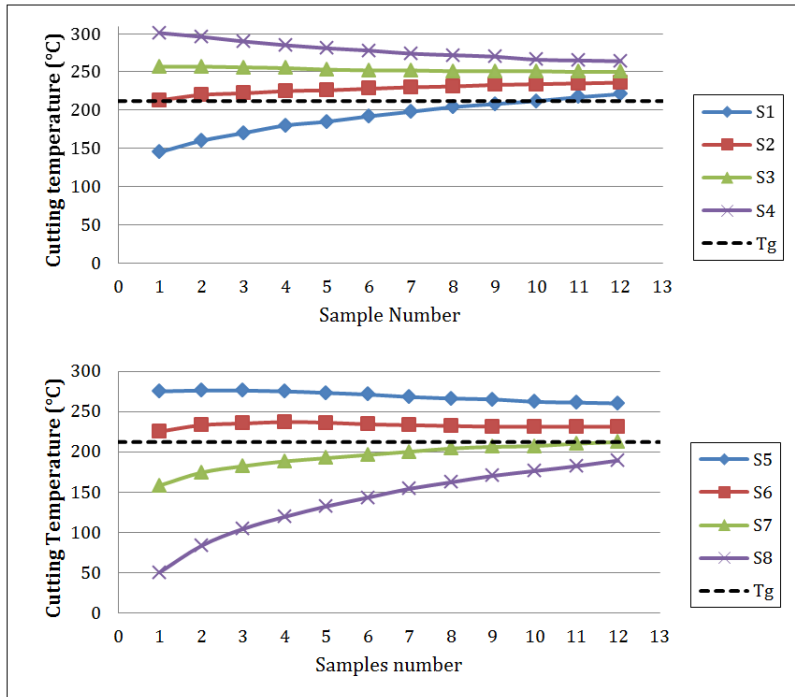
Fig. 5 Cutting temperatures of short beam samples (new tools)

produced (Table II). Strips S2 to S6 were machined with temperatures exceeding the glass transition temperature of the epoxy. The cutting temperature is converging towards the natural cutting temperature of the tool (which is function of the cutting parameters) for both series: it was found to be around 250°C (Fig. 5).

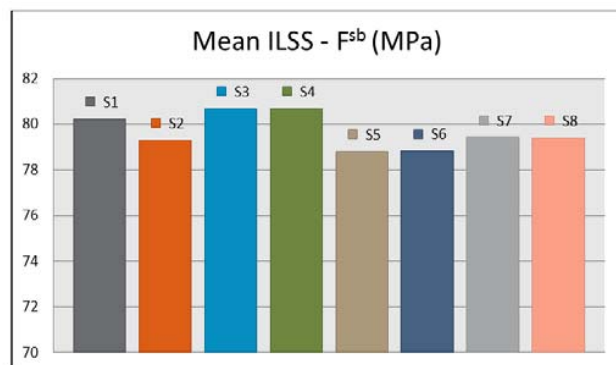
Fig. 6 Averaged ILSS values for each strip (new tools)

As shown in Fig. 6, results regarding interlaminar shear stress resistance for new tools could not show any trend regarding cutting temperature and length of cut. Looking at a single strip, there is no particular trend from sample number 1 to 12. Also, the mean ILSS value of each strip is comprised between 79 and 81MPa, which is due to ordinary variation. This phenomenon indicates that the cutting temperature has no influence on the ILSS resistance of the material when using a new tool.

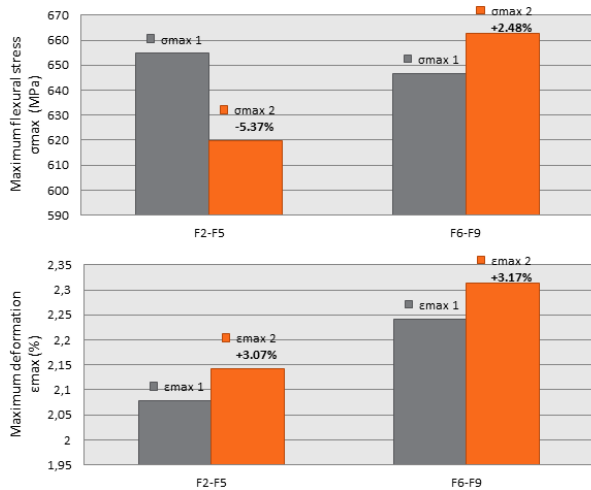
Fig. 7 Mean values from three point bending tests (new tools)

Results coming from the three point bending test show little variation: the trend regarding mean maximum flexural stress reverses, while the trend regarding maximum deformation is

too low to be attributed to the effect of rising cutting temperature (Fig. 7).

In Fig. 7, the mean values are calculated as:

The stress $\sigma_{max 1}$ and deformation $\varepsilon_{max 1}$ relates to first sample machined (lower cutting temperature) while $\sigma_{max 2}$ and $\varepsilon_{max 2}$ relates to second machined sample (higher cutting temperature) on a given strip.

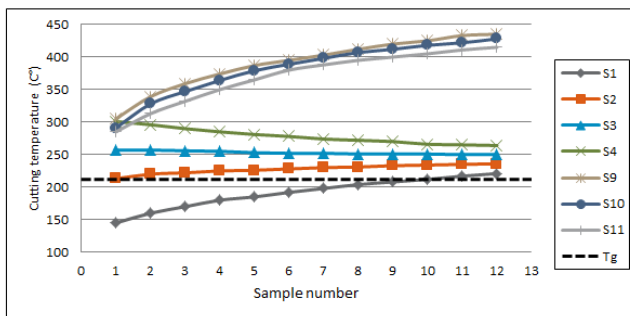
Fig. 8 Cutting temperature of short beam samples (new and worn tools)

The second approach proposes to proceed with the same methodology as previous, but using worn tools and an approximately constant preheating temperature. A total of 36 samples were machined using 3 worn tools exhibiting different levels of flank wear (Vb), coating integrity and cutting edge radii (Table IV). The cutting temperature now peaks up to 425°C at the end of the cutting process (Fig. 8). Globally, the temperature at which samples are machined is a lot higher than the glass transition temperature of the resin, thus thermal damage is likely to occur.

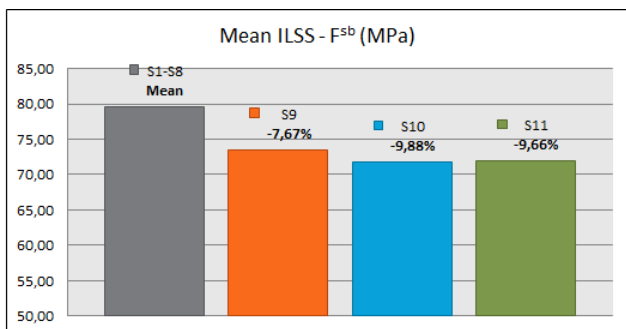
Fig. 9 Comparison between mean ILSS values of samples machined using new and worn tools

As shown in Fig. 9, ILSS did not show any conclusive variation with the cutting temperature on a given strip. However, the mean value of each strip (S9 to S11) compared to the averaged ILSS value over S1 to S8 strips shows that substantial amount of both thermal and mechanical damage occurs during machining. The loss of resistance ranges from -7.67 to -9.88%.

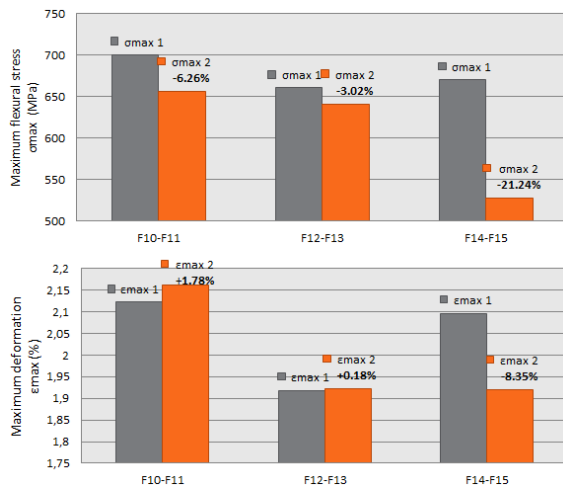
Fig. 10 Calculated mean values from three point bending tests

In Fig. 10, the mean values calculated are nearly equal to the mean results from samples machined using new tools. However, trends regarding the cutting temperature can be seen for all the tools when considering the maximum flexural stress. The second machined sample always exhibits a lower maximum flexural stress than the first one ($\sigma_{max 2}$ VS $\sigma_{max 1}$ = -3% to -21%). This phenomenon indicates that the rising temperature during the cutting induces increasing thermal damage: this explains why the second

portion of a given strip exhibits lower resistance than the first one.

In Fig. 10, the mean values are calculated as:

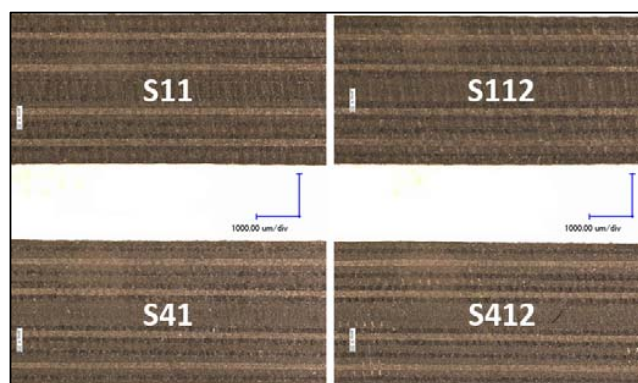
Inspection of the surface finish is an interesting way to anticipate or understand a reduction of the mechanical strength of the material. In this case, great surface integrity can be observed for the specimens trimmed with a new tool, regardless of the cutting temperature (Fig. 11). The -45° plies show some fibres pull-out, which is a typical defect when dealing with CFRP machining. As tool wear increases, degradation of the matrix occurs and the different plies become harder to differentiate from each other (Fig. 12). This strongly indicates that the resin went through deterioration, resulting in a softened and more homogeneous surface. Also, the surface appears to be darker, which suggests charring of

Fig. 11 Constant damage induced on the machined surface of short beam samples regardless of the cutting temperature (new tools)

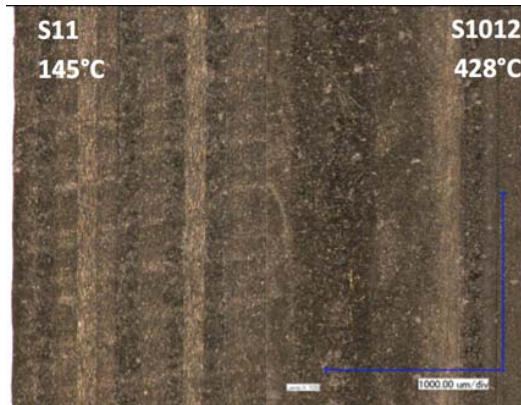
the matrix. In addition, little delamination on the surface plies and some fiber reorientation can be noticed. Also, looking at the surface of the laminate machined using worn tools, increasing degradation in the near zone of the cutting can be seen with the increase of the cutting speed: resin moves back towards the middle of the sample, leaving fibers out of the resin, resulting in some kind of delamination from thermal origin (Fig. 13). Damage on the surface plies for samples machined using new tools was constant and of brittle nature: simultaneous snatching of both fibers and resin and absence of delamination

Fig. 12 Comparison between the machined surface using a new tool at low cutting temperature and a worn tool at high cutting temperature

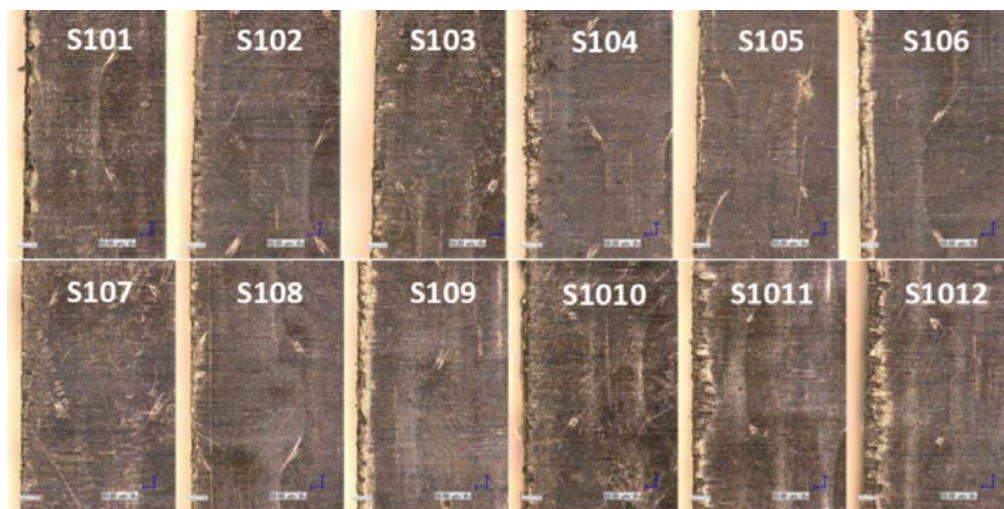
Fig. 13 Increasing damage on the surface ply of short beam samples (strip S10)
