Investigating the Effectiveness of a 3D Printed Composite Mold

Keywords—Additive manufacturing, carbon fiber, composite tooling, molds.

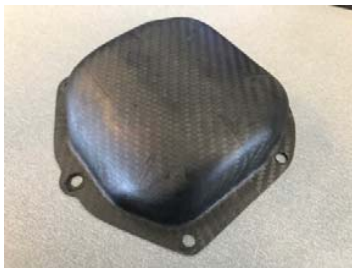
After curing in the autoclave, the carbon fiber valve covers were post processed. Each carbon fiber valve cover was sanded and finished to the dimensions of the original steel valve cover and the mounting holes of the valve covers were also drilled to match the original steel valve cover. Fig. 7 shows a completed carbon fiber valve cover after post processing.

Fig. 7 Completed carbon fiber valve cover

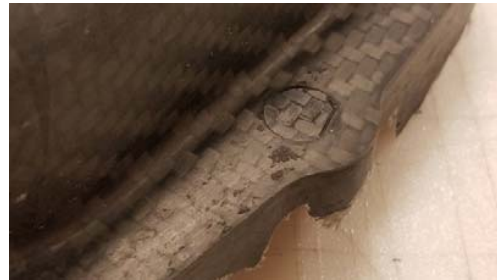
Fig. 8 Surface defects caused by mold surface chipping

A total of six carbon fiber valve covers were fabricated using the 3D printed composite mold. Dimensionally, the six carbon fiber valve covers were very consistent and all the carbon fiber valve covers mounted onto the aircraft reciprocating engine with no issues. The inconsistencies on the carbon fiber valve covers were mainly defects caused by the damages the 3D printed composite mold sustained after every part demolding process; although most of the defects on the carbon fiber valve covers as shown in Figs. 8 and 9 were cosmetic defects that can be easily remedied with some light post processing such as sanding and applying layers of clear coat. The condition of the 3D printed composite mold will continue to deteriorate as the fabricated part count increases. As a result of the deteriorating 3D printed composite mold, the quality of the carbon fiber valve covers will also continue to worsen.

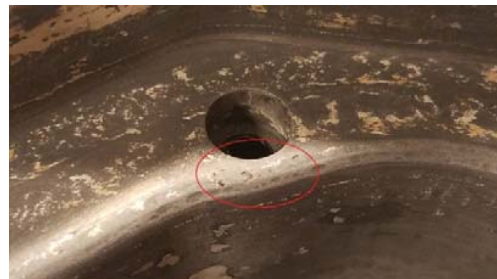
main defects the 3D printed composite mold had were chipping of the mold surface and some cracking on the mold surface between the bead interfaces as shown in Figs. 10 and 11 respectively.

Fig. 10 Mold surface chipping

In terms of the mold's performance, the 3D printed composite mold performed as expected and was used to successfully fabricate all six of the carbon fiber valve covers. All carbon fiber valve covers were cured and demolded from the 3D printed composite mold with no issues. However, durability wise, the 3D printed composite mold sustained increasing amounts of defect after every part demolding. The

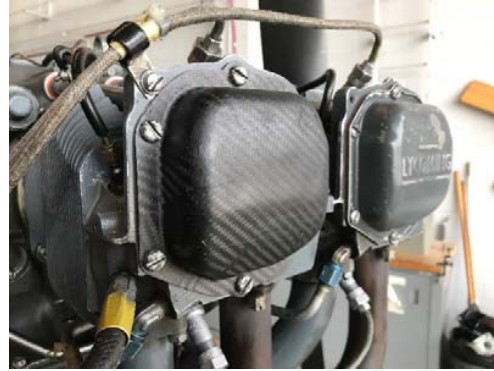
Fig. 14 Test fitting of carbon fiber valve cover

Based on the results from this study, the team was able to investigate the effectiveness of a 3D printed composite mold by producing six identical carbon fiber valve covers from a single 3D printed composite mold. The six carbon fiber valve covers were all test fitted onto the original aircraft reciprocating engine and all six carbon fiber valve covers fitted perfectly with no issues as shown in Fig. 14. The six carbon fiber valve covers however did have various surface defects that were caused by the mold surface gradually deteriorating from each part production, raising durability concerns for the 3D printed composite mold. There can be an abundance of factors that may have caused the deterioration of the mold surface. Some examples of these factors include porosity within the 3D printed composite mold, the 3D printing tool path of the 3D printed composite mold, and weak interfaces between printed beads of the 3D printed composite mold [1]. Many of these factors can essentially be removed by changes to the design and fabrication technique of the 3D printed composite mold. For example, the issue of porosity within the 3D printed composite mold can be rectified by heat treatments to the mold or by the application of surface coatings. Advance approaches forming molds with varying material composition also known as gradient materials may also be a suitable solution [6]. Other factors such as the printing tool path and weak interfaces between the printed beads may be solved by performing further tool-path optimization for the printing process of the 3D printed composite mold [7].
