# Investigation of Fire Damaged Concrete Using Nonlinear Resonance Vibration Method

Kang-Gyu Park, Sun-Jong Park, Hong Jae Yim, Hyo-Gyung Kwak

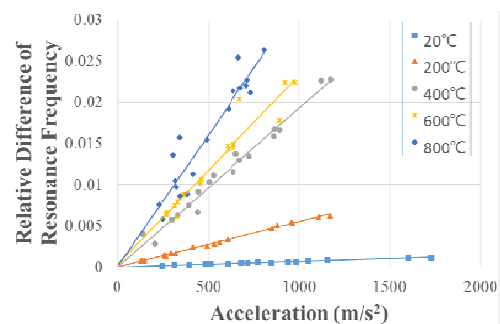
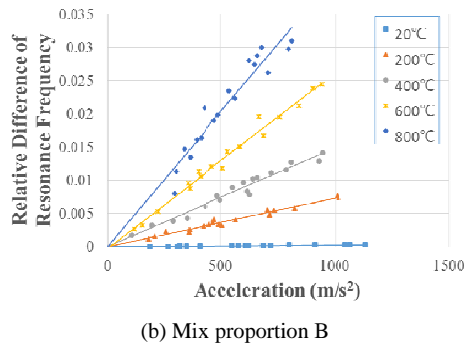
Fig. 3 The relative resonance frequency shifts versus excitation magnitude

The HNP was calculated from (1), as the slope between measured acceleration and relative shift of resonance frequency. Fig. 3 shows the linear regression analysis to determine HNP from the results. Each slope of the lines denotes the calculated HNP, and it became steeper as rising the target temperature.

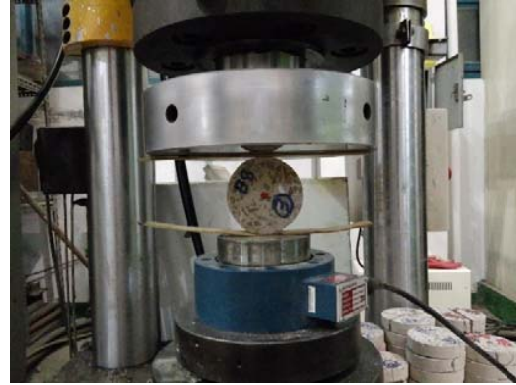
Fig. 5 Experimental apparatus

In order to validate the degradation of material properties in fire-damaged concrete, splitting tensile strength test was performed on each concrete disk. The overall test procedure was followed by ASTM C 496[11]. The experimental setup was consisted with universal testing machine, data logger for load cell. Fig. 5 shows a picture of experimental apparatus.

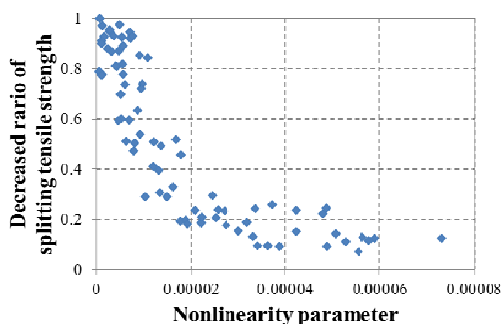
Fig. 7 Relation between ratio of splitting tensile strength and hysteretic nonlinearity parameter

According to preceding experimental results [15], hysteretic nonlinearity parameter can be sensitively interacting with micro damage in concrete induced by fire. Accumulated micro damage inside concrete reduces the material properties, which can be possible to correlate HNP with measured splitting tensile strength. The correlation between the two values is shown in Fig. 7 depending on mix proportions without consideration of curing periods and peak temperatures. From test results, splitting tensile strength ratio linearly decreased with an increased value of HNP. Also, after the value of HNP of 0.00002, the slope between the two parameters was almost not changed.
