Restoring, Revitalizing and Recovering Brazilian Rivers: Application of the Concept to Small Basins in the City of São Paulo, Brazil

Juliana C. Alencar, Monica Ferreira do Amaral Porto

Keywords—Sustainable drainage, river restoration, river revitalization, river recovery.

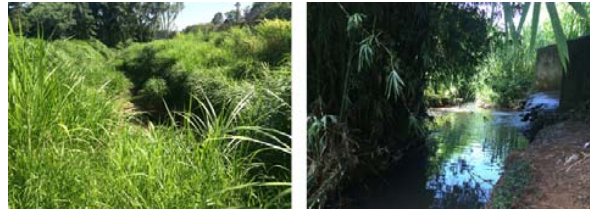
Fig. 3 Itaim stream in Tizo Park. Source: Photos of the author

In addition to the threats due to the release of pollutant loads, the channels within the park are not in totally natural conditions, and not integrated with the park goers. The section near the entrance to the park has its banks taken by tall exotic vegetation, which prevents access and even the view of the channel, as shown in Photo A of Fig. 3. Photo B of the same figure shows a second stretch of the canal where access is possible, but that presents the banks that are eroded and

without vegetation.

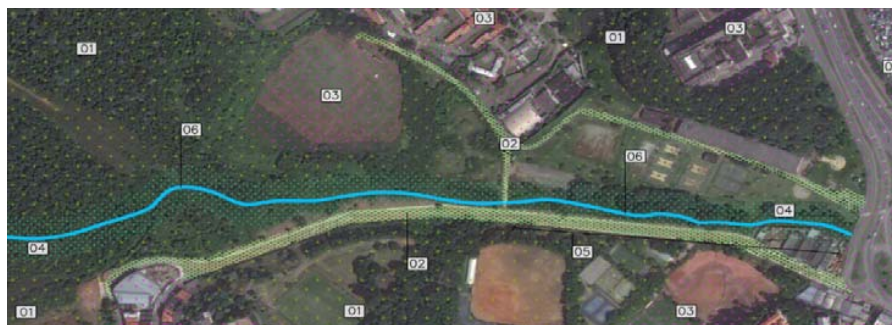
Legend: (01) Area that demands environmental enrichment; (02) Road that requires green infrastructure; (03) Buildings and facilities; (04) Requalification of the floodplain area; (05) Zone next to the visitation area: demands water observation equipment; (06) Requalification of the channel.

Fig. 5 Proposal for restoration of Itaim stream in Tizo Park. Source: Prepared by the author

Itaim stream has enormous potential for restoration since it is inserted in a context of vegetal remnant under protection; in this way, a series of measures were proposed for restoration, in order to attend the set of detailed techniques, as presented in the section of Figs. 4 and 5.

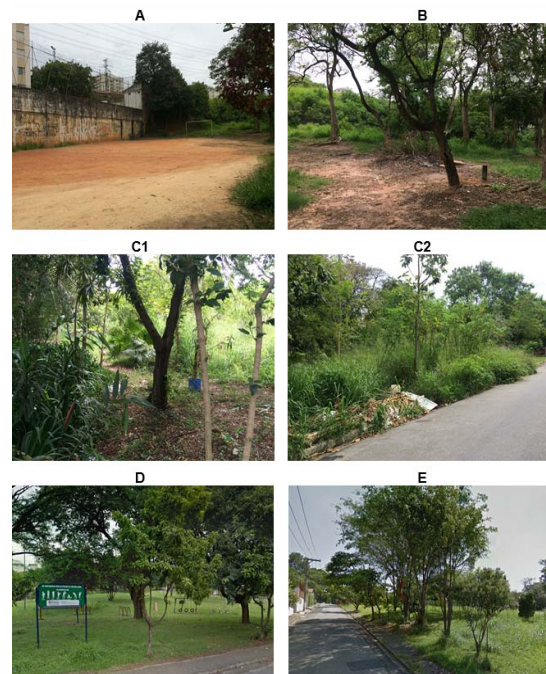
Fig. 7 Evandro Valério Square in the Jaguaré watershed. Source: Photos of the author

Fig. 7 shows emblematic points of the squares. Point A shows a football field installed by the population; photo B, photo C1 and photo E illustrate the density of vegetation at different points; photo C2 shows the lack of maintenance in one of the stretches, where vegetation invades the sidewalk, which ends up encouraging the inadequate deposit of waste by the population; and photo D shows an excerpt that has public equipment for sports practices.

The square also houses a spring that has a contribution from the underground aquifer, since it remains in the landscape with significant flow even in the dry season (Volumetric flow on 08/10/2015 = 0.33L/s), which is used intensively by the population for water abstraction for non-potable uses. In a 30-minute observation period from the source on a Saturday,

eight users were registered visiting the source for water collection (gallons) and car wash. The spring (photo G) was treated by the municipality service through the construction of a gravel trench, according to a resident, who directed the water to a catchment point where the population captures the waters (photo H2).

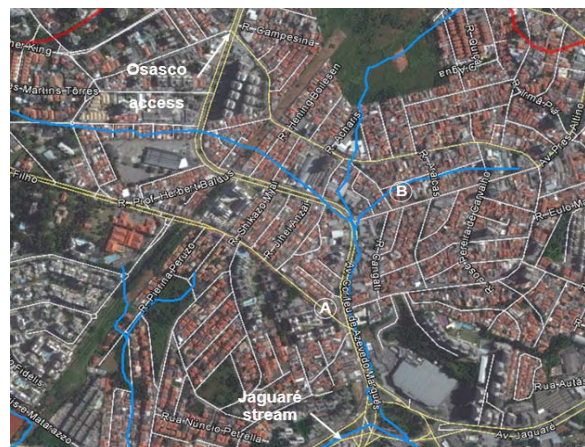
Fig. 10 Location of the canalized stream under Corifeu de Azevedo Marques Av. Source: Prepared by the author from Google Earth Pro

The stream under Av. Corifeu de Azevedo Marques is tributary of the Jaguaré stream, also runs under this avenue and surrounding streets; therefore, it has low potential for revitalization that would include the opening of the underground galleries since the avenue has heavy traffic. The channel opening in Corifeu de Azevedo Marques Avenue would require the complete deconstruction of the avenue, which is an important axis of circulation that connects Butantan village, Osasco city and Mario Covas highway. Today, the avenue has two lanes of road, one lane of buses and a track for cycling in each of the directions. In addition, the tributaries of the watercourse are under the narrow streets, so its opening would make it impossible for vehicles and traffic to travel these routes. The location of the watercourses and the situation of the roads are shown in Fig. 10 and Fig. 11, respectively.
