Risk of Occupational Exposure to Cytotoxic Drugs: The Role of Handling Procedures of Hospital Workers

J. Silva, P. Arezes, R. Schierl, N. Costa

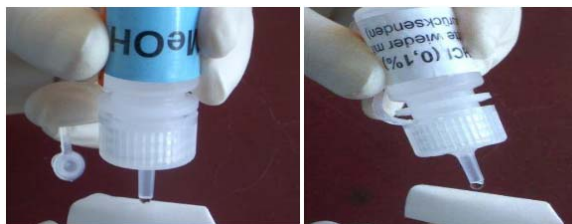
Fig. 2 Application of the fixatives (HCl and MeOH) to the paper filter (based on [12])

Fig. 3 Exemplification of how to hold the filter in order to clean the surface (based on [12])

- 1) The filters are pre-moistened, but not in excess, in order to prevent the sample from being wet. Add six drops of methanol (MeOH) to fix the 5-fluorouracil (5-FU) and six drops of concentrated hydrogen chloride (HCl) to 0.1% to fix the platinum (Pt). The fixatives should be slowly applied on the filters' surface (Fig. 2).

- 4) Some pressure should be exerted (Fig. 3) at the beginning, from a further point to another closer to the operator. Wipe the surface from left to right.

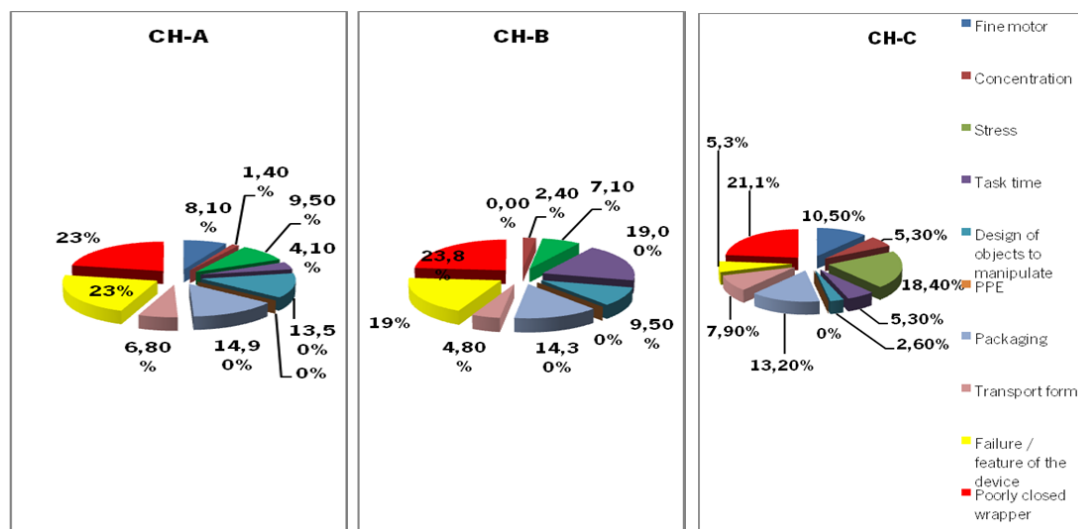
Fig. 4 Causes of spillage

The survey and its results were mainly focused on reported spillage, especially regarding the places where contamination occurs more frequently, as well as time within the working day and possible causes. Thus, the places where most spillages occurred were on the patient's chair during treatment (25 or 16.2%) and the on the laminar flow hood (19 or 12.3%) for professionals. These spillages occurred mainly in the morning, at the second and fourth hours of the working day, according to 17 (11%) professionals. Regarding the causes for spillages, 35 professionals (22.7%) referred to the inadequately closed wrapper. However, the failure/features of the devices were indicated by 27 (17.5%) professionals as well (Fig. 4).
