# Seismic Behaviour of Romanian Orthodox Churches, Modeling of Failure Modes by Rigid Blocks

Marius Mosoarca, Victor Gioncu, Ovidiu Cosma

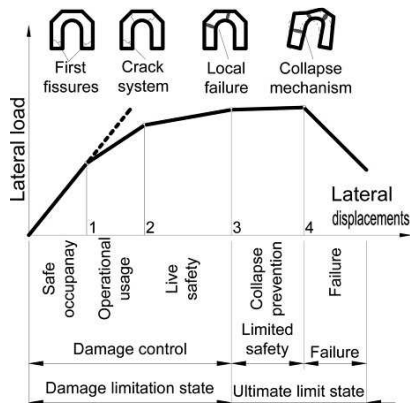
Fig. 1 Behaviour of a masonry triumphal arch

It is well known that masonry structure analysis requires nonlinear modeling accounting for the low tensile capacity and the consequent cracking phenomena. It is well known though that such models cannot be used in the case of very complex structural systems characterized by large number of degree of freedom. In the same time, it is very clearly that the methodologies required for the two limit states differ very much. While for damage limitation state one can use the elastic analysis (with or without considering some fissuration effects), for the ultimate limit state, the methodology must be very different. Therefore, analyzing the behavior of historical buildings, it is needed to be adopted a two step procedure as shown in Fig. 1.

i. Global behavior analyses for damage limit state, in the linear elastic range, through a complete and refined FE Method- 3D model. This analysis can give indications on the global behavior in the undamaged range and can only detect the weak part of the structure and the position of to come cracks. In the same time, it can be used to have indication about the efficiency of some strengthening methods.

ii. Global behavior analyses in the ultimate limit state, using the Collapse Mechanisms Method, considering the structure composed by some rigid body macro-elements with discontinuities concentrates only along the borders of these elements, resulted due to seismic action. This methodology is based on the observation in situ or on the models concerning the cracks system of a damaged building, leading to a collapse mechanism. This analysis is very useful to establishing the most efficiently strengthening method.

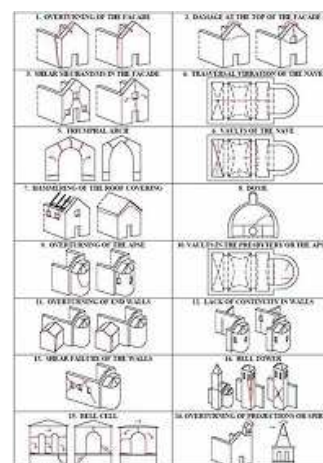
Fig. 2 Romanesque churches. Masonry rigid block [5]

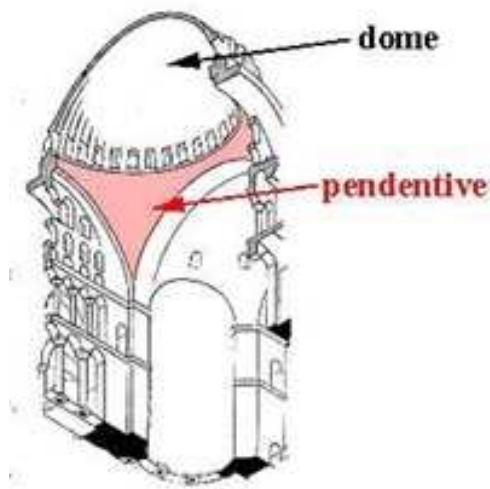
Fig. 3 Pendentive in Byzantine churches

The buildings of Romanian Orthodox churches are based on the Byzantine style, being characterized by the using pendentives and dome on pendentives as in Fig. 3. It must be pointed that the main structural characteristic of Byzantine architecture is the use of pendentive domes, dome on pendentives, and tower on pendentives. This is unique way of adjusting the circular form of a dome or tower to a square plan. The pendentive dome is derived by trimmer the sides of a circular dome over a square plan as in Fig. 4. The pendentives dome enables to transfer the total load of the roof to the four corners of the building.

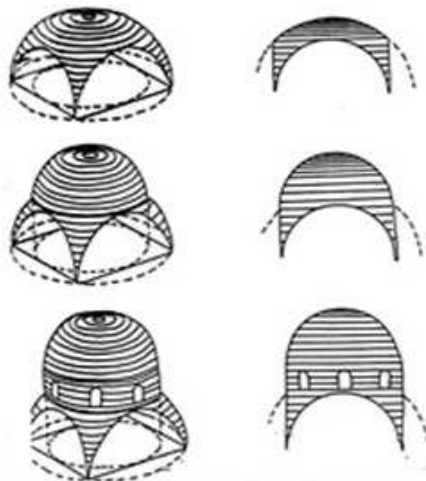
Fig. 4 Pendentives and dome and tower on pendentives

Additionally, the top dome enables to transfer the total load of the roof to the four corners of the building. The top of the pendentive can be trim to introduce another dome on top. The additional dome can further be raised to introduce a cylindrical tower between the pendentive dome and the additional dome.

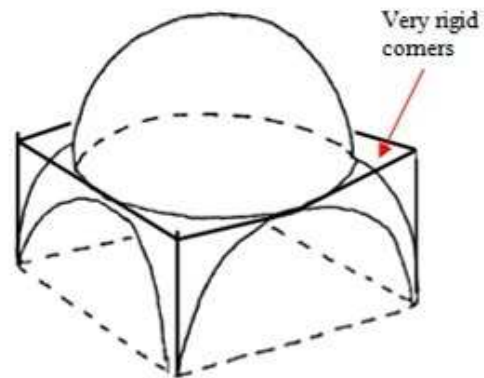
Fig. 5 Rigid corner pendentives, including the surrounding walls

Windows can then be introduced in the cylindrical tower enabling architects to create interior light effects. The surrounding infilled and exterior masonry walls also contribute to carry out the loads, forming very rigid corner pendentives as in Fig. 5.

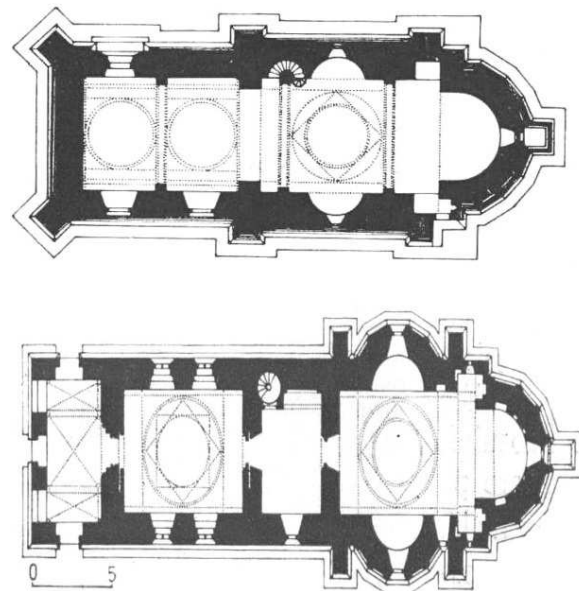
Fig. 6 Typical rectangular and tree-lobed plans [8]

The typical plans of Orthodox churches are presented in Fig. 6: rectangular nave with one lob and three-lobed nave. Unlike the Catholic churches, the Romanian Orthodox churches are relative small in size. The main typical Romanian orthodox churches are the three-lobed plan. This form plays a crucial role in the improving the church behaviour during the earthquakes, because it reduces the distance between stiffness centre and centre of gravity on the longitudinal axis of symmetry [8]. In some cases, some churches were provided with buttresses in order to reduce the distance between these two centers.

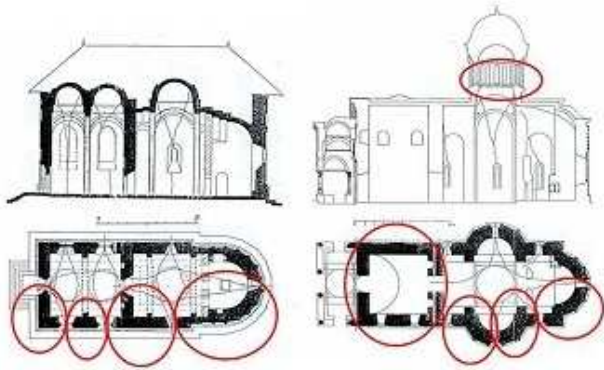
Fig. 7 Damage of Borzesti and Cozia churches due to 1977 Vrancea Earthquake [2]

earthquakes, Fig. 7 presents the Borzesti (rectangular plan) and Cozia (three-lobed plan) churches [2].

Analyzing the occurred system of fissures and cracks it is very clear that the spatial collapse mechanism is formed by a longitudinal fracture and multiple transversal fractures which round the pendentives, due to the great rigidity of these ones.

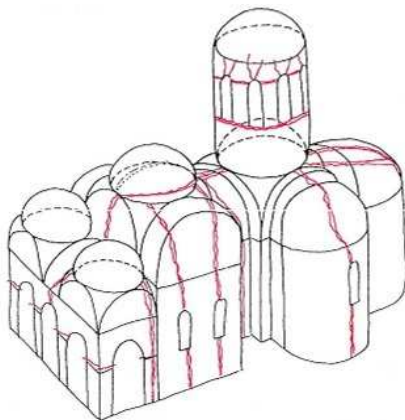
Fig. 8 Blocks system in ultimate limit state [2]

In addition, cracks occurred at the base of tower. The cracks start always from the windows, due to reduced rigidity in these zones. Considering the system of fractures, it is very clear that, in the ultimate limit state, the churches form a block system, working independently each other's as in Fig. 8.

The blocks are formed by the wall delimited by two indows and the corresponding corner pendentives. Due to the seismic actions, the blocks rotate around a basis axis. This rotation is equilibrated by the gravity loads, mainly due to the masonry weight.

The ration between overturning and stabilizing forces gives the possibility to determine the ultimate limit loads, this one being the minimum of all the values [12], determined for each block [5].

- i. The biggest cracks are developed in the eastern wall next to the altar, in full compliance with the structural issues outlined above in Fig.8.
- ii. Next, most important, are the cracks from the southern wall, the northern being much less cracked;
- iii. Asymmetrical turning tendency can be seen on the walls of the western tower, south wall is much more cracked than the northern, while at the western and eastern walls, cracks were insignificant;

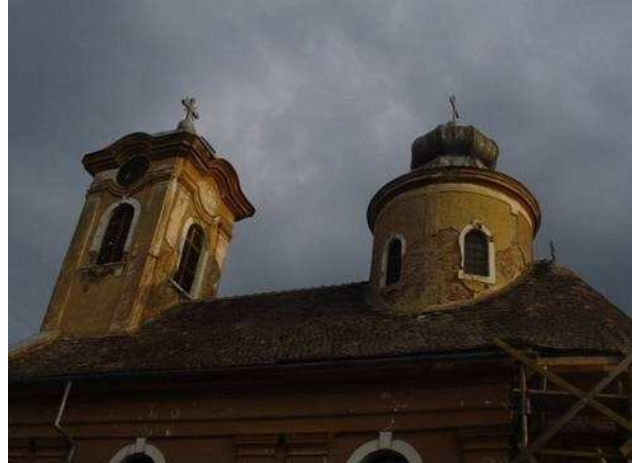
Fig. 9 The two towers of the church

Hall-type church building is covered with brick arches and wood framing. The church has two towers: the West Tower and East Tower in Fig. 9 and Fig. 10.

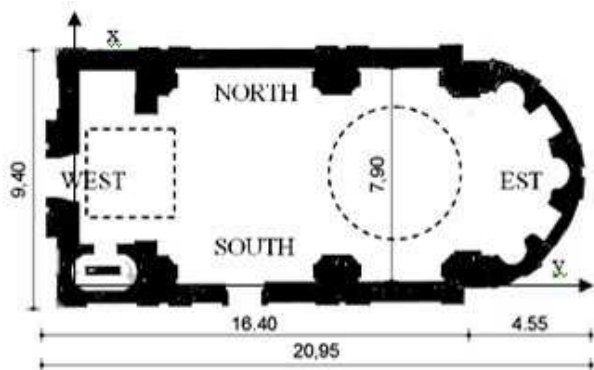
Fig. 10 Horizontal section

- i. The church was divided into rigid blocks based on observations recorded after earthquakes cracks in the Banat area since 1991. Transfer blocks are shown in Fig. 17, based on 3D drawing. Global system of axes is shown in Fig. 10.

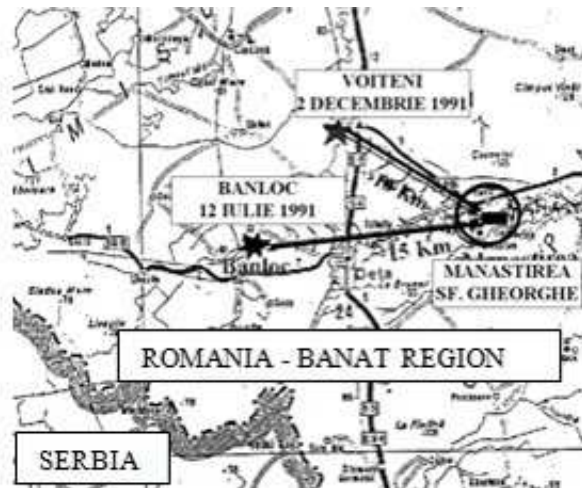
Fig. 11 The distances to the earthquake poles

Unveiling of foundations in the altar area and in North facade revealed that there are no cracks in the foundation. Because the distances to the two poles are 15 km and 10 km as in Fig.11, this earthquake fits the category of "epicentral earthquake" which is characterized by:

In these circumstances, taking into account the position of the church to the two poles, the church's main action direction is longitudinal. Given the longitudinal asymmetry of the church, the west is much stiffer than the east. The center of rigidity of the structure is moved to the west. At the same time, taking into account the different stiffness of the stair area on the opposite side, the center of rigidity is moved in north. Rotation of the church from the center of rigidity is shown in Fig. 12. It can be noticed that the round wall next to altar is the most stressed, being the farthest from the center of rigidity.

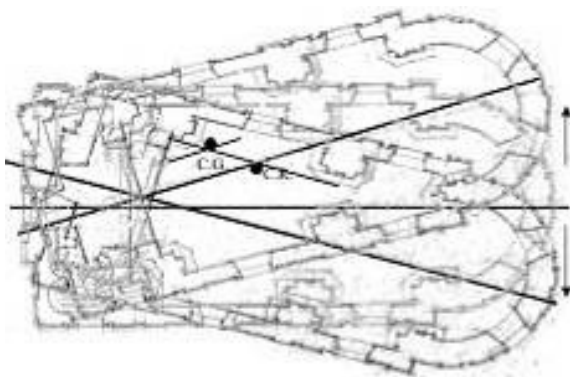
Fig. 12 Rotation of the church

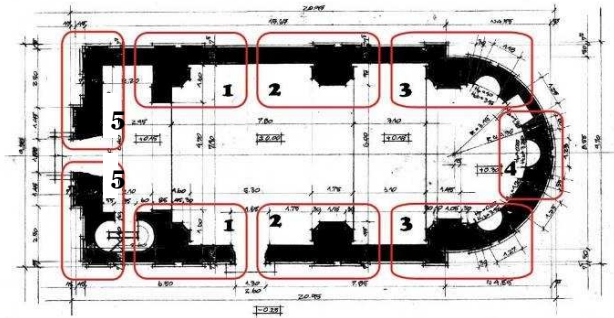
Fig. 13 Mechanism blocks

Under these conditions, considering the presence of openings, masonry has a tendency to separate into blocks by splitting of arches above the openings thus forming nine blocks. The most stressed is block 4 of the eastern wall where are the largest lateral deformations in Fig. 13.

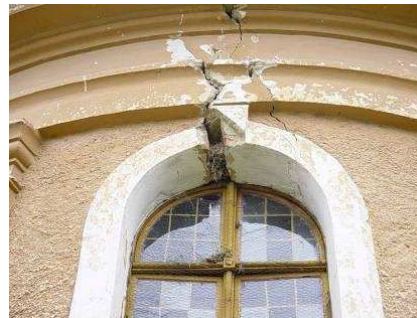
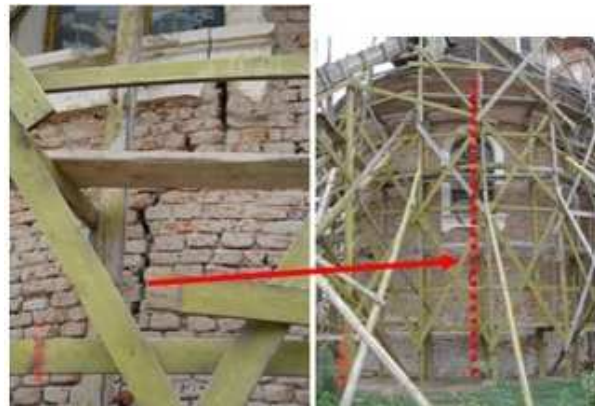
Fig. 14 Cracks at the eastern wall

Brick walls are 75 cm thick, reinforced with brick pillars in front of the roof arches. Masonry structure has a longitudinal symmetry, except the West side where the presence of the stair has introduced an asymmetry characterized by walls with a thickness of 40-45 cm. The window openings on the altar apse and reduced thickness of the wall under the windows have caused cracks in Fig. 14.

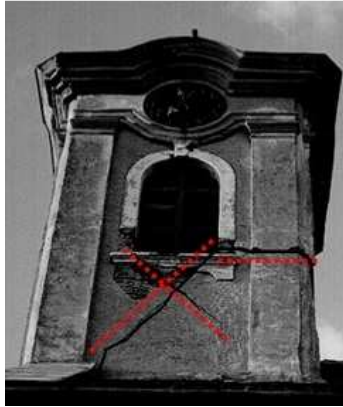
Fig. 15 Cracks at bell tower

The cover in the central area is made of two domes on brick pendants resting on arches. One of the vaults supports a tower with circular section. Rectangular bell tower section is being supported on one side of the church walls, and on the opposite side of a brick arch that has no tie to the beginning and shows cracks. Under the bell tower windows, X cracks were found on the South and North facades, damages characteristic of seismic actions in Fig. 15.

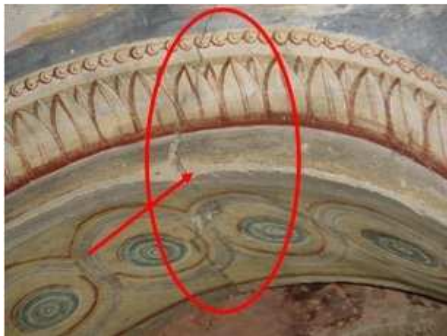
Fig. 16 Cracks at arches

Eastern Tower, not being bounded by land and moving freely with the dome, has minor cracks. Inside the church there are cracks at the top of the vaults because arches don't have ties for taking vertical loads in Fig. 15.

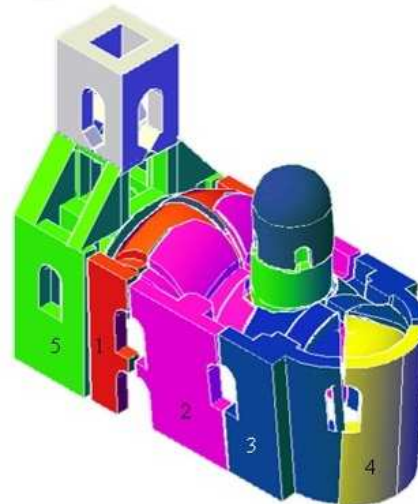
Fig. 17 St. George church, blocks system in ultimate limit state

- ii. Because the greatest damages were recorded in the nave and apse altar, a special attention was given to these areas. They were divided into blocks 1, 2, 3 and 4.

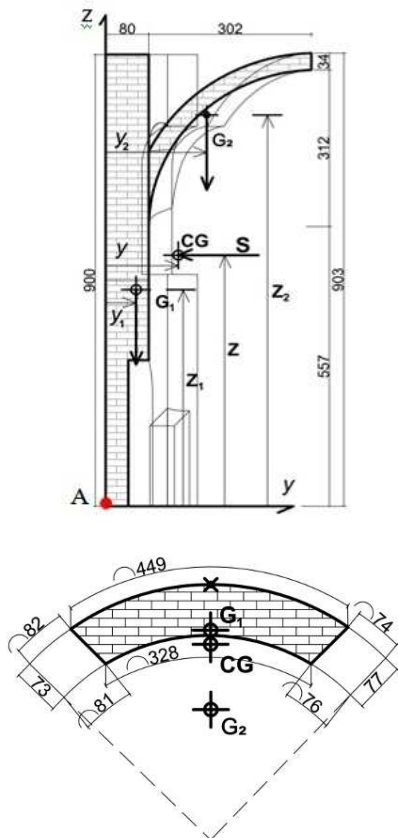
Fig. 18 Dimensions in plan and positions of centers of gravity for block 4

- ix. The equilibrium relation between overturning moment and stabilisation moment was written for each failure block in relation to point A from the wall as shown in Fig. 18. It is located at the outer end wall. According to [6] the proportion ratio between the overturning moment and the stabilization moment of the transfer block is called seismic coefficient and is noted by  $\lambda$ . It has subunit value and represents the maximum value of ground acceleration for which the building collapse that occurs outside of the plan of the failure block. Maximum seismic acceleration of ground in the Monastery of St. George is  $0.16g$ , so  $\lambda_{\max \text{ field}} = 0.16g/g = 0.16$ .  $\lambda$  values calculated by theoretical modeling for each failure block were compared with this value of  $\lambda_{\max \text{ field}}$ . Blocks with a value of  $\lambda$

Because the most damaged transfer block after 1991 earthquakes is block 4, in Figure 18 are presented the dimensions and position of the center of gravity and the point of application of seismic force. There are only two centers of gravity for masonry and bolt and one for the entire block 2. The Name of symbols used in Figure 18 are shown in Table I.

For failure block 4, who was the most damaged after earthquake,  $\lambda$  is determined with (1) [9]. Calculations are presented in Table II. The value of  $\lambda$  is calculated in (2).

$$\lambda_4 = 0,168 \quad (2)$$

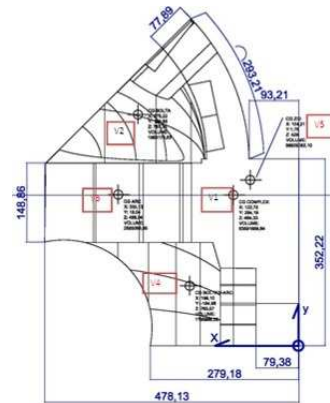
Fig. 19 Dimensions in plan and positions of centers of gravity for block 2

In Fig. 19 and Fig. 20 are shown the dimensions in plan, the positions of the center of gravity and the point of application of seismic force for failure blocks 2 and 3 in 3D coordinates. There are five centers of gravity for each failure block caused by wall, domes and arches. Values of stabilization and overturning moments are presented in Tables III and Table IV. The values are presented in (3) and (4).

$$\lambda_2 = \frac{3167 \text{ kNm}}{11988 \text{ kNm}} = 0,264 \quad (3)$$

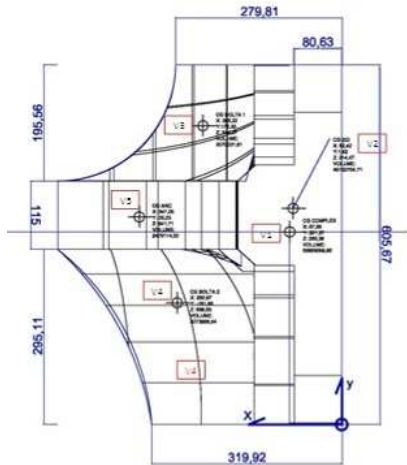
Fig. 20 Dimensions in plan and positions of centers of gravity for block 3

$$\lambda_3 = \frac{2052 \text{ kNm}}{6054 \text{ kNm}} = 0,338 \quad (4)$$
