Seismic Behaviour of Romanian Orthodox Churches, Modeling of Failure Modes by Rigid Blocks

Marius Mosoarca, Victor Gioncu, Ovidiu Cosma

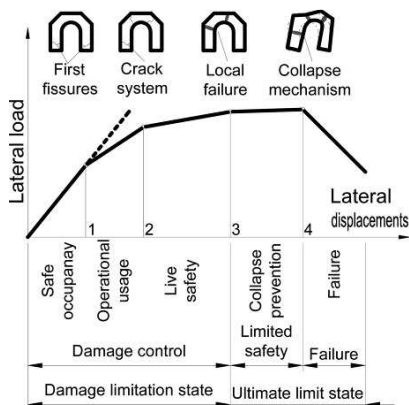
Fig. 1 Behaviour of a masonry triumphal arch

It is well known that masonry structure analysis requires nonlinear modeling accounting for the low tensile capacity and the consequent cracking phenomena. It is well known though that such models cannot be used in the case of very complex structural systems characterized by large number of degree of freedom. In the same time, it is very clearly that the methodologies required for the two limit states differ very much. While for damage limitation state one can use the elastic analysis (with or without considering some fissuration effects), for the ultimate limit state, the methodology must be very different. Therefore, analyzing the behavior of historical buildings, it is need to be adopted a two step procedure as shown in Fig. 1.

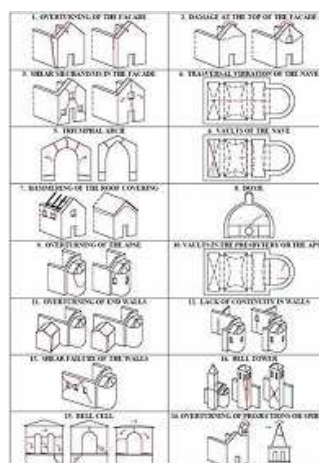
Fig. 2 Romanesque churches. Masonry rigid block [5]

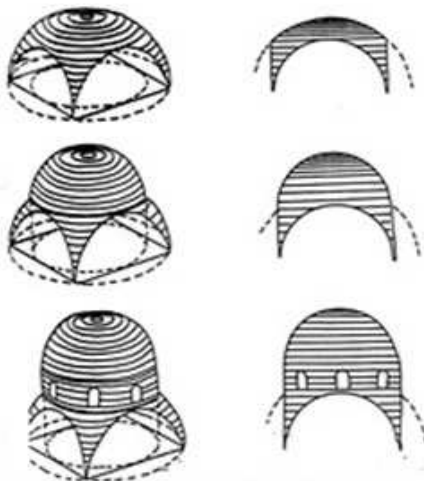
Fig. 4 Pendentives and dome and tower on pendentives

Additionally, the top dome enables to transfer the total load of the roof to the four corners of the building. The top of the pendentive can be trim to introduce another dome on top. The additional dome can further be raised to introduce a cylindrical tower between the pendentive dome and the additional dome.

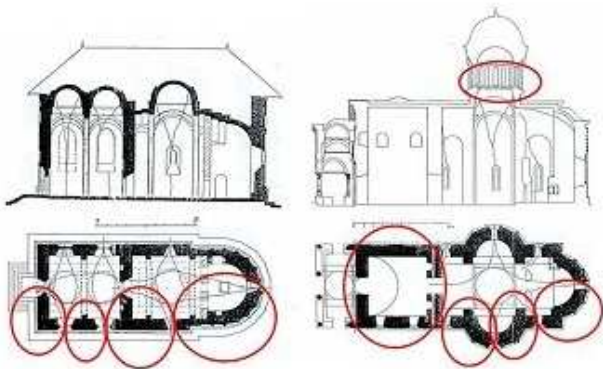
Fig. 7 Damage of Borzesti and Cozia churches due to 1977 Vrancea Earthquake [2]

earthquakes, Fig. 7 presents the Borzesti (rectangular plan) and Cozia (three-lobed plan) churches [2].

Analyzing the occurred system of fissures and cracks it is very clear that the spatial collapse mechanism is formed by a longitudinal fracture and multiple transversal fractures which round the pendentives, due to the great rigidity of these ones.

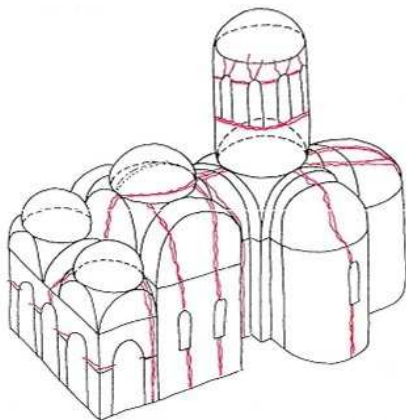
Fig. 8 Blocks system in ultimate limit state [2]

In addition, cracks occurred at the base of tower. The cracks start always from the windows, due to reduced rigidity in these zones. Considering the system of fractures, it is very clear that, in the ultimate limit state, the churches form a block system, working independently each other's as in Fig. 8.

The blocks are formed by the wall delimited by two indows and the corresponding corner pendentives. Due to the seismic actions, the blocks rotate around a basis axis. This rotation is equilibrated by the gravity loads, mainly due to the masonry weight.

i. The biggest cracks are developed in the eastern wall next to the altar, in full compliance with the structural issues outlined above in Fig.8.

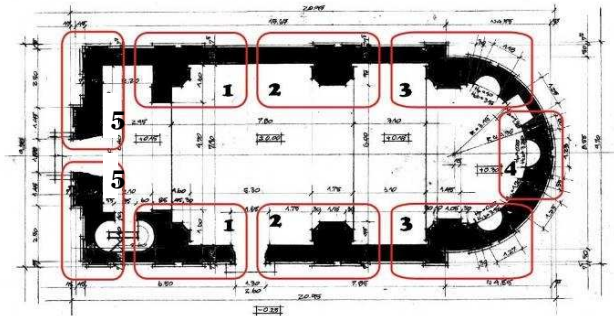
Fig. 13 Mechanism blocks

Under these conditions, considering the presence of openings, masonry has a tendency to separate into blocks by splitting of arches above the openings thus forming nine blocks. The most stressed is block 4 of the eastern wall where are the largest lateral deformations in Fig. 13.

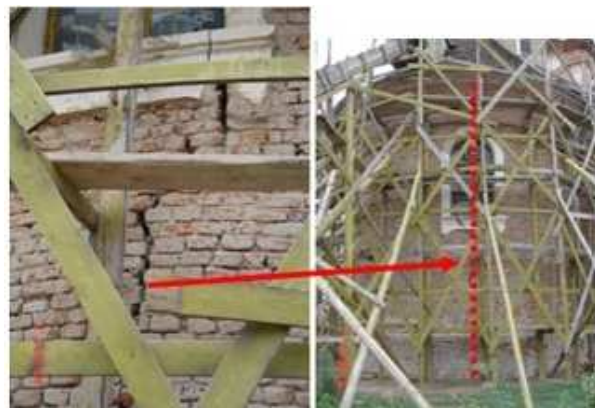
Fig. 14 Cracks at the eastern wall

Brick walls are 75 cm thick, reinforced with brick pillars in front of the roof arches. Masonry structure has a longitudinal symmetry, except the West side where the presence of the stair has introduced an asymmetry characterized by walls with a thickness of 40-45 cm. The window openings on the altar apse and reduced thickness of the wall under the windows have caused cracks in Fig. 14.
