# Structural Engineering Forensic Evaluation of Misdiagnosed Concrete Masonry Wall Cracking

W. C. Bracken

**Keywords**—Concrete masonry, masonry wall cracking, structural defect, structural damage, construction defect, forensic investigation.

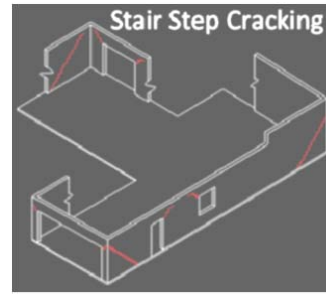
As previously discussed, the most common types of cracking manifest consist of stair step mortar joint cracking, horizontal joint cracking and vertical cracking. For purposes of analysis it is often helpful to map the locations and configurations of the cracking observed. This mapping serves to record the configuration, orientation and extent of propagation of the cracks manifest. See Figs. 1 and 2 for examples of crack mapping showing the types and common locations of cracking.

Fig. 1 Stair Step Crack Mapping

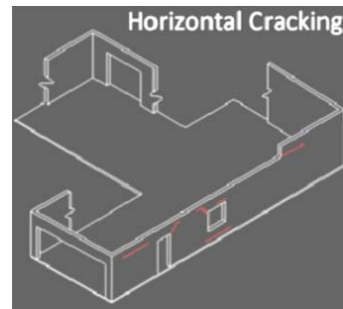
Fig. 2 Horizontal Crack Mapping

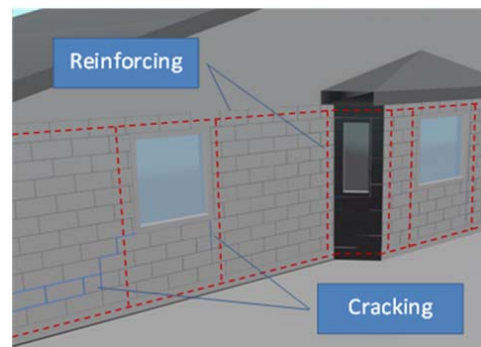
The [structure] exhibited signs of widespread negligible (hairline) to very slight (~ 1/32") masonry cracking. The majority of this cracking is the result of differential settlement of the foundation [shown in Fig. 3].

Fig. 3 As-observed by engineer #2

The location of vertically-orientated rebar/concrete filled masonry block cells were identified and found to be on either side of every opening and at a maximum spacing of 8 feet within the field of the walls [shown in Fig. 3].

Clearly, based on the fact pattern as presented, Engineer #2 has failed to consider the impact of anticipated cracking as the cause of the negligible, non-structural “hairline” to “very slight” ( $< 1/32"$  or 0.8 mm) masonry cracking observed. In addition, Engineer #2 neglected to consider the full impact of the reinforcing within the wall.

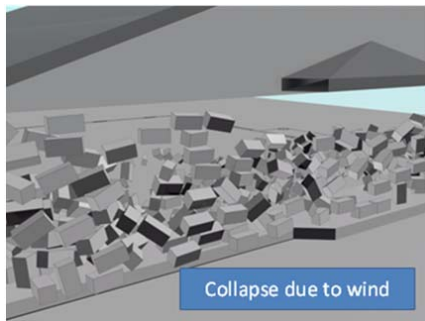
- 2) During the wind load case, considering that both uplift axial and out-of-plane bending forces must be transferred and resisted by the masonry structural components (masonry, mortar and the bond between the two) at the same time, the uplift counteracts the gravity loads limiting the flexural capacity gained by self-weight and dead load. Therefore, a wall segment that has been weakened by consecutive settlement related cracks may not adequately resist the building code mandated out-of-plane loads resulting in the failure shown in Fig. 4.

Fig. 4 Failure as theorized by Engineer #2

In other words, Engineer #2 opined that when the wind blows the wall will fall down based on the following:

- 3) When the wind blows it will generate sufficient uplift to “lift the roof” off its supporting walls and relieve all axial loads,
- 4) Because the wall has cracks, it is incapable of resisting out-of-plane bending,
- 5) With no axial load to resist bending, the cracking will allow the wind to blow the wall down, and
- 6) If the wall cannot resist wind loads, it is structurally compromised.

This failure to consider causes other than differential settlement, combined with a failure to consider the impact of the reinforcing, combined with a failure to perform any computational analysis in support of the opinion, resulted in a catastrophically flawed analysis which was used to promote and prolong litigation. Furthermore, continued failure to consider anticipated causes of cracking within concrete masonry walls combined with a failure to perform a proper analysis, will only continue to result in or be used to support litigation.
