The Comprehensive Study Based on Ultrasonic and X-ray Visual Technology for GIS Equipment Detection

Abstract—For lack of the visualization of the ultrasonic detection method of partial discharge (PD), the ultrasonic detection technology combined with the X-ray visual detection method (UXV) is proposed. The method can conduct qualitative analysis accurately and conduct reliable positioning diagnosis to the internal insulation defects of GIS, and while it could make up the blindness of the X-ray visual detection method and improve the detection rate. In this paper, an experimental model of GIS is used as the trial platform, a variety of insulation defects are set inside the GIS cavity. With the proposed method, the ultrasonic method is used to conduct the preliminary detection, and then the X-ray visual detection is used to locate and diagnose precisely. Therefore, the proposed UXV technology is feasible and practical.

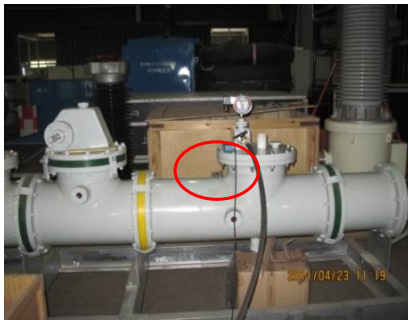
Fig. 5 The site layout photos of the detection equipment

machine, the imaging plate, the computer workstation and other components. During the detection process, the X-ray machine is placed at a certain distance in front of the GIS model, and the imaging plate is close to the GIS cavity and is behind it. The head of the X-ray machine is at the same horizontal line with the center of the imaging plate, and the imaging plate is connected to the computer workstation through the software to receive, display, store and process the data. The site layout photos of the X-ray machine and the imaging plate are shown in Fig. 5 (b).

(a) Site layout of the ultrasonic detection equipment

(b) Site layout of the X-ray detection equipment

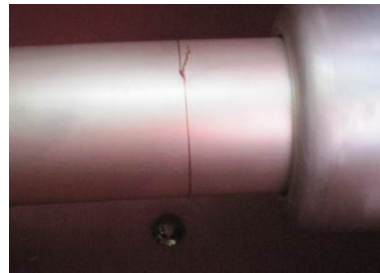
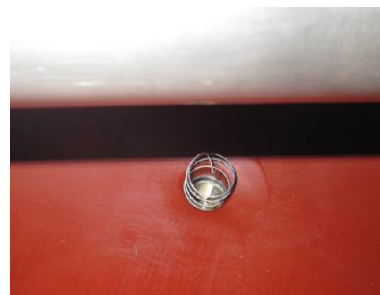
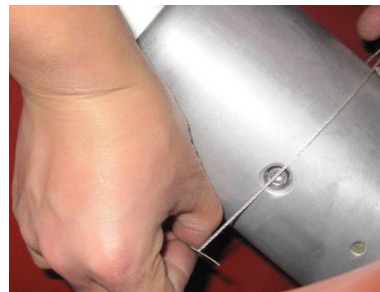
Fig. 6 The physical layout photos of teh simulated insulation defects

protrusion and the metal suspension as the insulation defect models which are usually caused by poor processing, mechanical damage or scratches when assembling. The high field strength area is created around the metal protrusion, and PD occurs consequently. During the experiment, a section of copper wire is wrapped around the high-voltage conductive pole in the bus segment chamber to simulate this defect type. It is shown in Fig. 6 (a). The length of the tip is 40 mm and the diameter is equivalent to 300 μ m. The second defect model is shown in Fig. 6 (b). A metal tip is set inside the GIS chamber wall. The material is iron wire whose equivalent diameter is 100 μ m and whose cutting-edge length is 30mm. The third model is shown in Fig. 6 (c). A piece of aluminum block is hung in the high-voltage conductive pole by the insulation rope. The distance is 20mm between the aluminum block and the high-voltage conductive pole.

(a) Tip on the high-voltage conductive pole

(b) Tip on the ground electrode

(c) Floating potential
