The Effectiveness of Synthesizing A-Pillar Structures in Passenger Cars

Chris Phan, Yong Seok Park

Keywords—A-pillar, crashworthiness, design synthesis, finite element analysis.

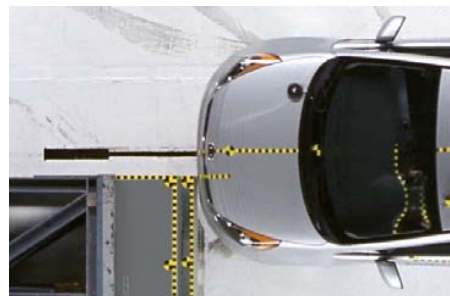
Fig. 1 Moderate Overlap Frontal Test Configuration

The most common type of crash resulting in fatalities is the frontal crash. For this reason, major efforts have been made to improve front protection, mainly from the crash test program that the NHTSA began in the late 1970s and the crashworthiness evaluations that IIHS began in 1995. When IIHS began the moderate overlap frontal crash test, the majority of vehicles were rated poor or marginal. Today, all vehicles earn good ratings since vast improvements have been made to occupant compartments and standard passive safety restraints such as safety belts and airbags protect the passengers. In the moderate overlap frontal crash test, a vehicle travels at 40 mph into a 2 feet tall deformable barrier made of aluminum honeycomb. A Hybrid III dummy representing an average-size man is positioned in the driver seat. 40% of the total width of the vehicle strikes the barrier on the driver side. This test simulates a frontal offset crash between two vehicles of the same weight, each traveling at 40 mph [5].

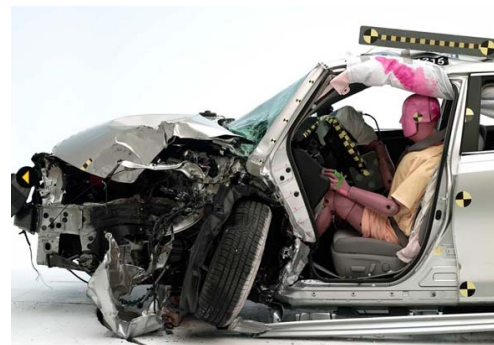
Fig. 6 2012 Camry Small Overlap Frontal Crash Results

The post-crash image of the 2012 Camry shows that the A-pillar has buckled and there is major intrusion into the occupant cabin. There is definite contact between the dummy's legs and the dashboard from firewall intrusion. The dummy's position in relation to the door frame, steering wheel, and instrument panel after the crash test indicates that the driver's survival space was not well maintained.

When comparing the two images of the 2012 and 2015

Camry post-crash images, it is apparent that the A-pillar deformed much less in the newer car. Thus, it is possible that Toyota upgraded the A-pillar structure in the 2015 Camry to earn a “good” rating in the frontal small overlap crash test.

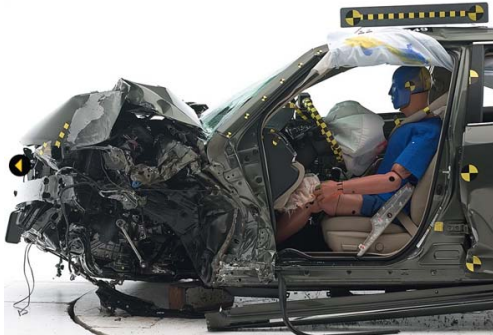
Conversely, the post-crash image of the 2015 Camry shows that the A-pillar has low deformation and the occupant compartment has little intrusion. The dummy's position in relation to the door frame, steering wheel, and instrument panel after the crash test indicates that the driver's survival space was maintained reasonably well in the IIHS' test.

Fig. 7 2015 Camry Small Overlap Frontal Crash Results

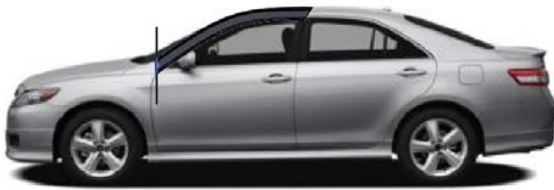
Fig. 11 CAD Modeled A-Pillar Overlay of 2012 Camry

Two A-Pillar CAD models were drawn in SolidWorks software to be analyzed. An image of the side profile of both the 2012 and 2015 Toyota Camrys were pasted into SolidWorks to accurately define the scale to find the actual size of the vehicle. Both vehicles had a wheelbase of 2772.2 mm and the scale was set accordingly. A spline was drawn to close follow the curvature of the A-pillar as a backbone. A generic A-pillar cross-section was drawn and extruded to follow the spline previously made to create the structure for the 2012 Camry. The wall thickness was set to 1.27 mm according to the 18-gauge steel commonly used in A-pillar sheet metal in most cars. The same process was executed for the 2015 Camry A-pillar, using the 2012 Volvo XC60 cross-section. These two A-pillars will have their performance tested in a simulation using ANSYS software.

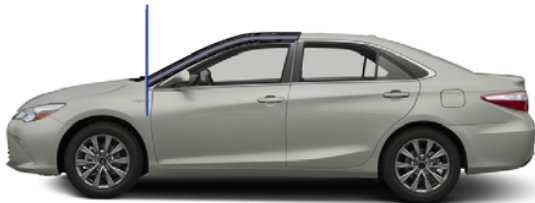
Fig. 12 CAD Modeled A-Pillar Overlay of 2015 Camry

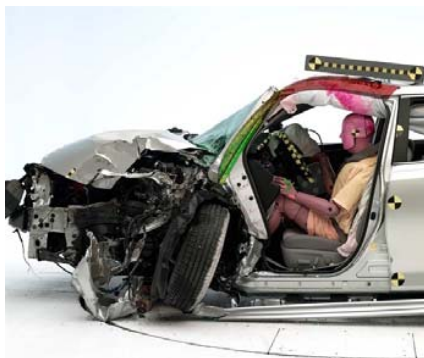
Fig. 15 Overlay of 2012 Camry A-Pillar Simulation on Actual Crash Photo

Comparing the results from the A-pillar simulations to the actual IIHS small overlap crash test photos containing the A-pillar structures, parallels can be seen. The total deformation of 9.843 in. in the longitudinal direction on the 2012 Camry appears to be consistent with the A-pillar buckling in the photo of the 2012 Camry in the IIHS crash test. Similarly, the lack of deformation of 1.154 in. from the 2015 Camry simulation matches the IIHS crash test photo for the 2015 Camry. Using the 61 cm. scale from the photo, the actual deformation is fairly close to total deformation from the simulation for both models. Examining the stress concentration denoted in red on the 2012 A-pillar in the simulation, it appears to be a match to the point of buckling on the actual 2012 Camry A-pillar. There is also a small stress buckling on the 2015 Camry pillar that matches the slight buckling on the actual pillar. Observing the data from NHTSA's NCAP test report for interior intrusion of the upper pillar, it appears to be a close match to the simulation results. The 2012 Camry reported an upper hinge pillar intrusion of 19 cm. whereas the simulation stated 25.4 cm. The 2015 Camry reported only 8 cm of upper hinge pillar intrusion and the simulation showed 2.93 cm. Comparing the values from the simulation, the data are a close match (within 6 cm) of the numbers from NHTSA's reports for both Camry models. Thus, the simulation performed validates the possibility of a cross-section shape upgrade between 2012 and 2015 in the Toyota Camry.

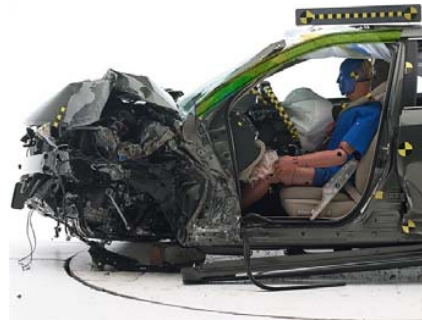
Fig. 16 Overlay of 2015 Camry A-Pillar Simulation on Actual Crash Photo
